Payson Ranger District – Bull Springs Allotment Inspection Report

File Code: 2210, 2230
Date: 10/10-10/11/2018
Document: Inspection Report

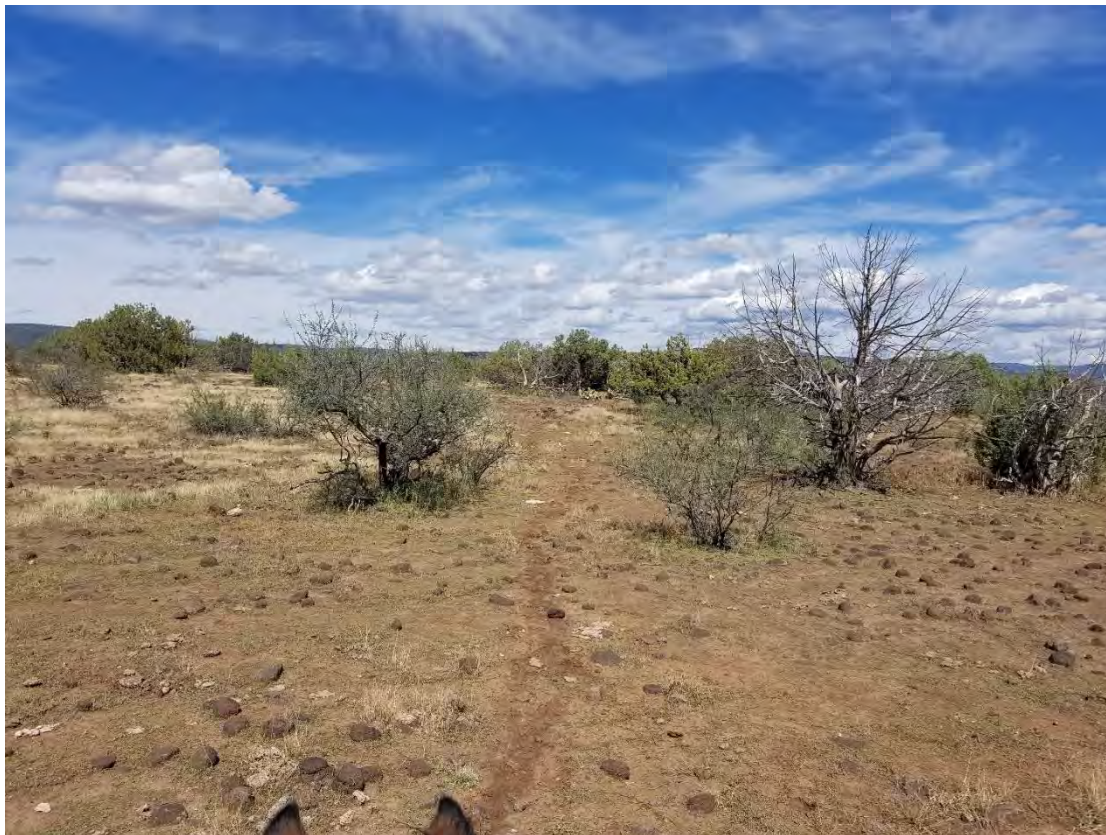
We began the inspection on October 10th, and started at the Doll Baby trailhead. We took Arizona Trail and headed to Red Saddle Tank on top Polles Mesa. When we got up on the Polles Mesa, the gate to the pasture was laid open across the trail. I observed fresh cattle tracks heading north to Red Saddle Tank. We can confirm tracks were within a day or so, as it had rained no longer than 3 days prior to the inspection.

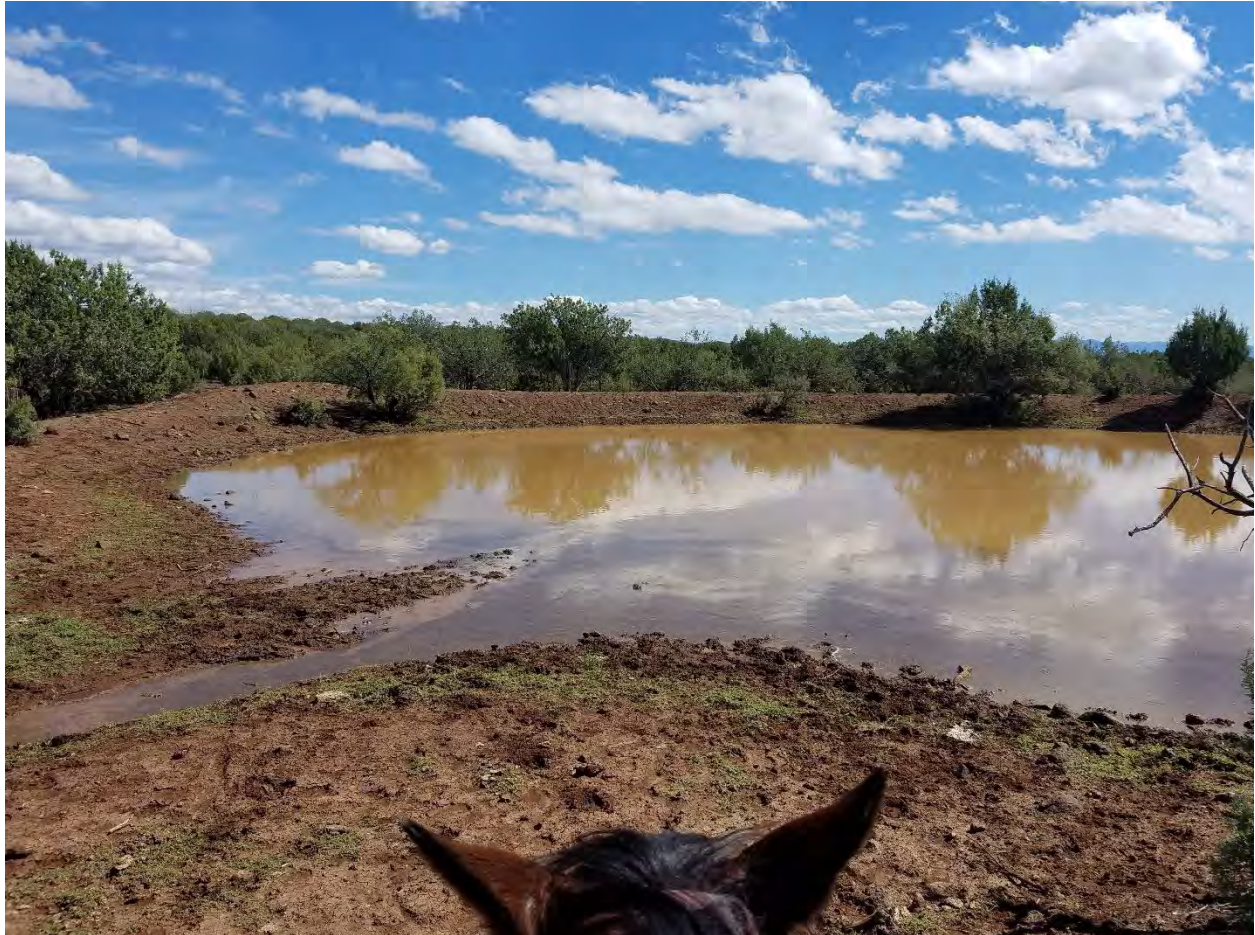
We followed cattle tracks to Red Saddle Tank. The tank was full and cows are actively watering here. There is a trap surrounding the tank that has recently been repaired. There are several gates around the tank. All gates were left open.

Red Saddle Tank is full and cows actively watering here. This area is not scheduled for use

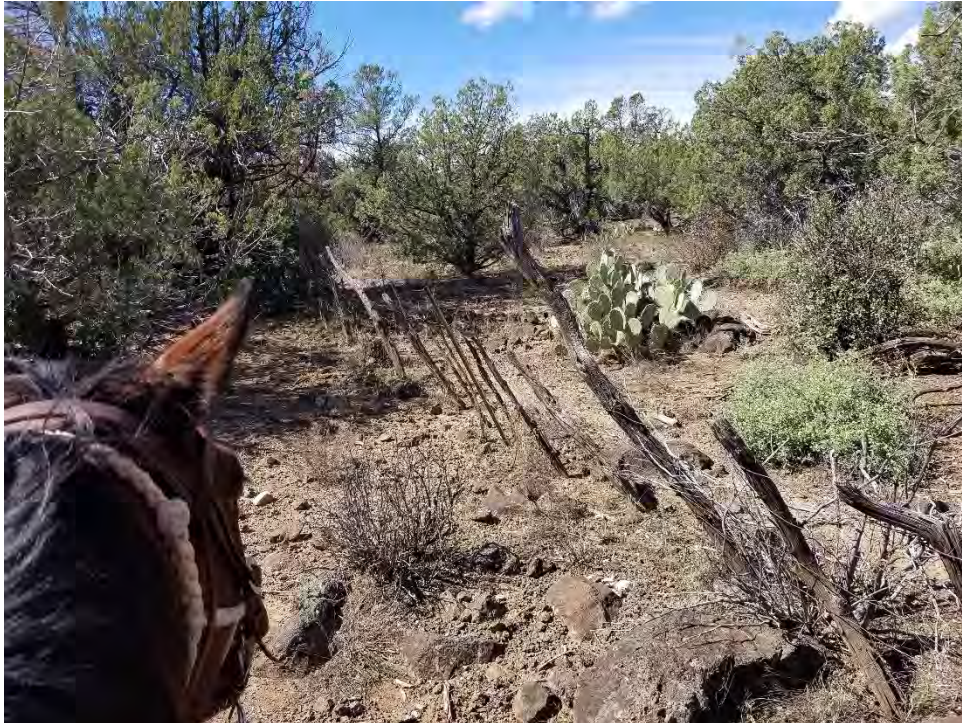
From here we followed tracks to the northern boundary of the allotment. The allotment boundary gate between Bull Springs and Hardscrabble allotment was found closed. We rode west across the mesa and inspected the fence line. A deadline of May 1, 2018 was given to the permittee to have all northern boundary fence complete. This fence line was complete, although in poor condition. It appears to be of original construction and is not built to Forest Service Standard or any discernable standard.

Polles Mesa- northern boundary fence. Fence is standing although in poor condition. The fence here is constructed of four single strands of smooth wire and the 5th (bottom wire) is barbed.

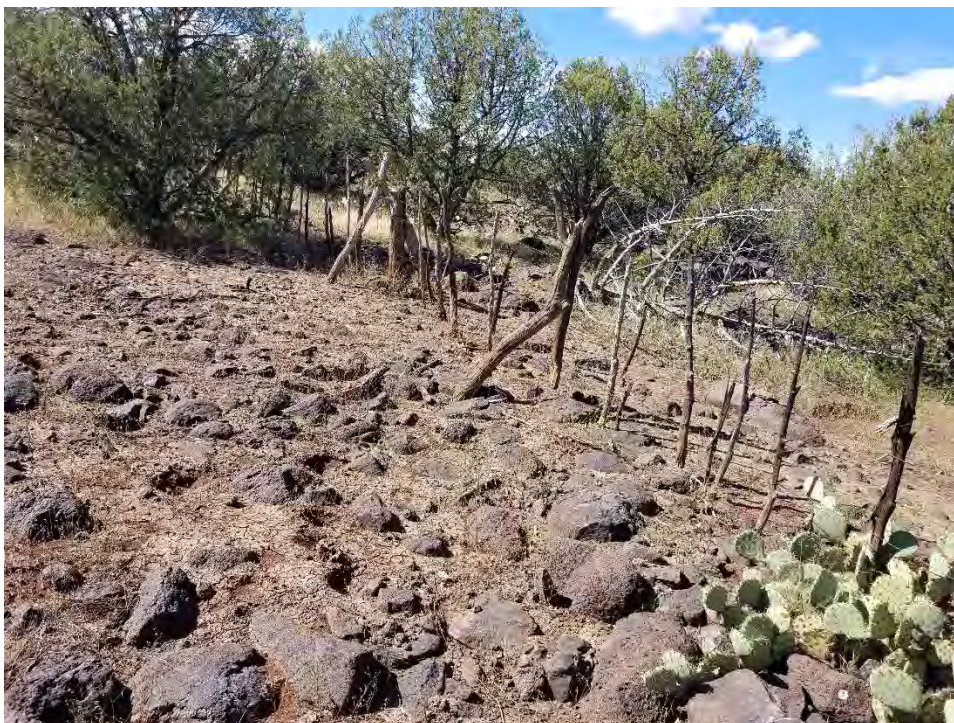
Polles Mesa- northern boundary fence. Fence stays are almost entirely wood. There are junipers leaning against the fence propping it up in places.

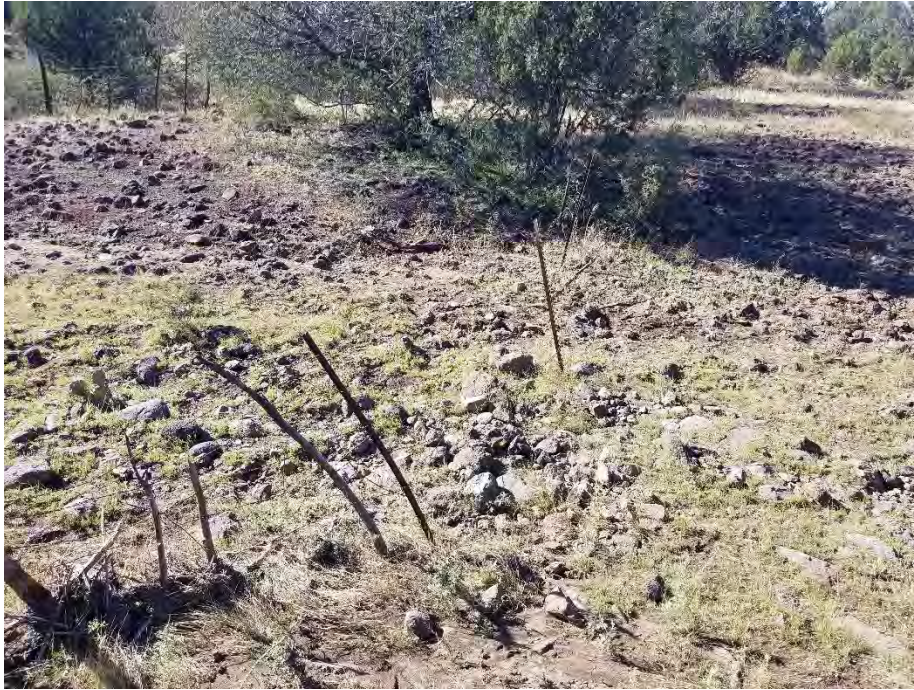
As we rode the northern boundary, we crossed from East Polles pasture into Mid Polles pasture, and then into West Polles pasture. The only closed gate I encountered during the entire inspection over the course of two days was found here. I did not have to open this gate to pass through because the fence was down just south of it. Fence between these pastures was down in at least 4 locations and has been for some time. There are cattle trails going through these areas (see attached inspection map).

Fence down between West and Mid Polles Pastures

- The fence line between West and Mid Polles pasture is non-functional. All fences on Polles Mesa were to be repaired by December 2015.
- There are at least 50 cattle currently on Polles Mesa. Cattle are not authorized to be in these pastures. The permittee was notified of this on July 25, 2018 and asked to move them to their scheduled pastures. As per the mediated agreement and general good management practices, pastures will be cleaned within 14 days.

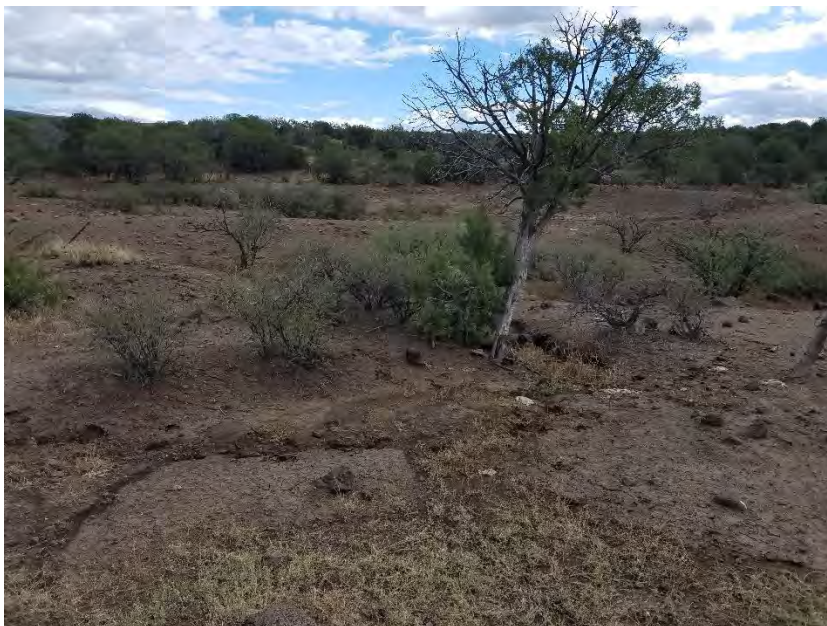
West Polles Tank is blown out and dry. Here a fence around it is down and separates West and Mid Polles Pastures

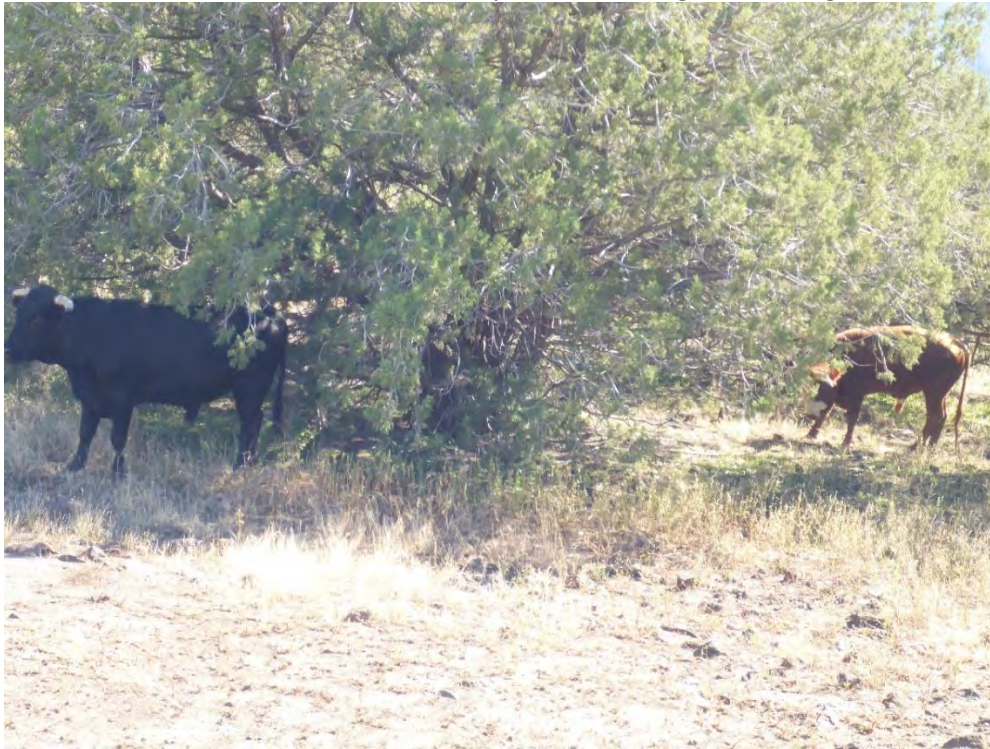
Two unbranded bulls were observed at the north end of West Polles pasture. I got within 10 yards of a black horned bull and did not observe any brands, ear tags or markings.

Two unbranded bulls in West Polles pasture.

- Nearly half of all animals observed on the allotment were unbranded. Per the Term Grazing Permit, part 2(g), only livestock marked, tagged, or branded as shown in the application upon which this permit is based as may be required under Section 8(f), will be allowed to graze under this permit unless the permittee has advance written approval from the Forest Officer in charge to do otherwise.

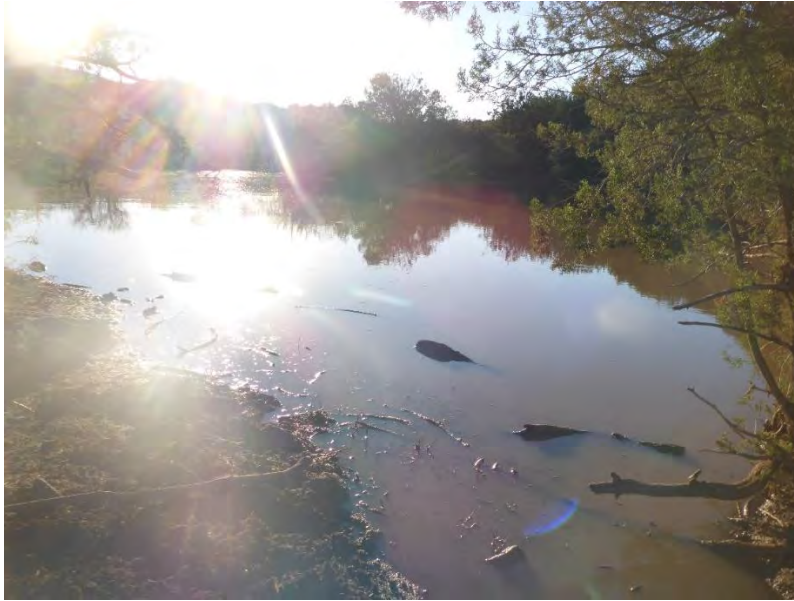
Division Fence Tank

We inspected the fence to the south where it bluffed out. Here we stayed overnight at Division Fence Tank. The tank was full. At the tank we watched an unbranded cow/calf come into water. More cows were heard to the east bawling.

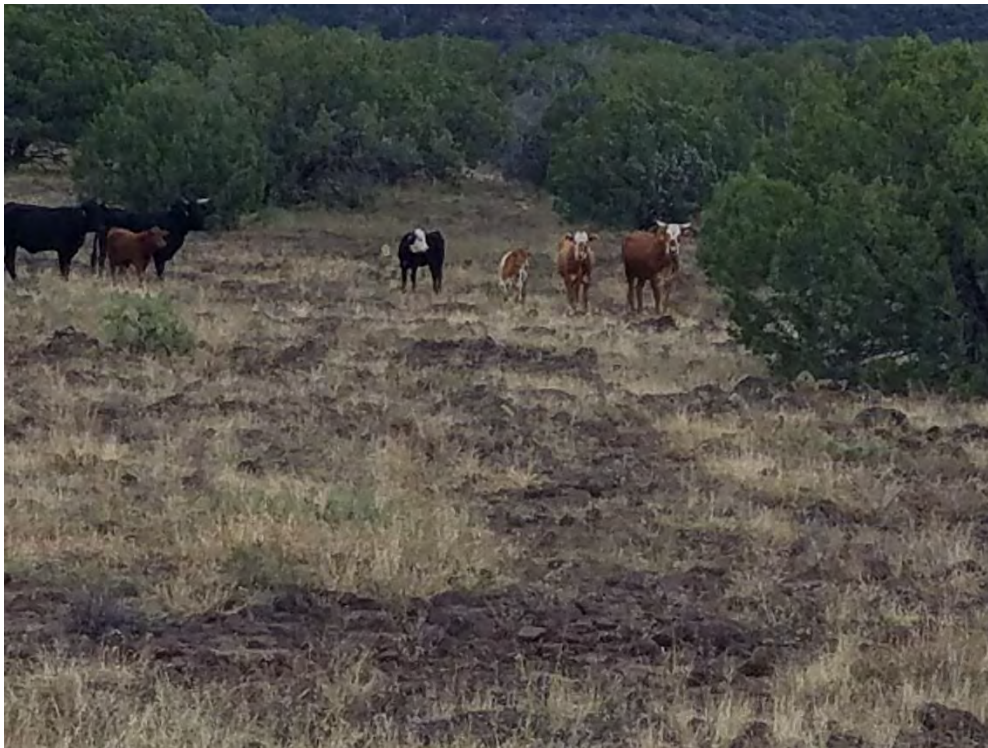
In the morning, Tyler and I split up. He went south to inspect Oak Grove pasture and I went back up on Polles Mesa. I rode west and did a loop across West Polles pasture. I came across 3 unbranded cows (appeared to be a mother with a yearling and calf). I headed off in the direction of the cattle which took me to the fence line between West and Mid Polles pasture. I followed a cow trail through the damaged fence line and located a herd of animals. There were 15-20 animals here. Some animals were branded/marked and some were not.

Cattle at the West Polles/ Mid Polles pasture divide. There were 15-20 animals here.

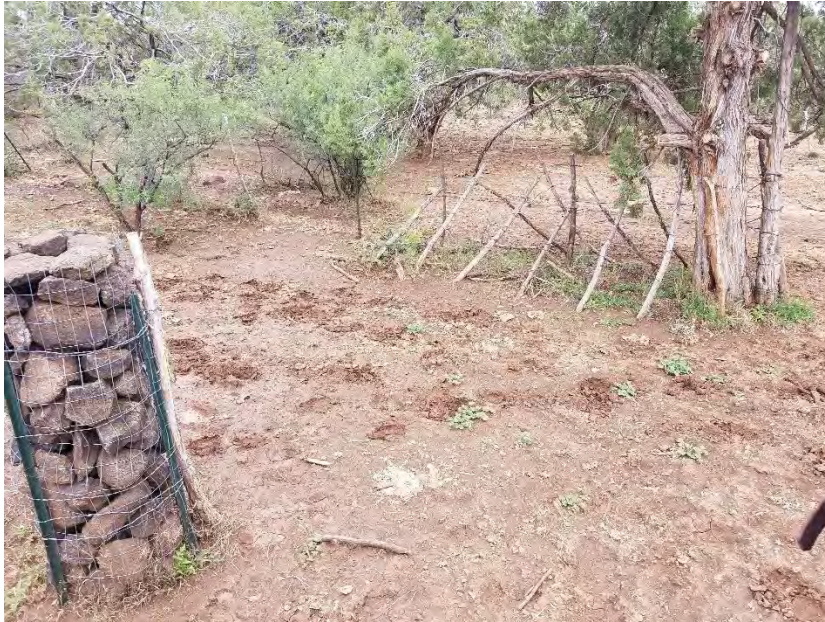
I rode around Mid Polles pasture. Seven animals were observed on the east end of the pasture. I heard more animals bawling but was unable to locate them. After riding around the pasture, I headed to Mid Polles tank. The tank was full of water and fence around it was recently repaired. All gates around the tank were down. While inspecting Mid Polles tank a branded bull came to the tank.

Fences down around Mid Polles tank. Gates have been open long enough for vegetation to grow in a sheltered areas where they are protected from grazing.

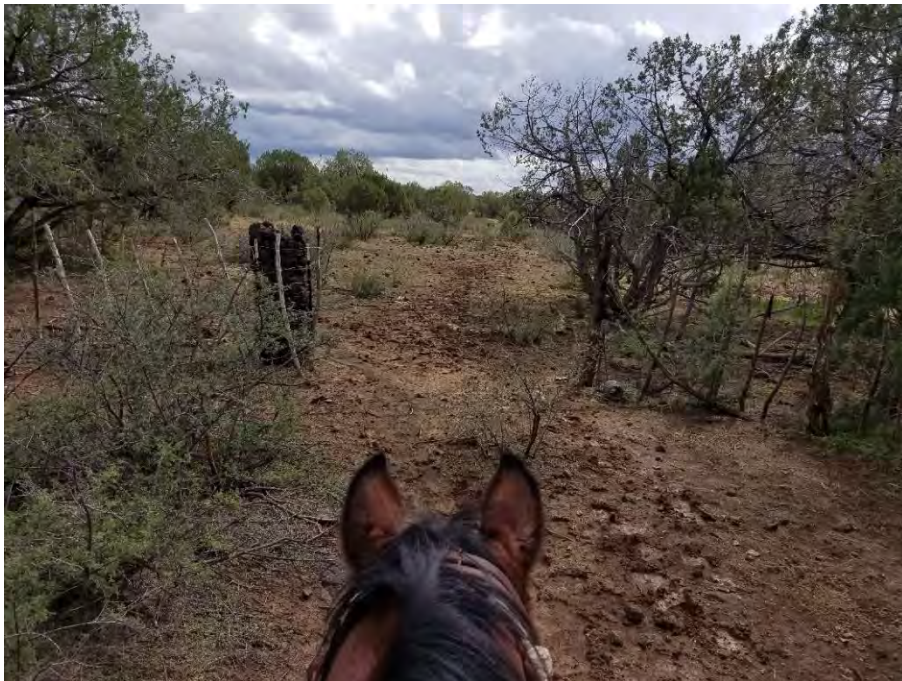
Gates open between Mid Polles and East Polles pastures. A trap next to the water lot was open and branding irons left to the side.

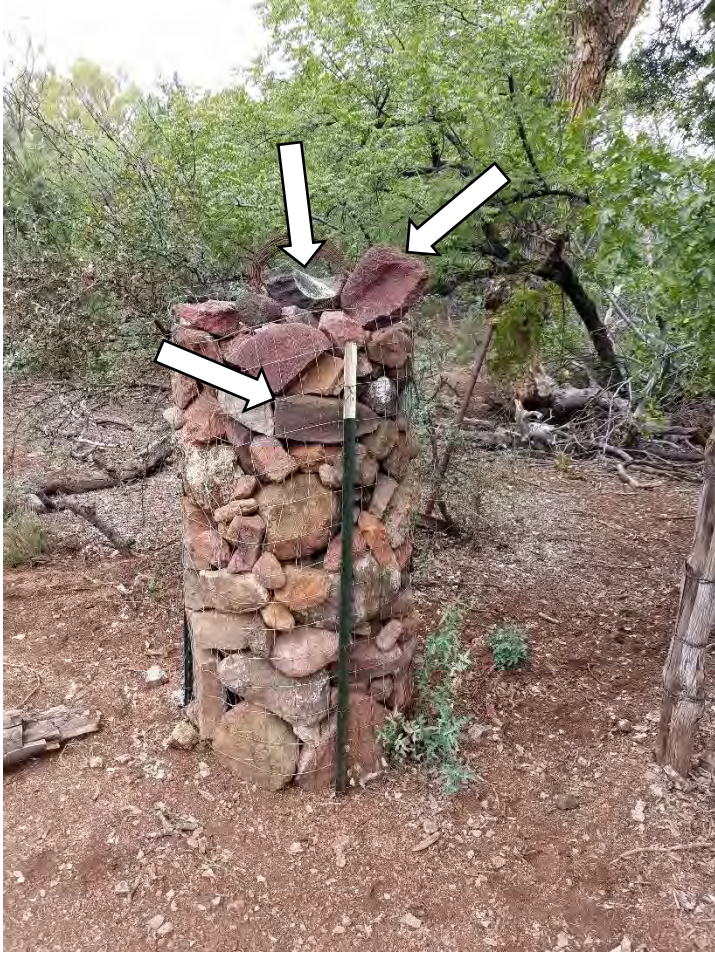
I continued east along to Arizona Trail to Polk Springs. Adjacent to the trail, a rock gabion (used here in fence line construction) appears to have been recently been constructed using metates (Native American grinding stones). Cultural artifacts like these are protected under the Archaeological Resources Protection Act of 1979 (ARPA), which governs the excavation of archaeological sites on federal lands and removal of archaeological collections from those sites. There is likely a site nearby and the source of these grinding stones. This appears to be an egregious violation of the Act.

Several metates can be see displayed in a rock gabion adjacent to the Arizona Trail, next to Polk Spring.

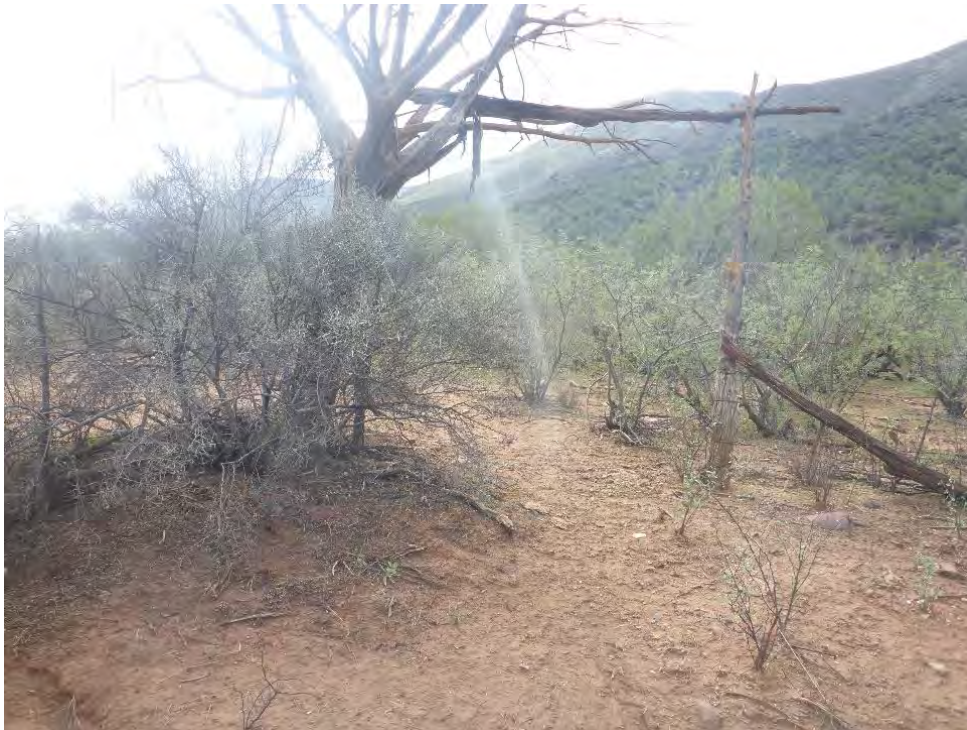
I met with back up with Tyler nearby and we continued back to the trail head. Tyler shared with me what he saw in Oak Grove pasture. He had inspected the Oak Grove trap which was assigned to be completed by August 1, 2018. The fence around the trap was standing, although condition of the trap is poor.

Oak Grove trap was to be completed by August 1, 2018. It appears fence is standing around it although the condition is poor and a limited attempt was made to “complete” it.

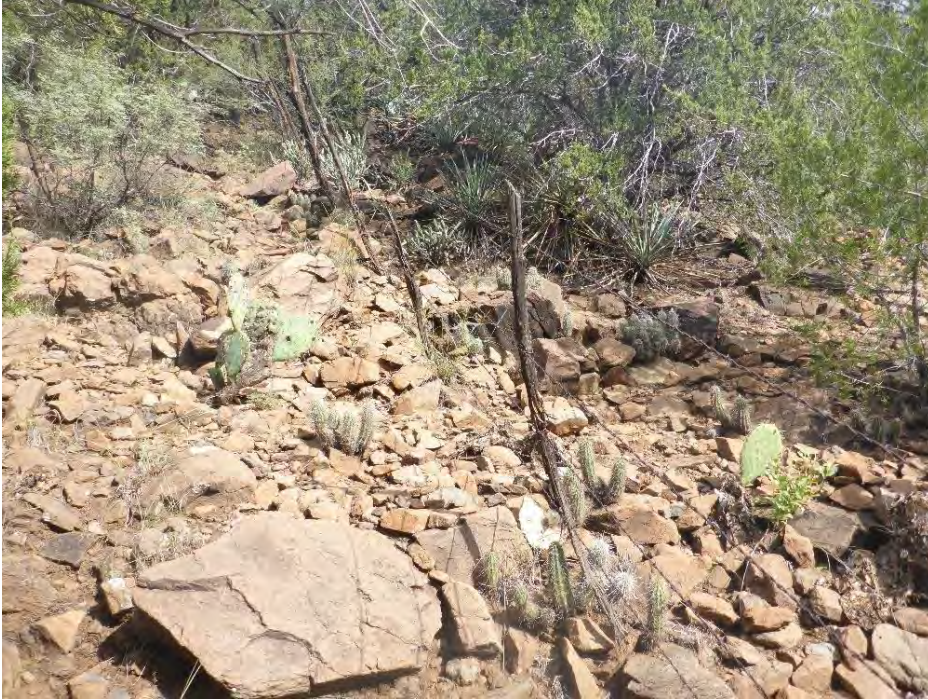
The condition of fence around Oak Grove trap is poor

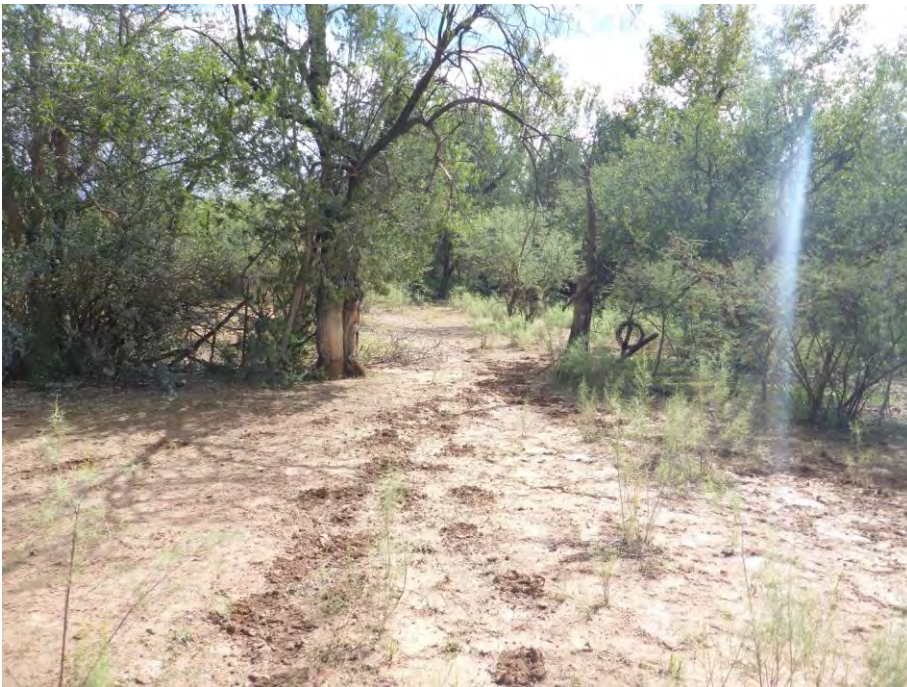
A gate left open between Pocket and LF pasture. Cattle recently passed through here.
