Babocomari River PFC Revisited October 2018

Jeff Simms, Fishery Biologist

Photo Catalog from PFC conducted in October 2013

Photo Catalog from the Filed Survey to Revisit Stream Function in October 2018

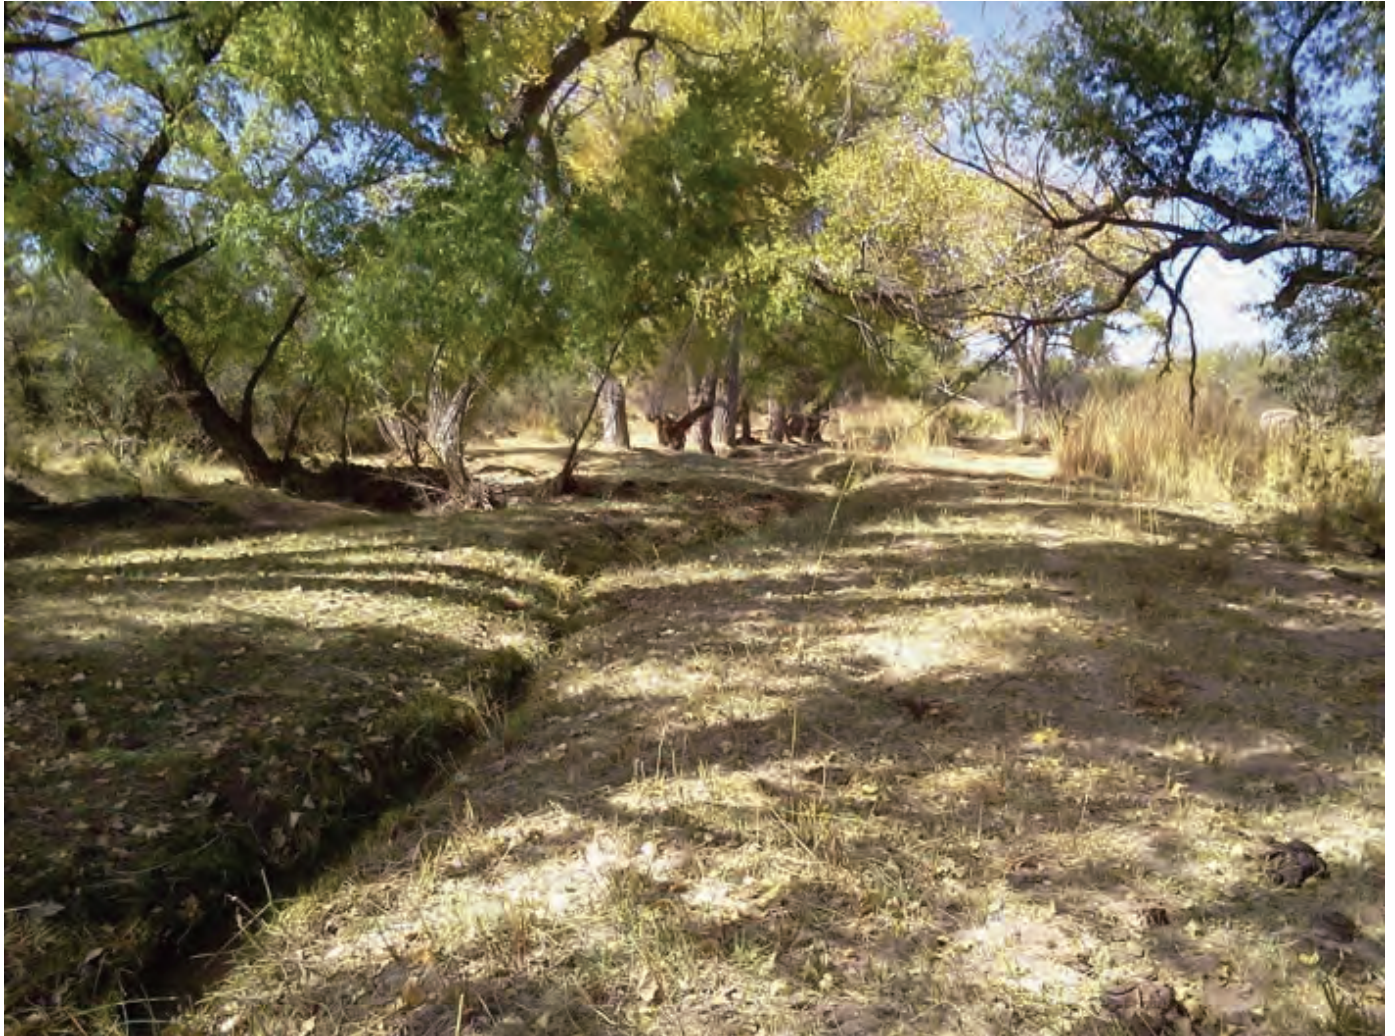
Figure 1. Cow trail on floodplain becoming incised. Herbaceous cover heavily grazed.

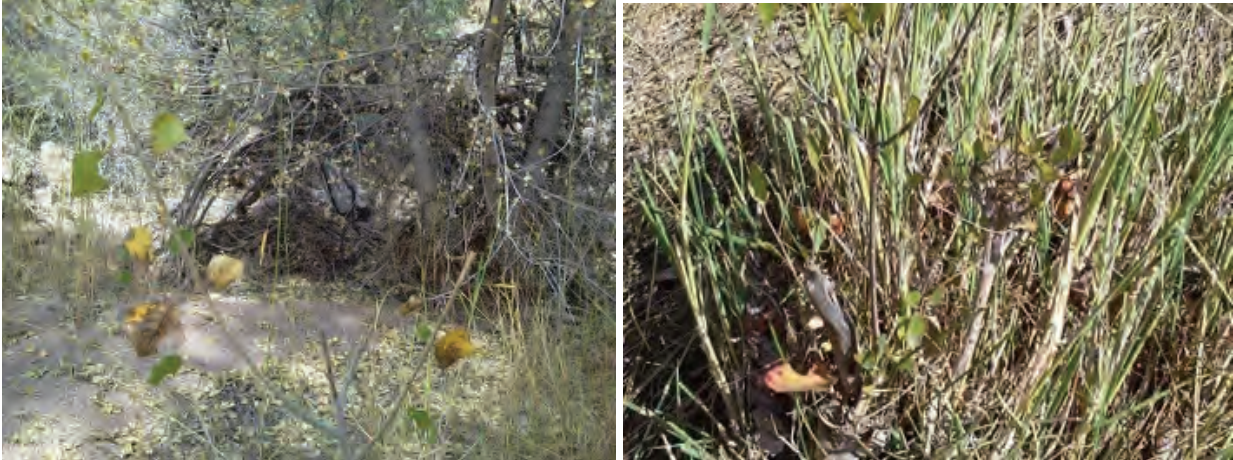
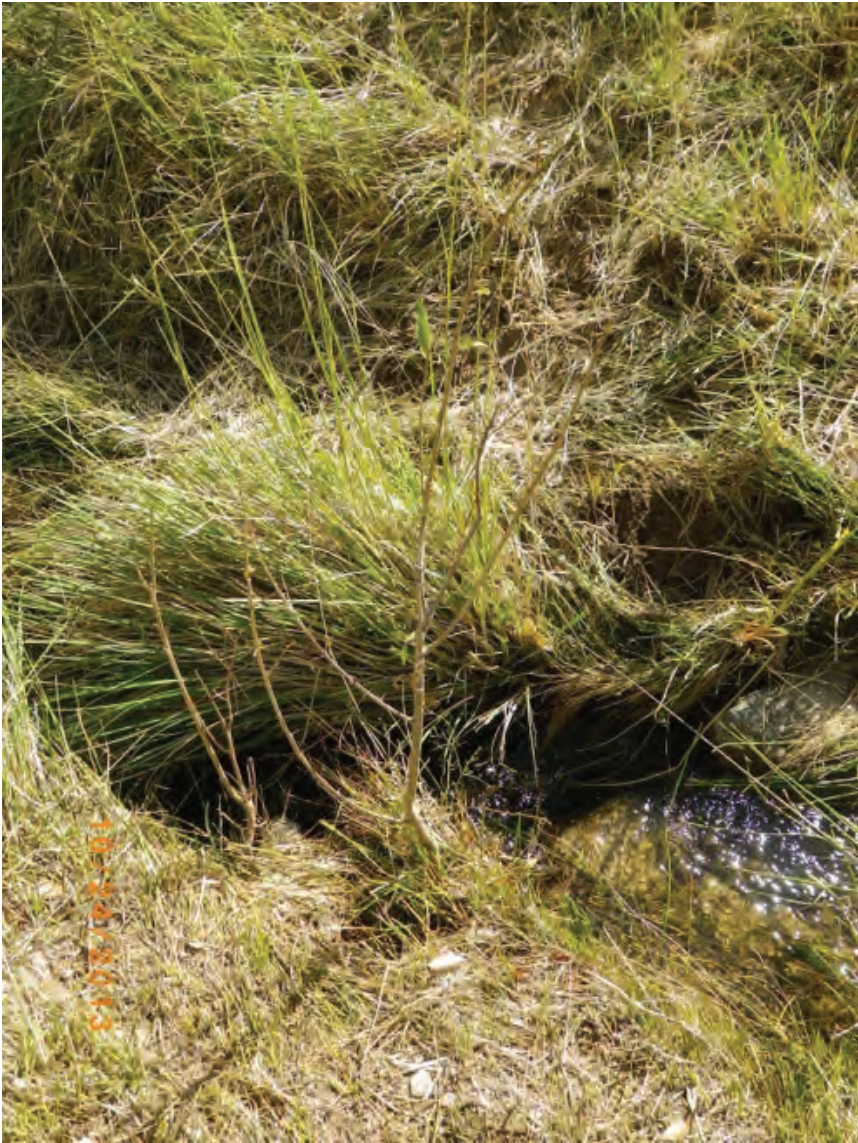
Figure 2, 3 and 4. Sapling trees showing characteristics of being repeatedly browsed.

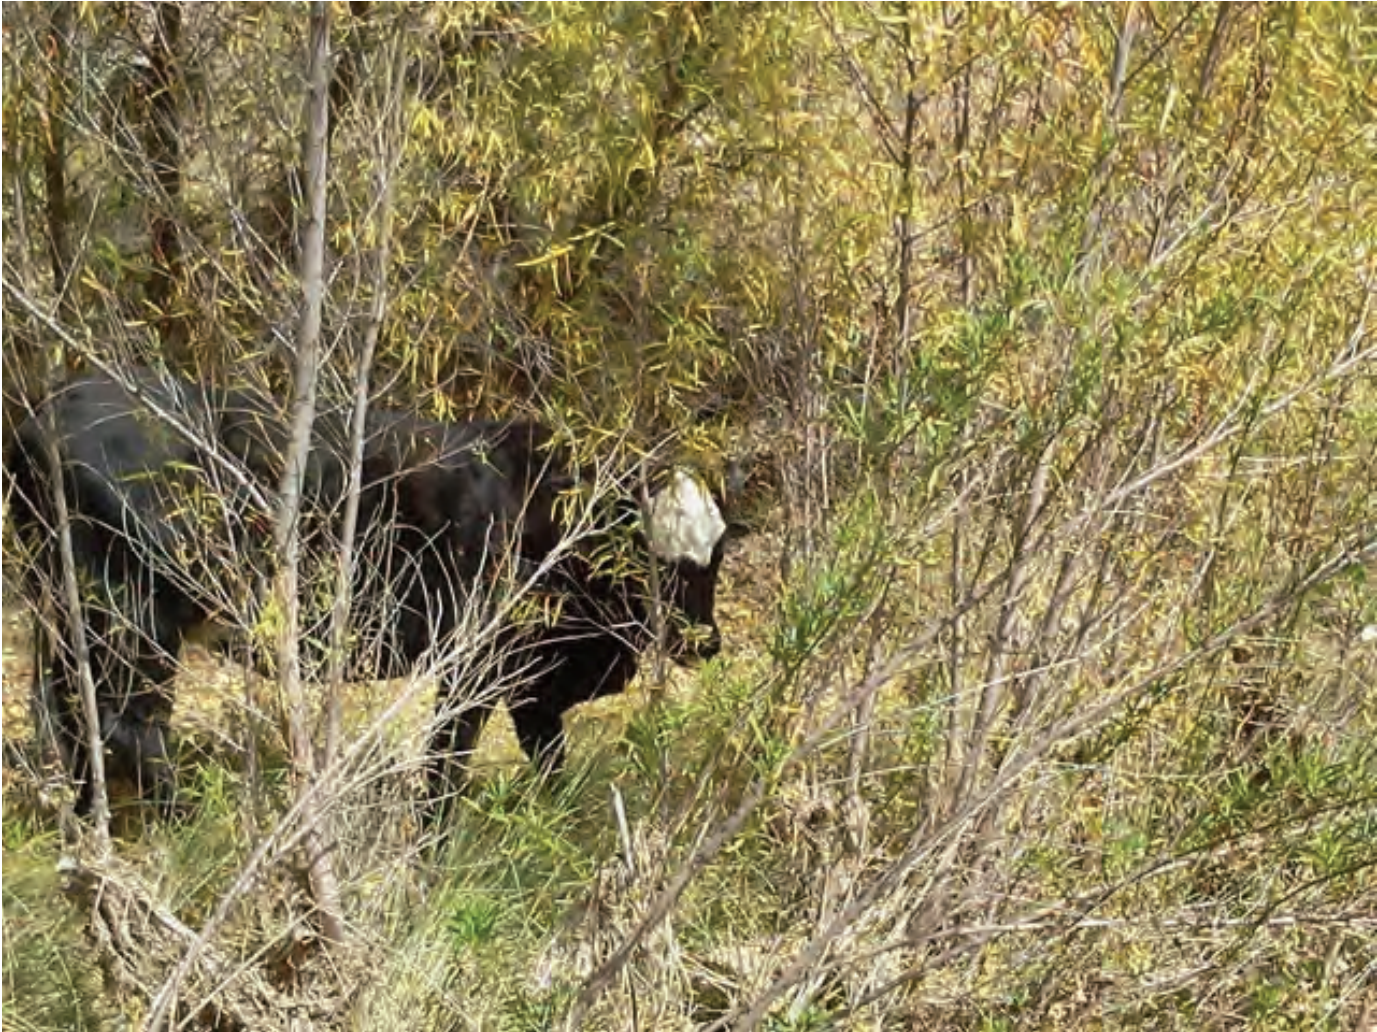
Figure 5. Cow foraging in riparian area.

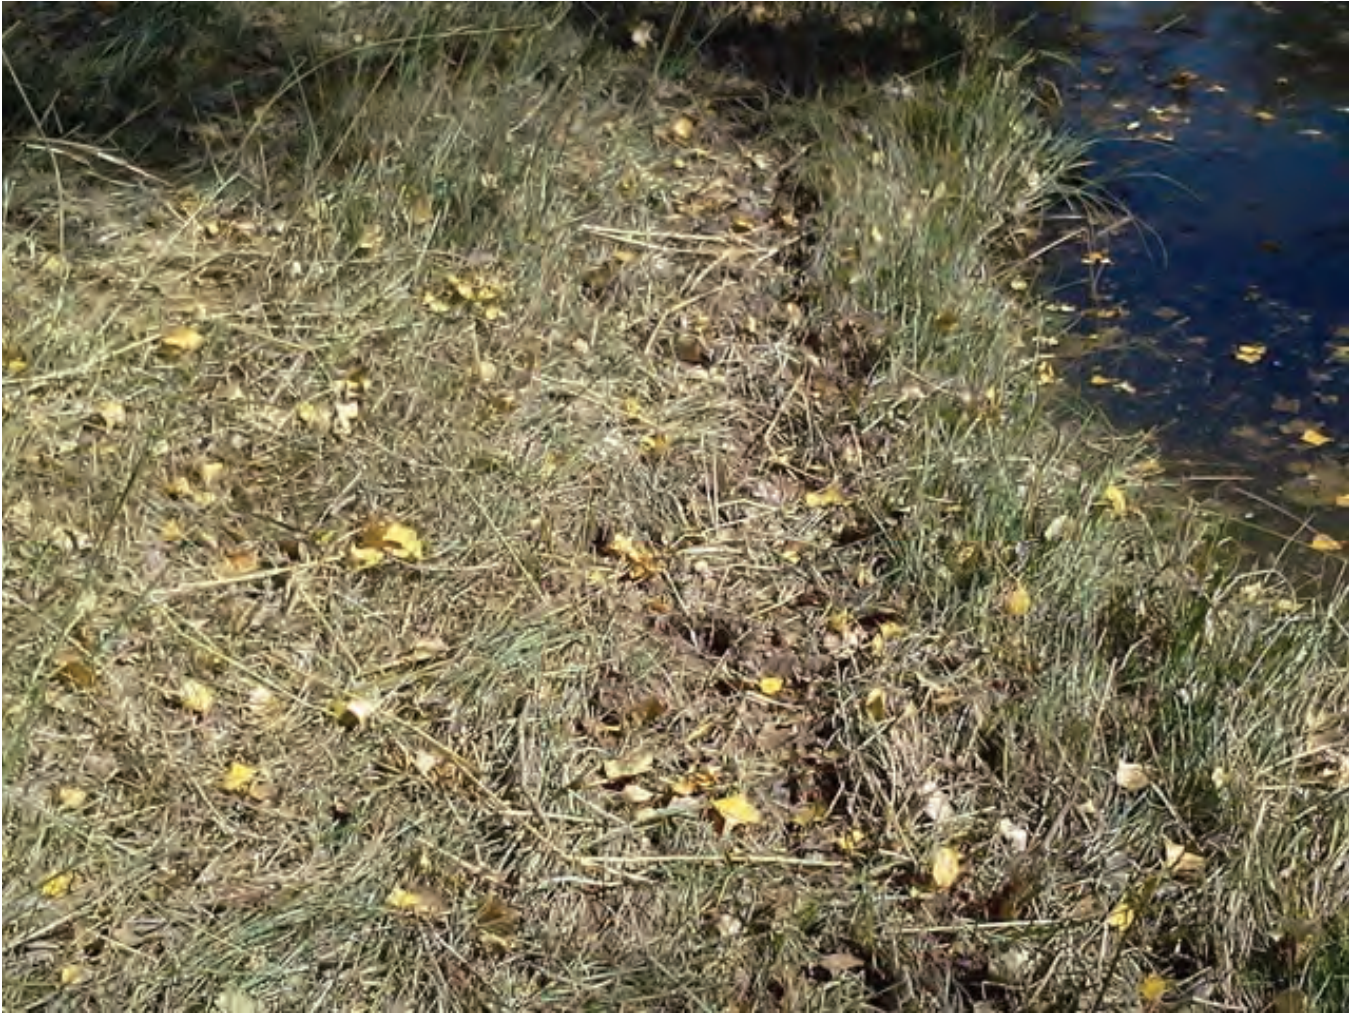
Figure 6. Grazed herbaceous bank cover and bank sheering.

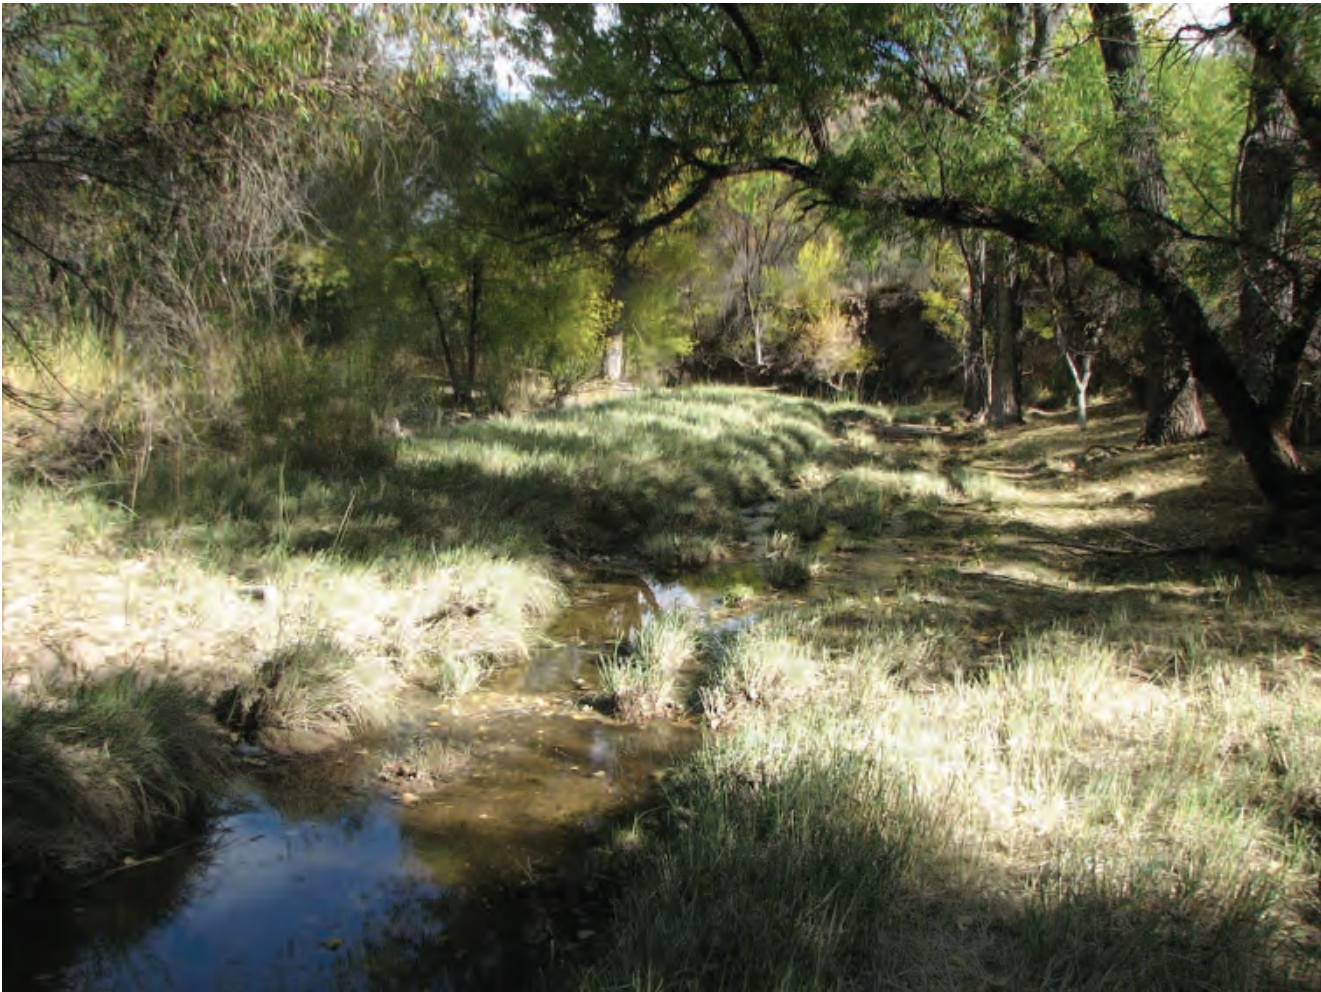
Figure 7. Multiple channels resulting from degradation of cow trails.

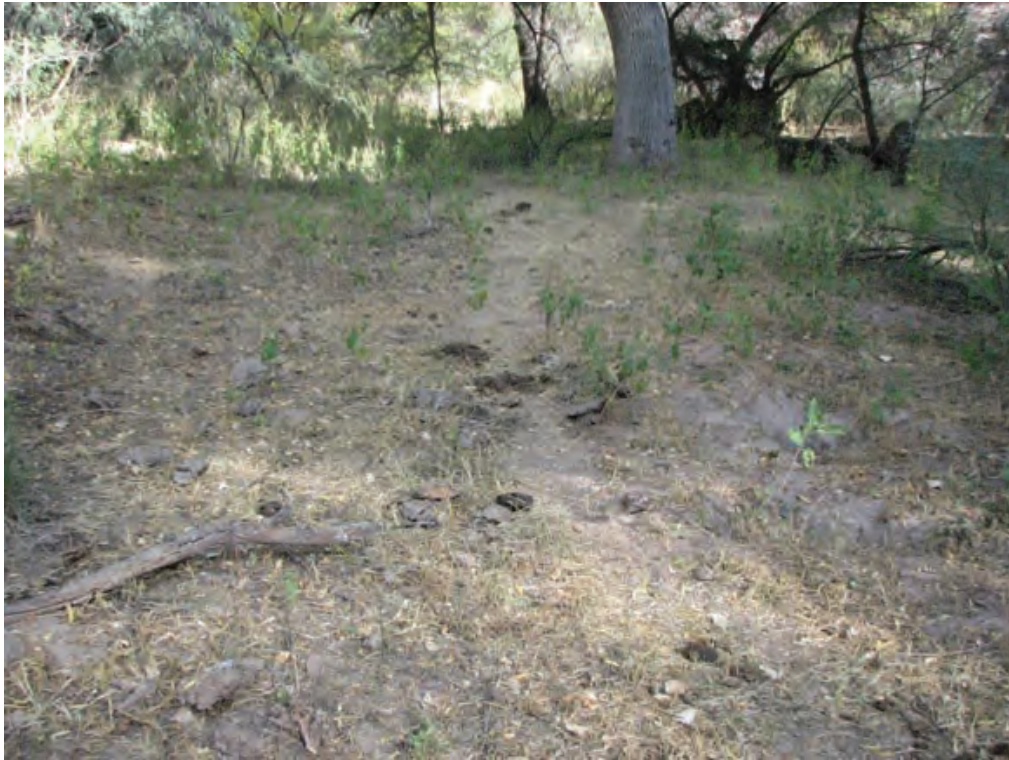
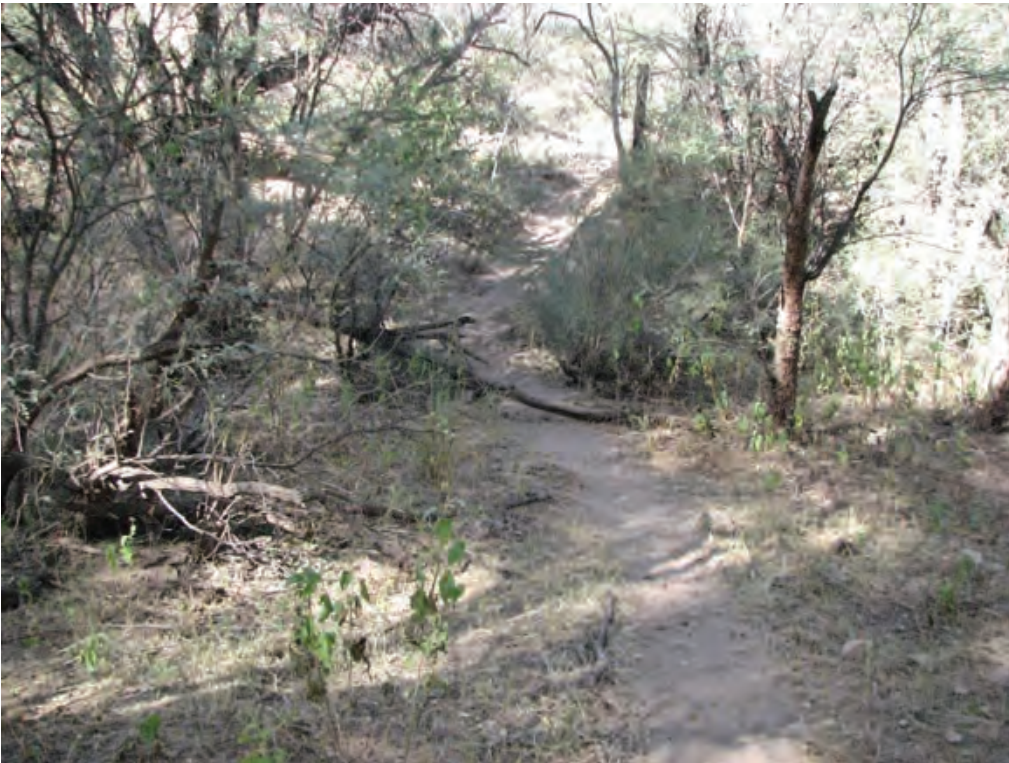
Figure 8 and 9. Examples of well-worn trail and grazed herbaceous cover. Trails are vulnerable to incision with flooding.

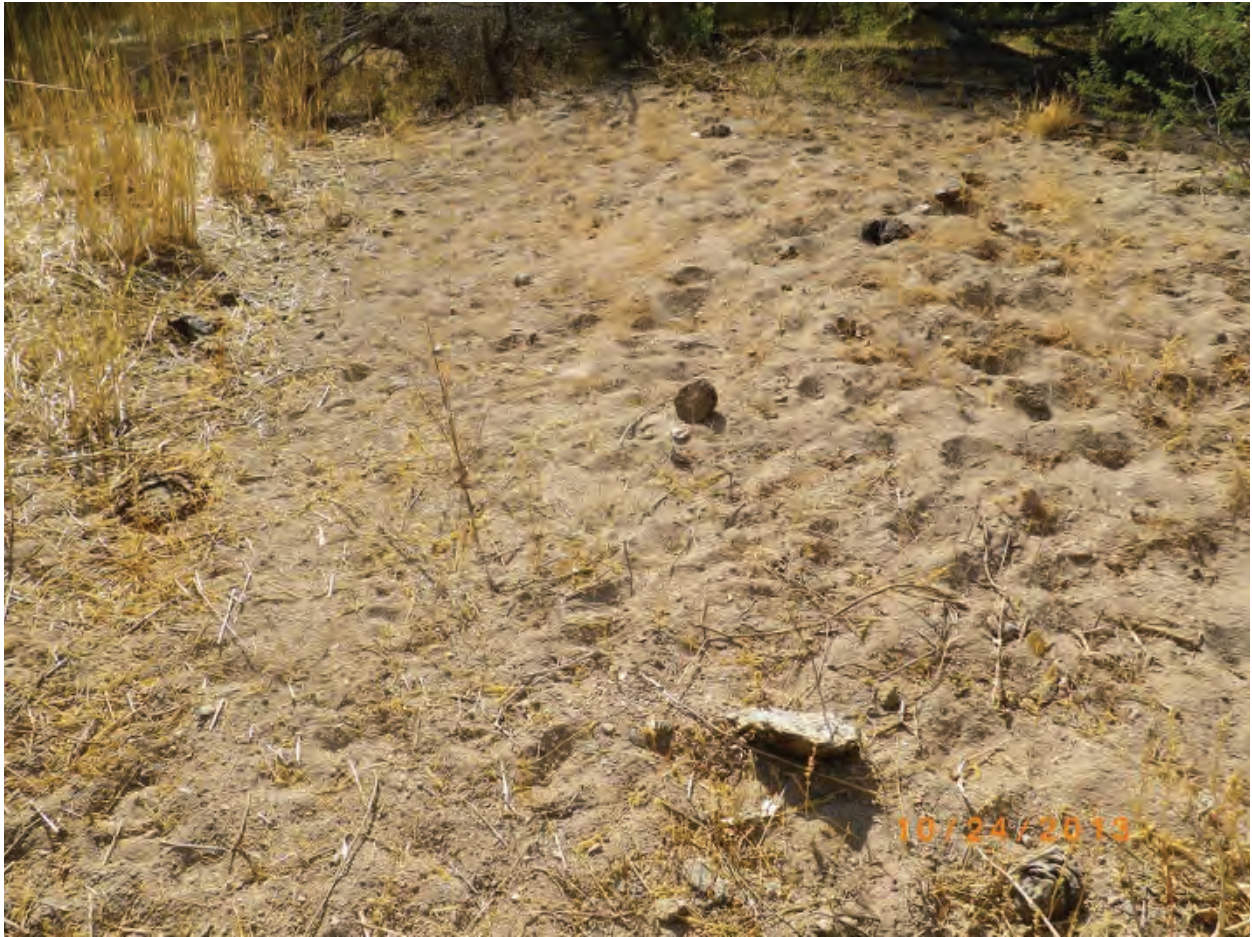
Figure 10. Trampled bank and floodplain on sandy soil. Regular trampling prevents establishment of vegetation and promotes accelerated erosion.

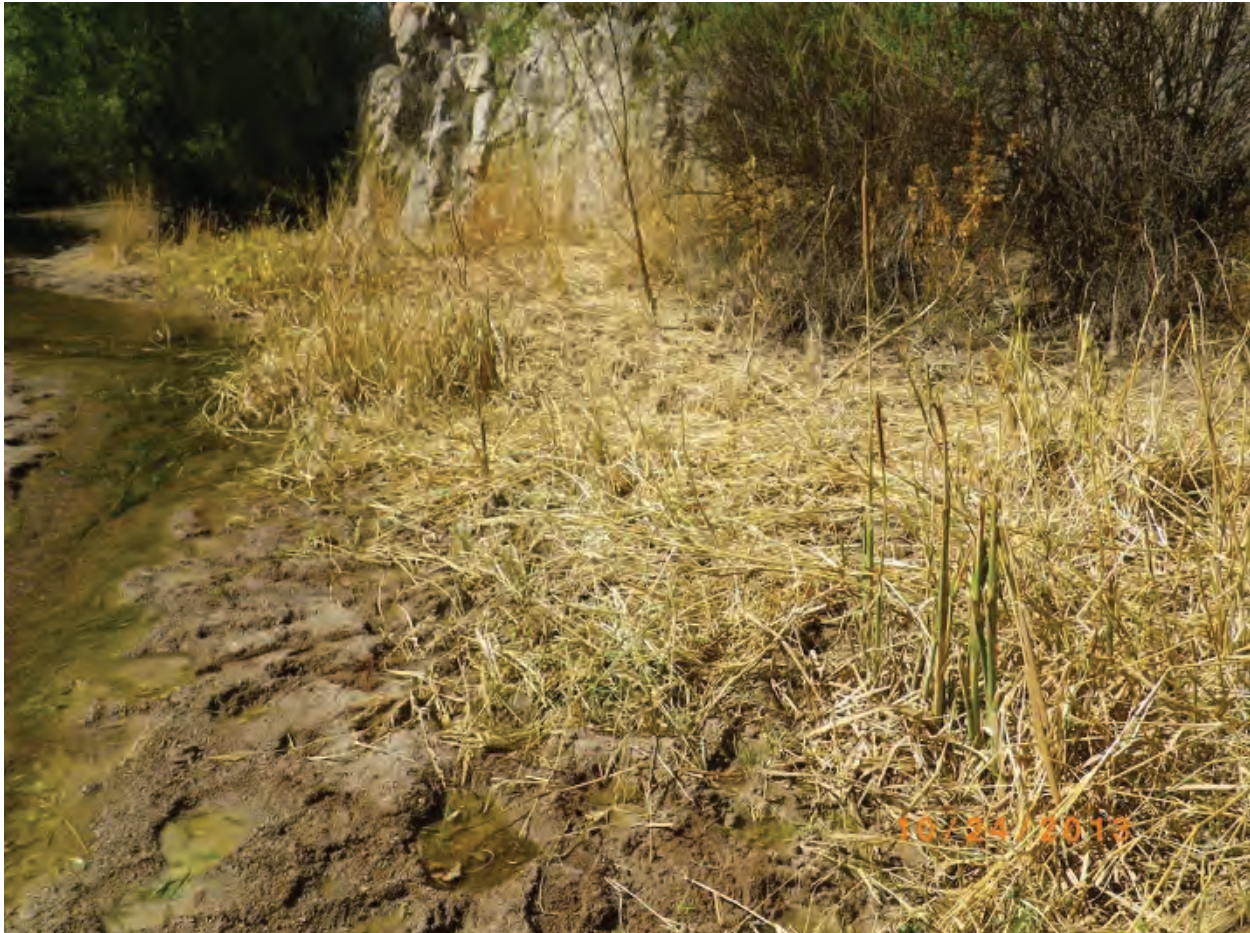
Figure 11. Trampled bank and floodplain on sandy soil. Regular trampling prevents establishment of vegetation and promotes accelerated erosion. Johnson grass abundant on this site.

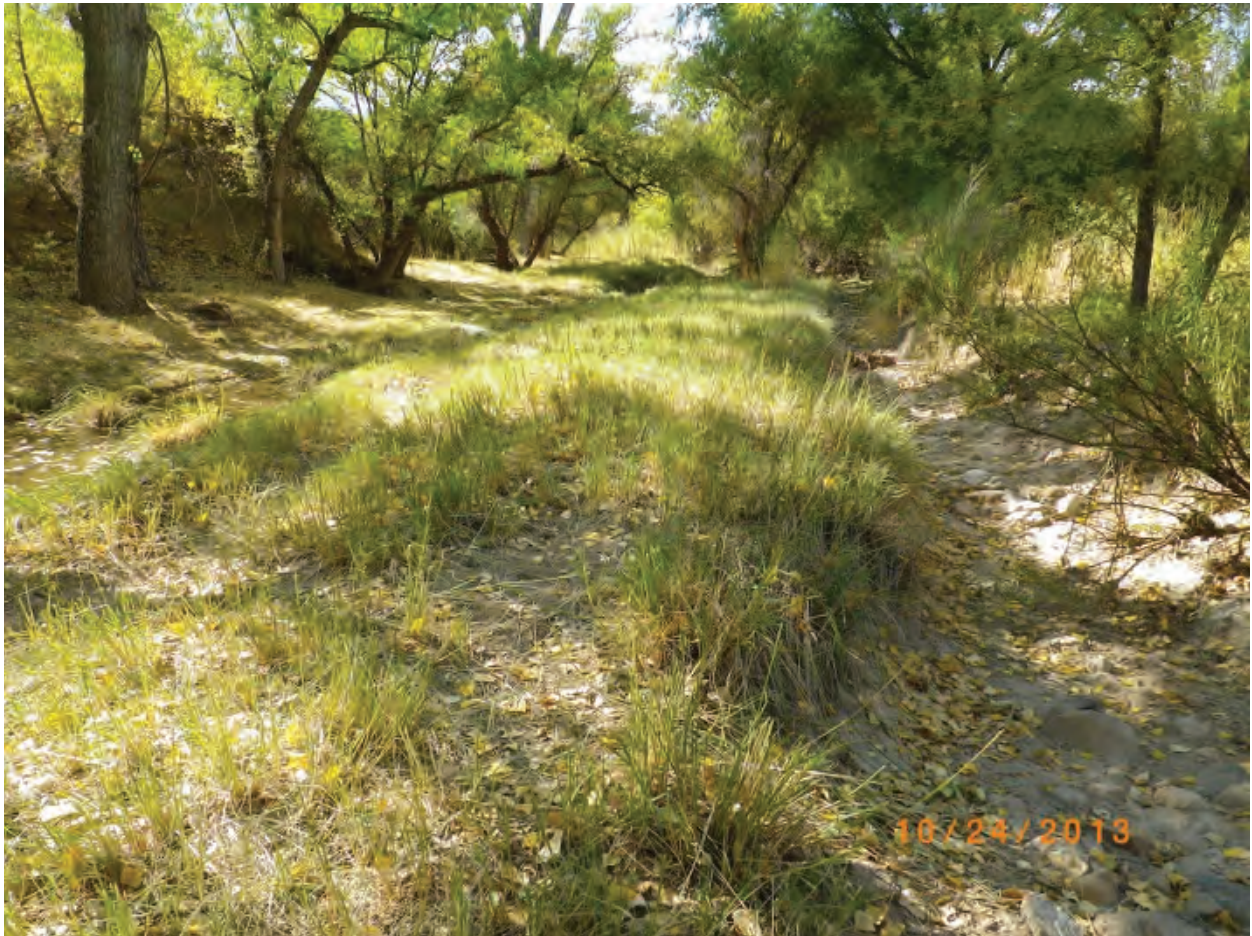
Figure 12. Flood plain on right has incised cow trail. Note that flow of creek on left.

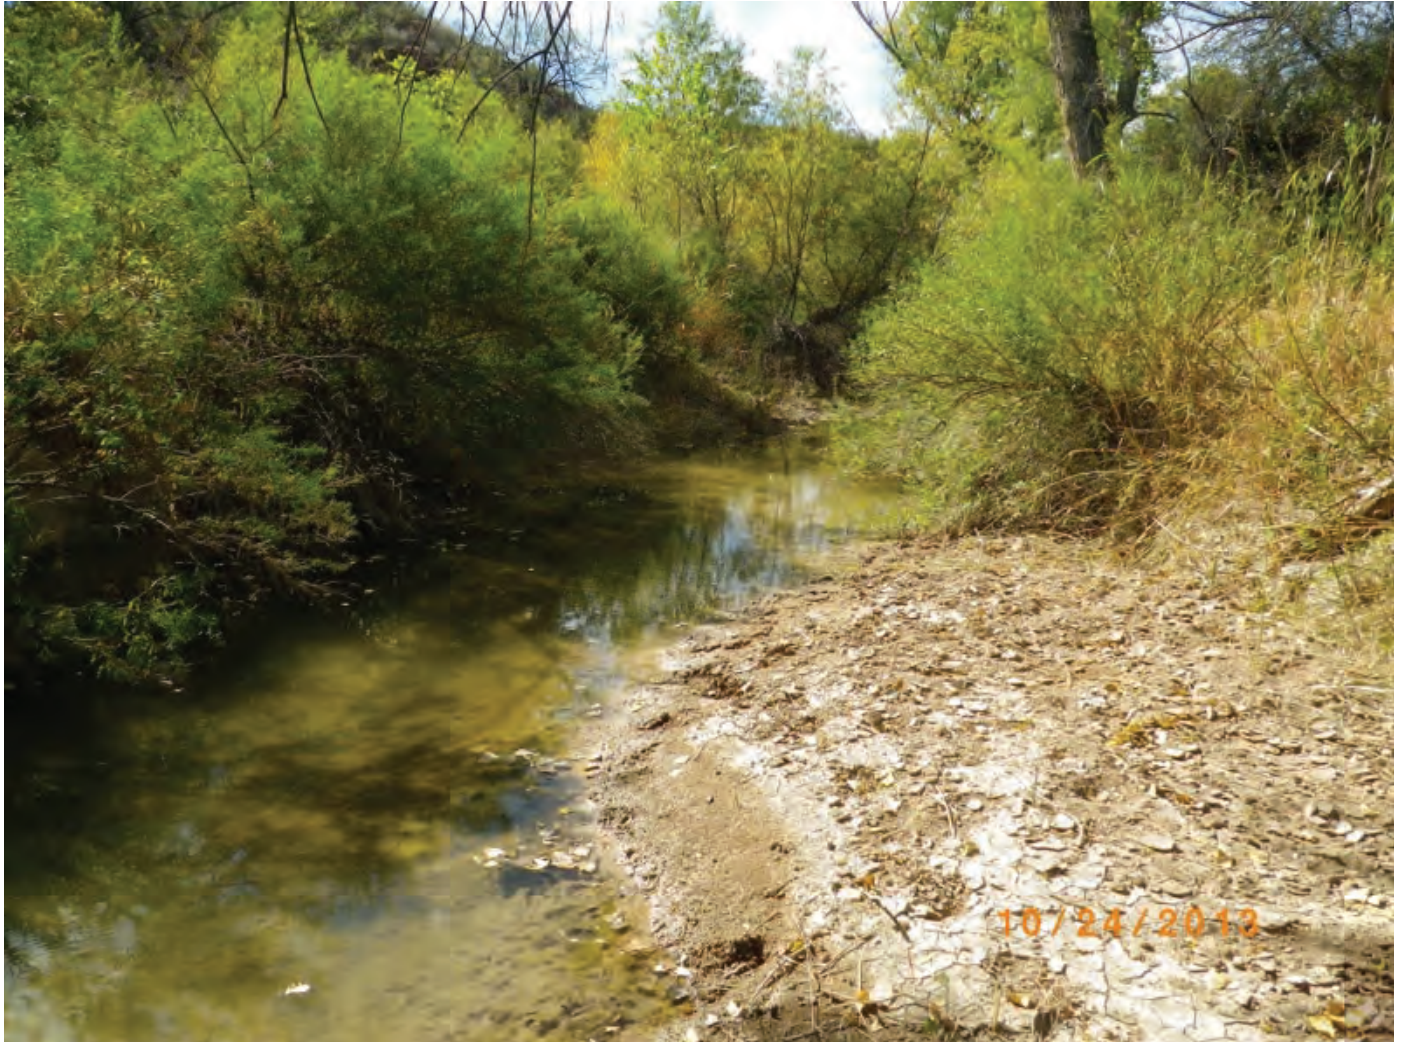
Figure 13. Point bar forming. Trampling has prevented vegetation recruitment.

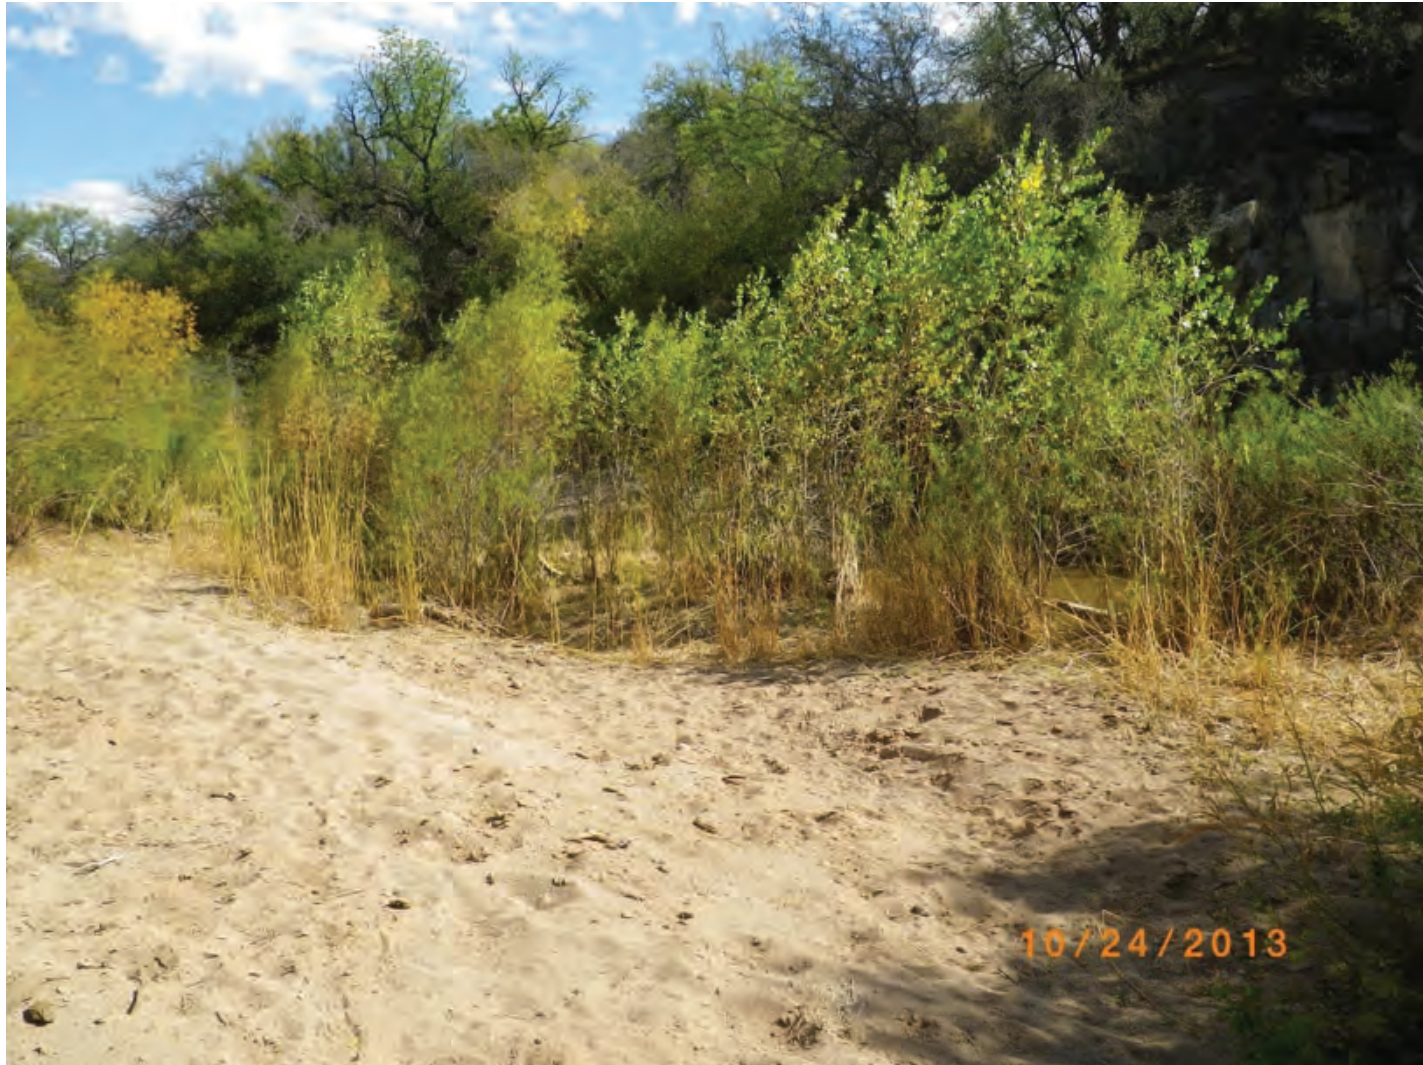
Figure 14. Trampled bank and floodplain on sandy soil. Regular trampling prevents establishment of vegetation and promotes accelerated erosion. Healthy sapling cottonwood and willows in background away from waters edge.

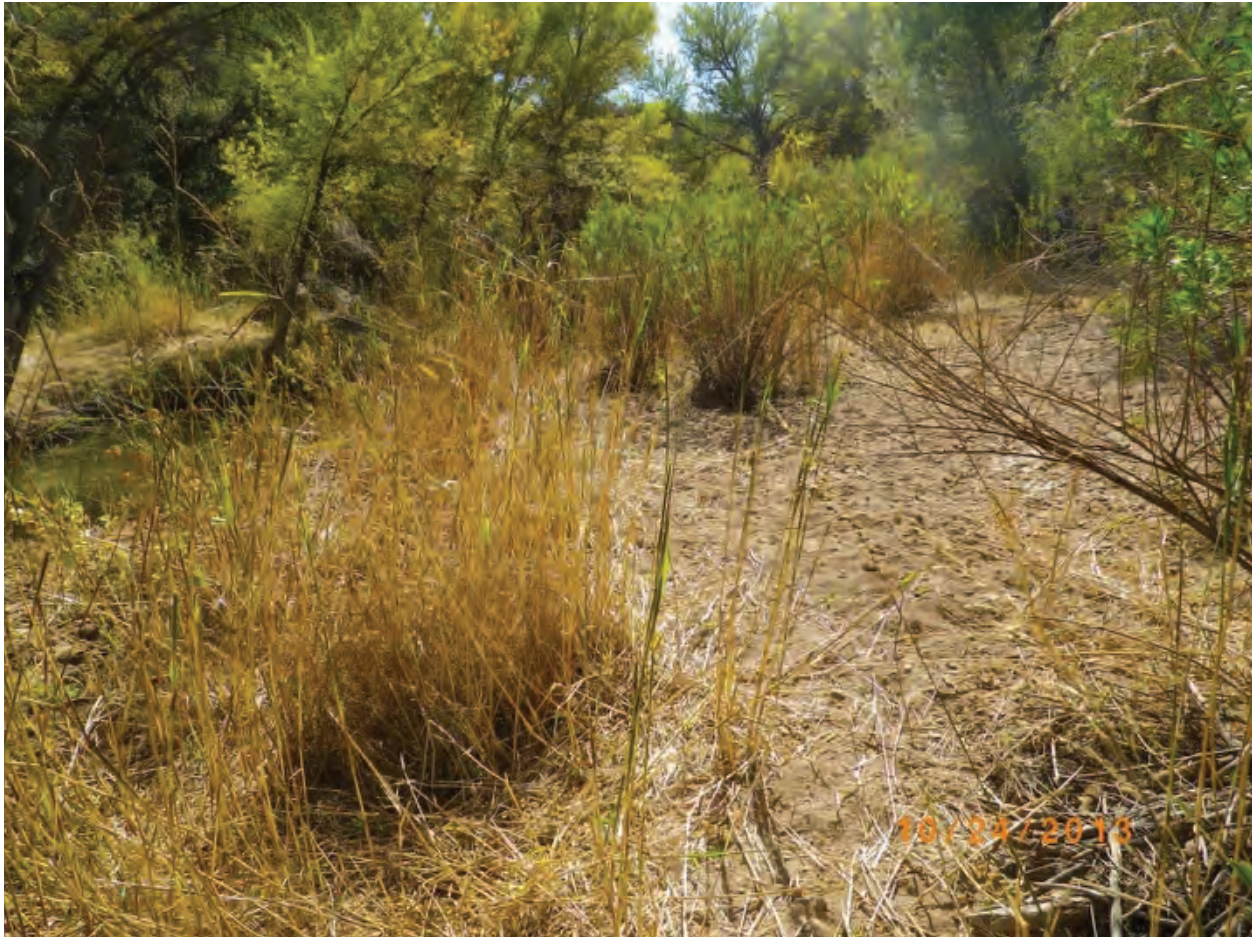
Figure 15. Heavily trampled floodplain on sandy soil. Regular trampling prevents establishment of vegetation and promotes accelerated erosion.

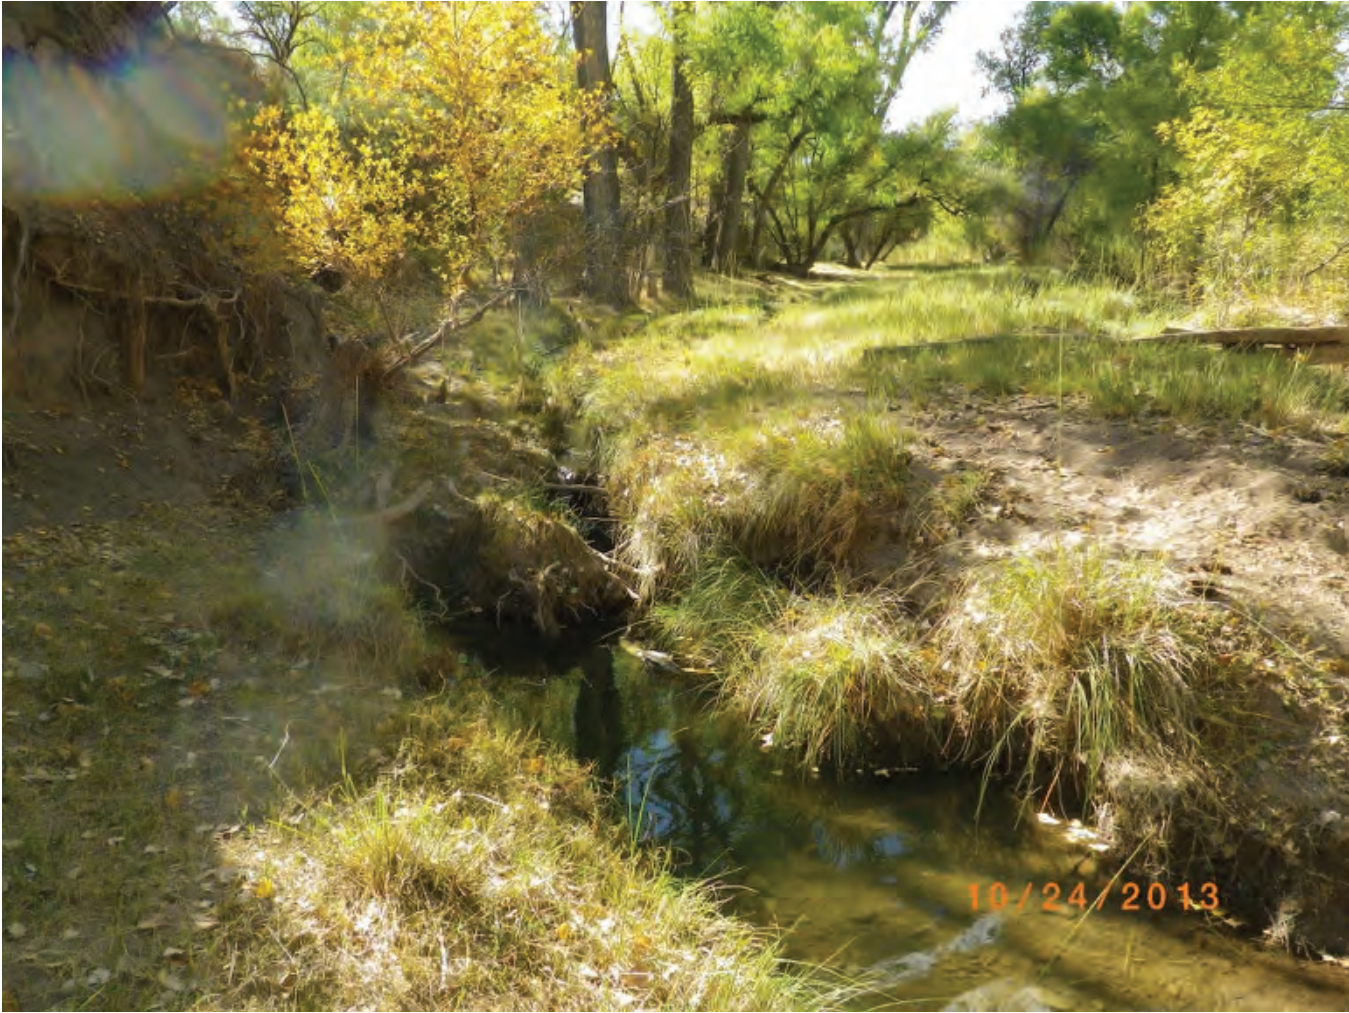
Figure 16. Channel incised and bank damage. Note exposed roots and trampling on floodplain.

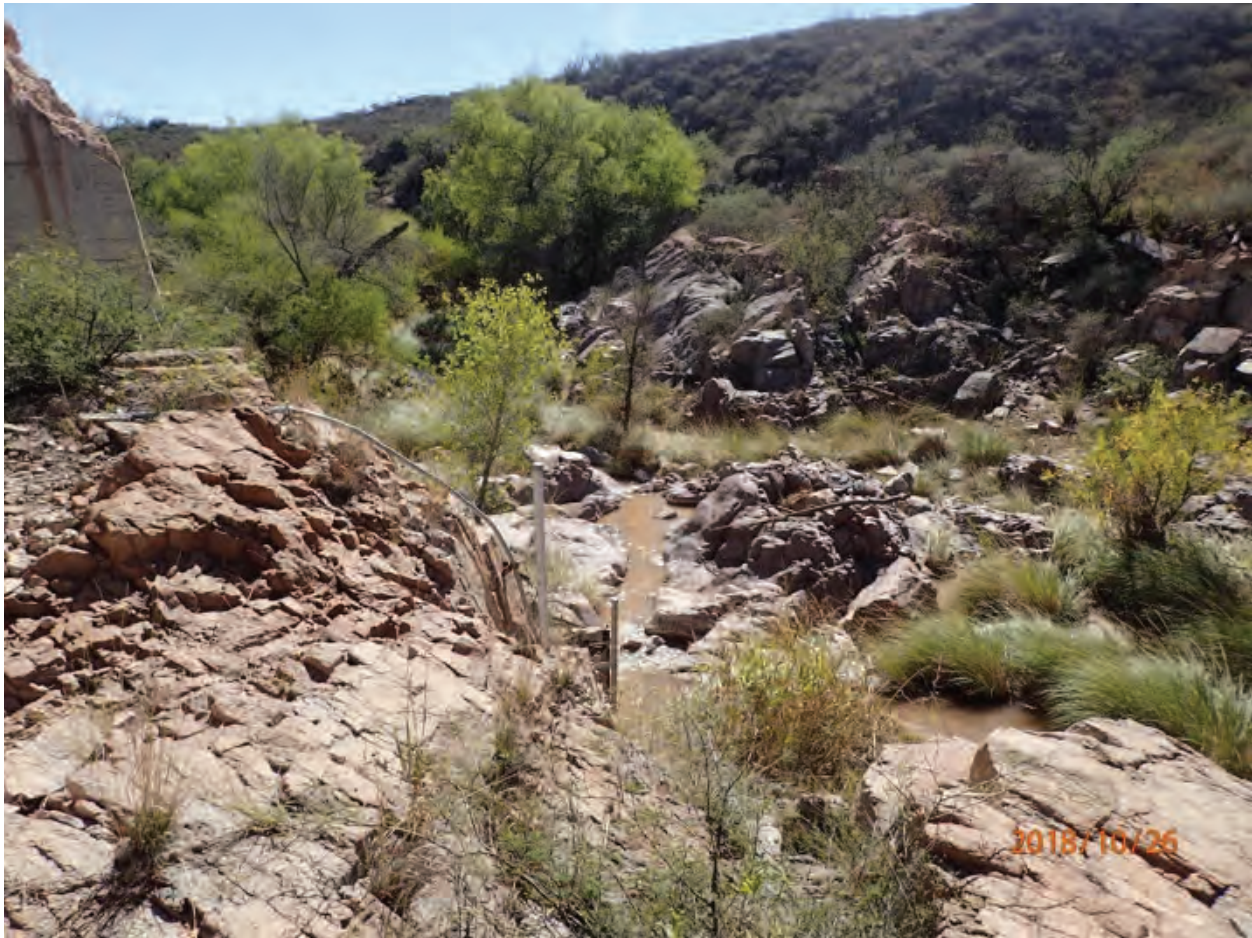
Figure 1. Bedrock and boulder channel just below USGS Stream gage. Some dead willows occurred in area likely due to a lack of sufficient soil moisture during late spring. This was uncommon elsewhere in the reach.

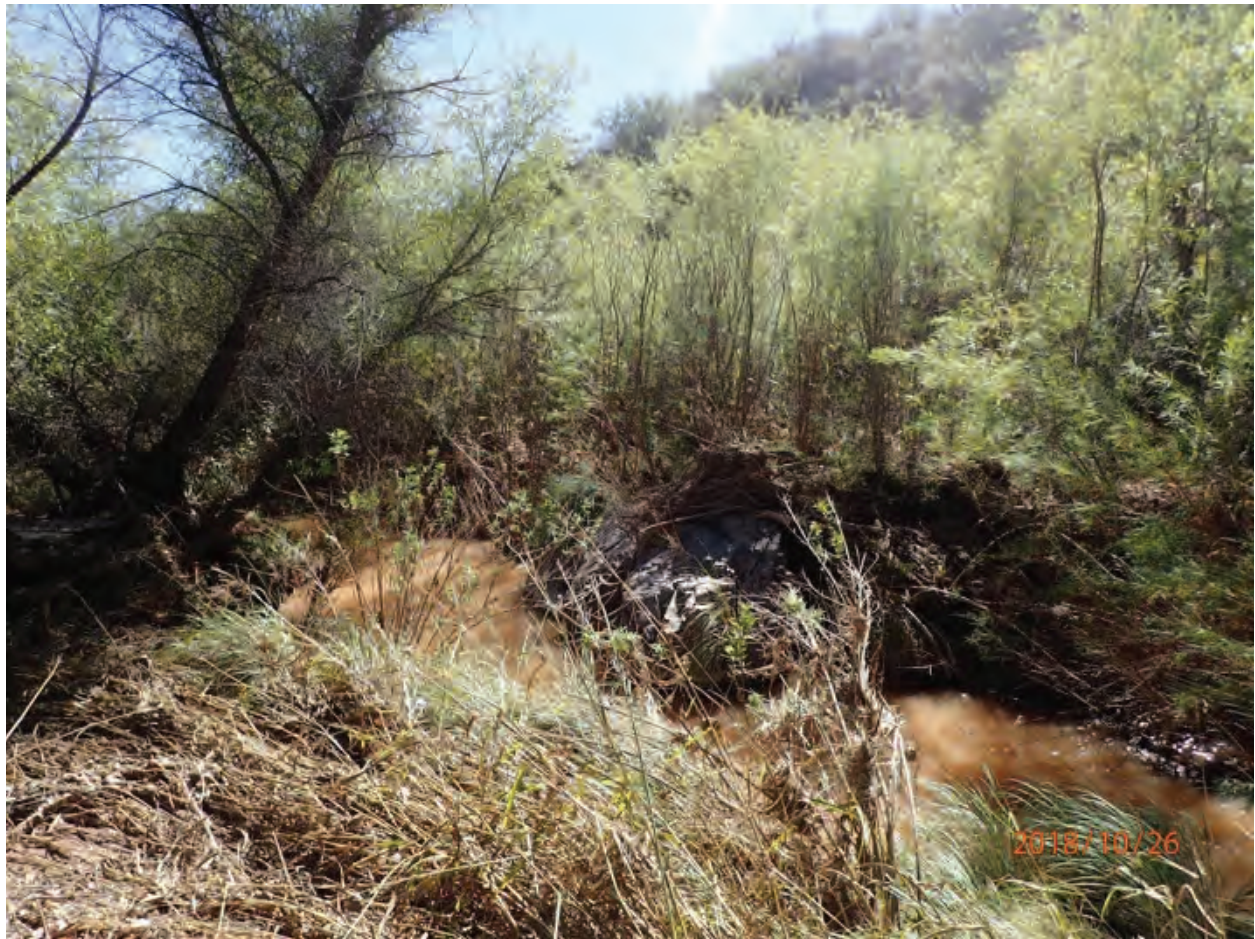
Figure 2. Vegetation pushed over by recent flooding. Goodding Willow in foreground. Coyote Willow in background. Flow 2 days earlier peaked at 350 cfs.

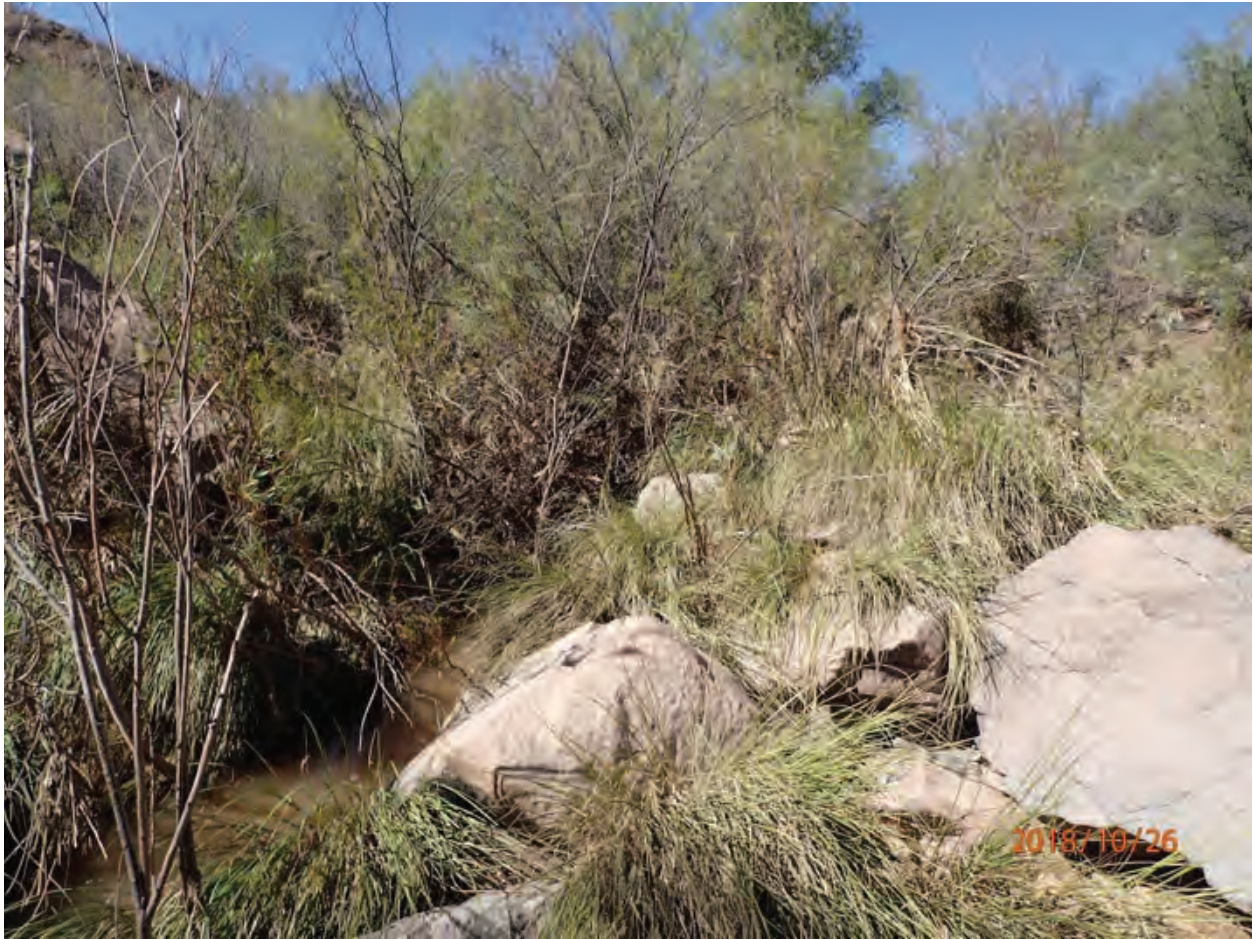
Figure 3. Dead willows in boulder field likely died from drought during late spring as there may be little alluvium to hold ground water to allow for survival through the dry season.
