Babocomari River PFC Revisited October 2018

Jeff Simms, Fishery Biologist

Photo Catalog from PFC conducted in October 2013

Photo Catalog from the Filed Survey to Revisit Stream Function in October 2018

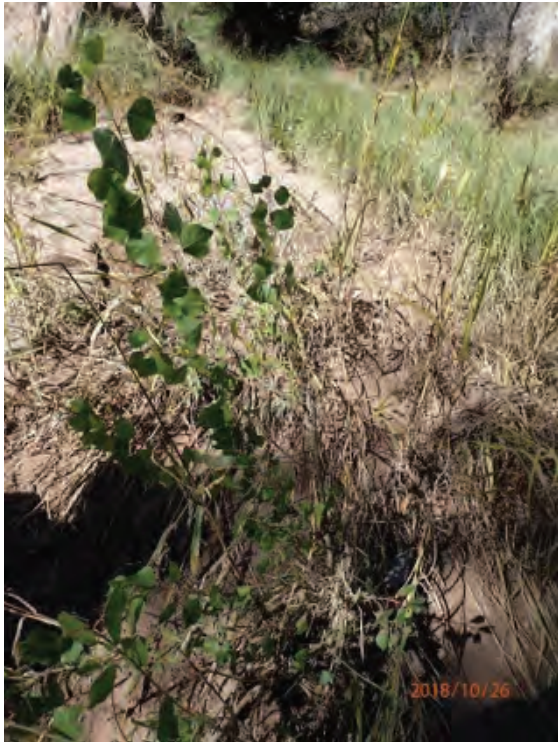
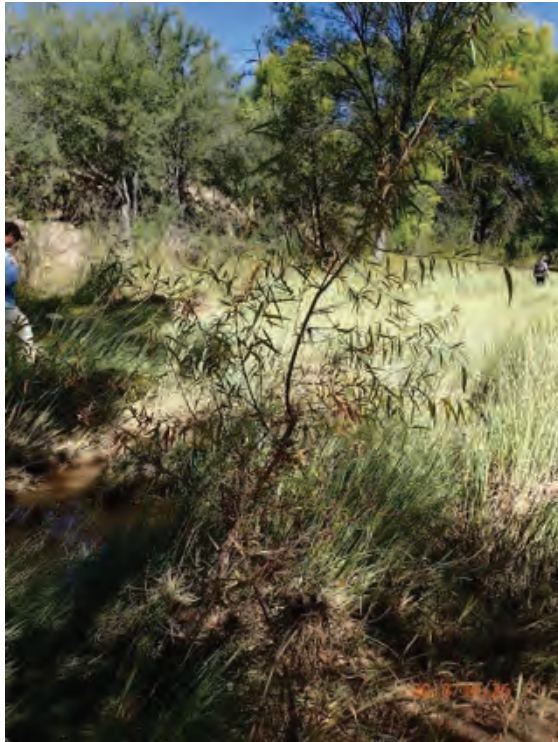
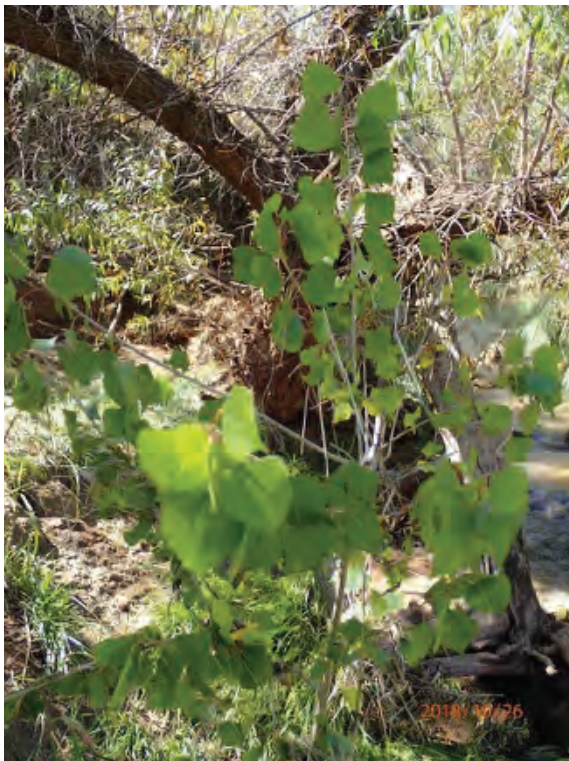
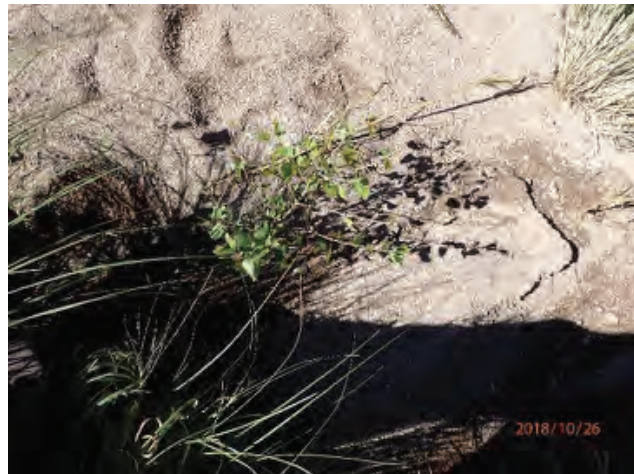
Past browsing of sapling cottonwood, willow, and ash trees was evident on nearly all saplings when observe at short distance. Repeated browsing tends to stunt the growth of trees which allows them to be browsed for several years before they reach a height where they out of the reach of livestock and deer. Both cows and deer likely contributed to the generally poor condition of saplings. Nonetheless, most saplings are likely to become young trees given rest from browsing. Ash tree seedlings and saplings were especially abundant and colonizing newly forming point bars and banks. Cottonwood and willow seedlings and saplings were much less common. The short segment in the vicinity of the stream gage which is comprised of bedrock and boulders did have some dead trees. These trees likely did not have access to ground water once surface water ceases in late spring. Otherwise, surface and ground water appeared to be adequate to support a robust riparian area.

Figure 4, 5, 6, and 7. Examples of browsed cottonwood and willow saplings in the reach. Note crooked stems and changes in stem thickness at crooks.

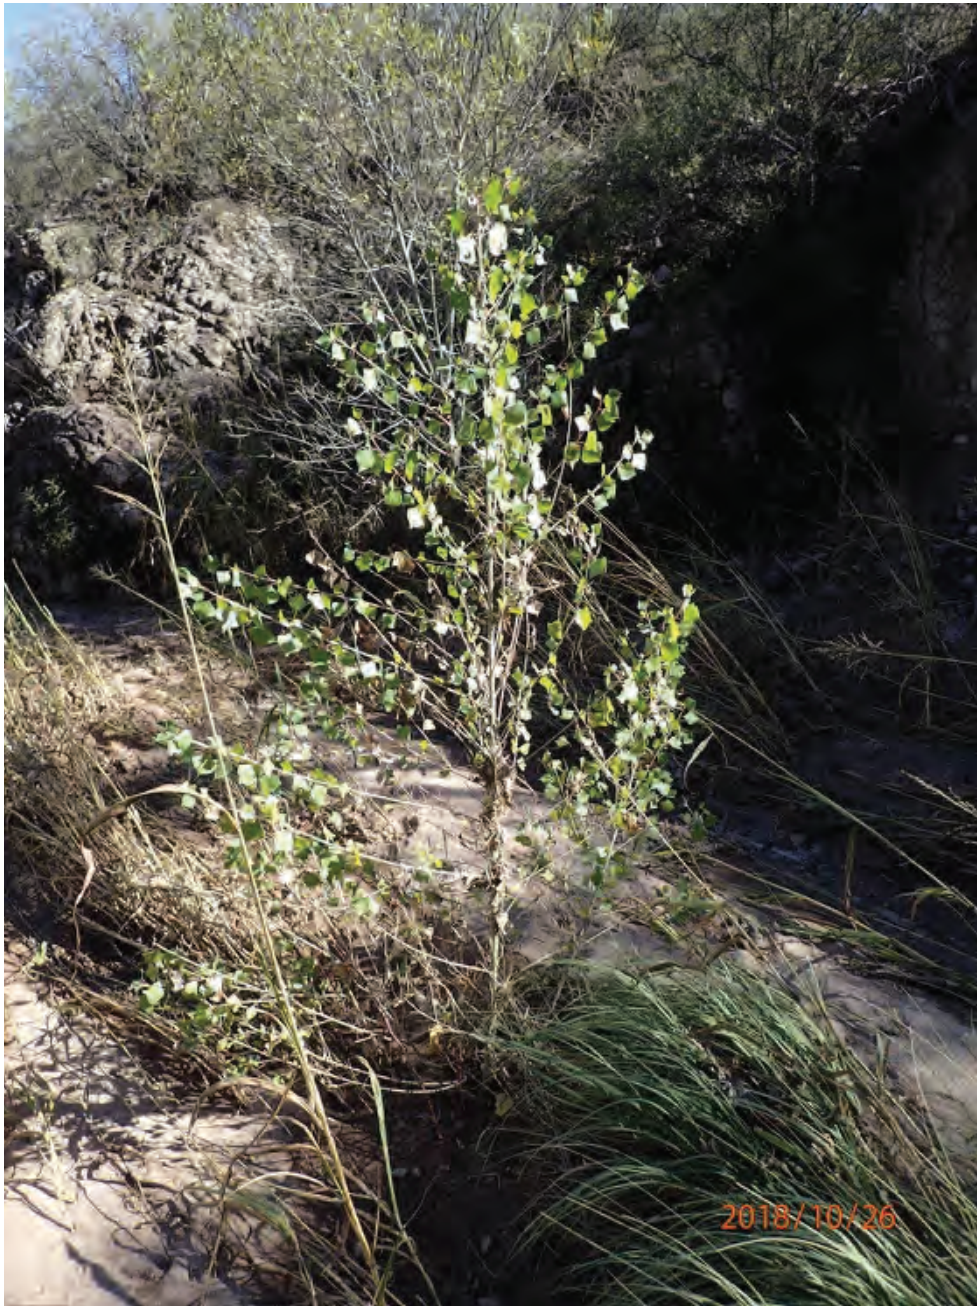
Figure 8. Examples of unbrowsed cotton wood sapling. Note “arrow straight” stem.

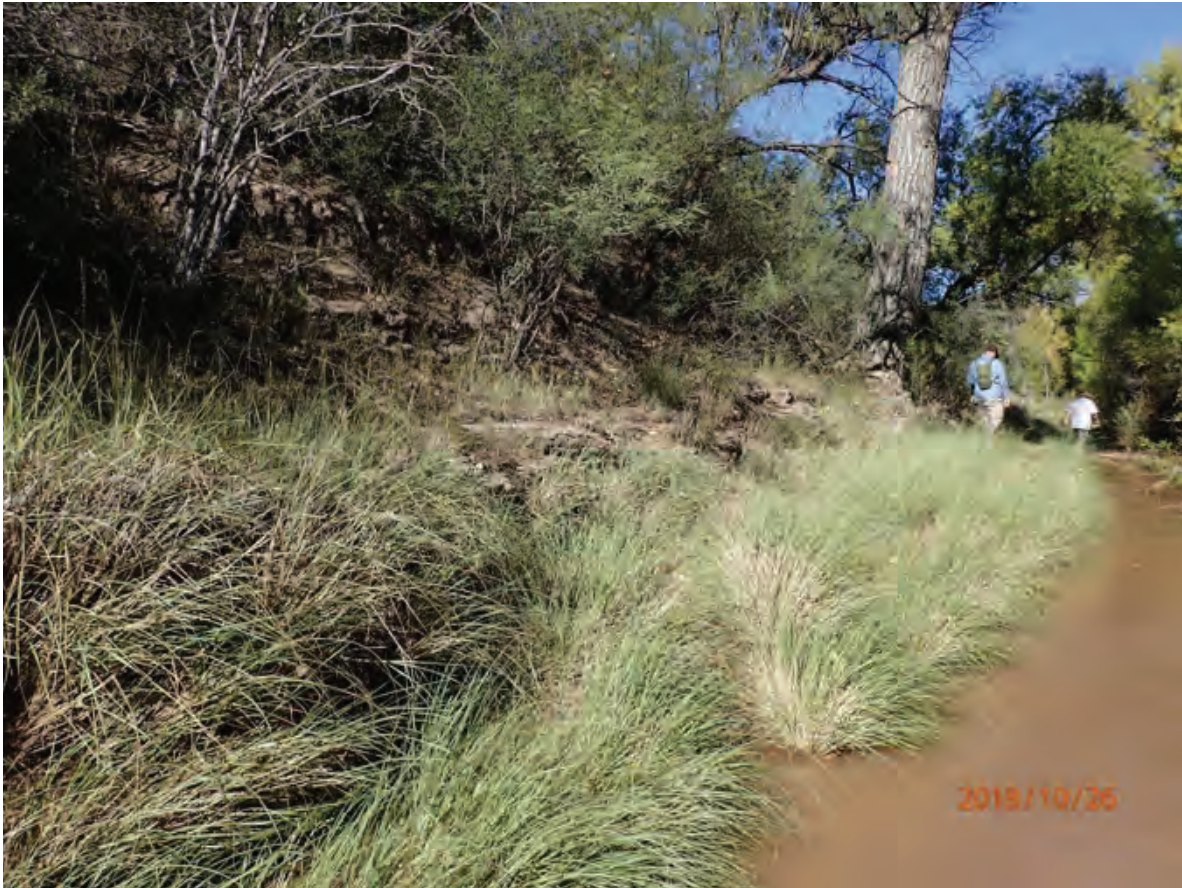
Figure 9. Stable bank in confined portion of river reach. Note large cottonwood root extends along bank above deer grass. Bank stability is excellent at this location.

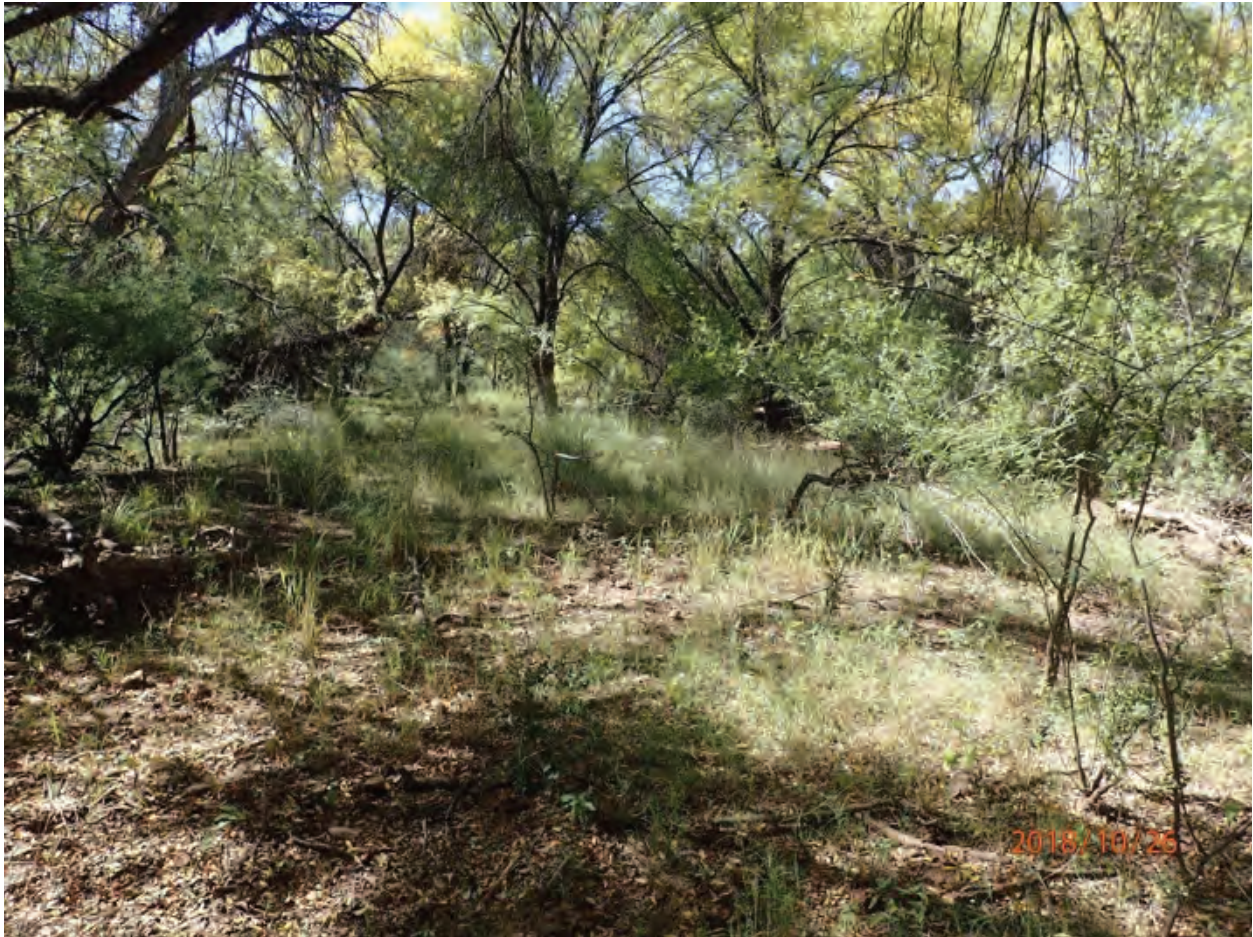
Figure 10. Stable Floodplain with vegetation. Well-worn and incised cow trails from 2013 no longer observed on floodplains. The collection of sediment on vegetated surfaces covered any sign of incision from 2013.

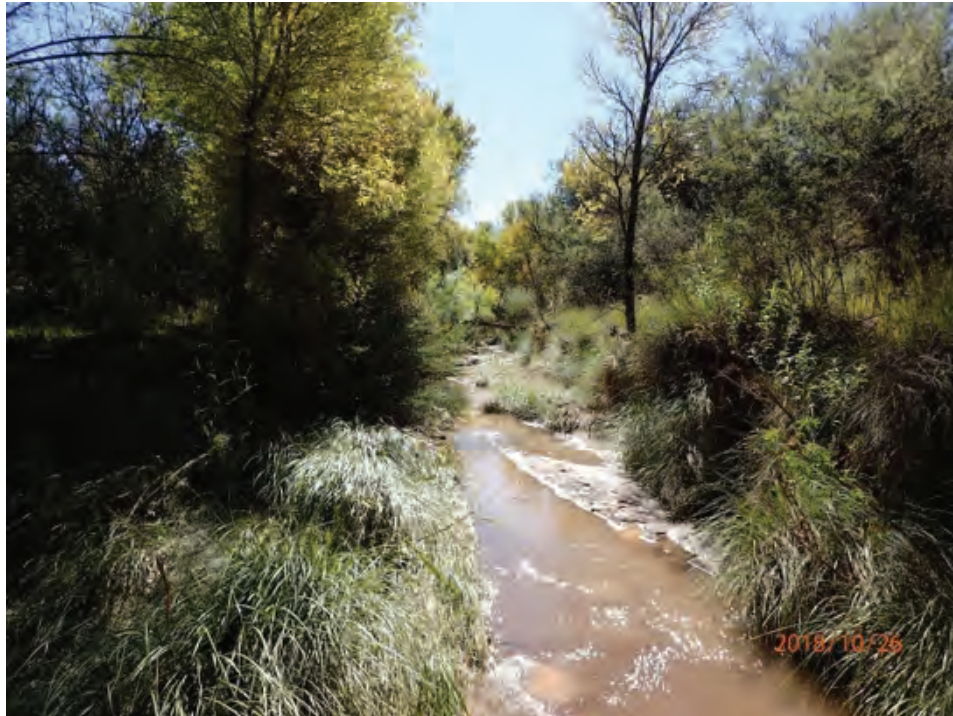
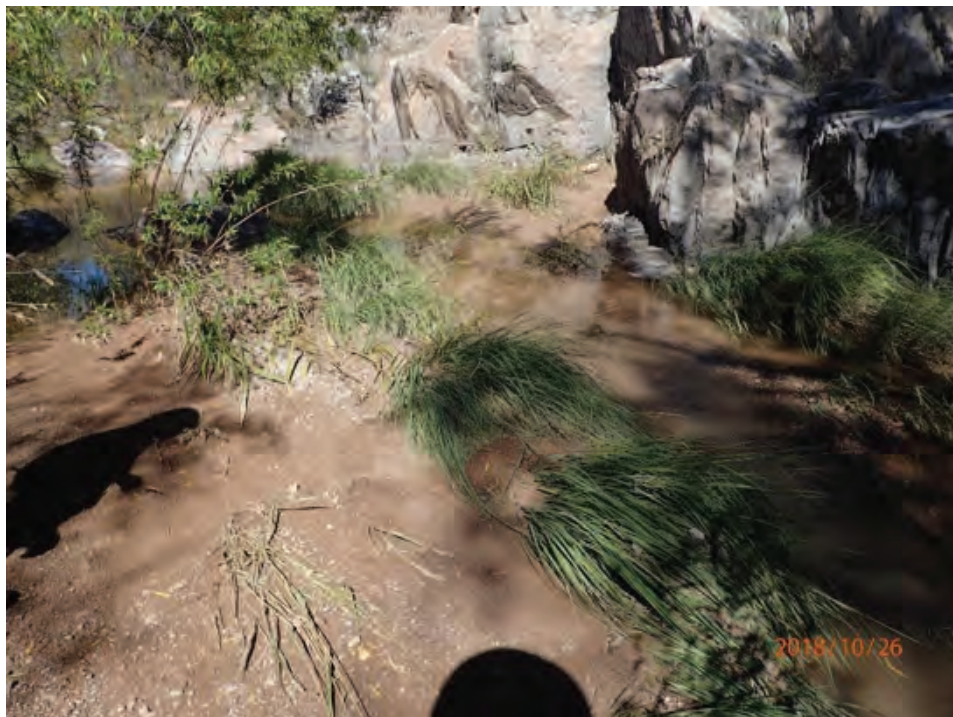
Figure 11 and 12. Heavy sediment supply following flood earlier in the week evident in first photo. Point bar in the distance being colonized by deer grass. Second photo shows sediment capture by deer grass.

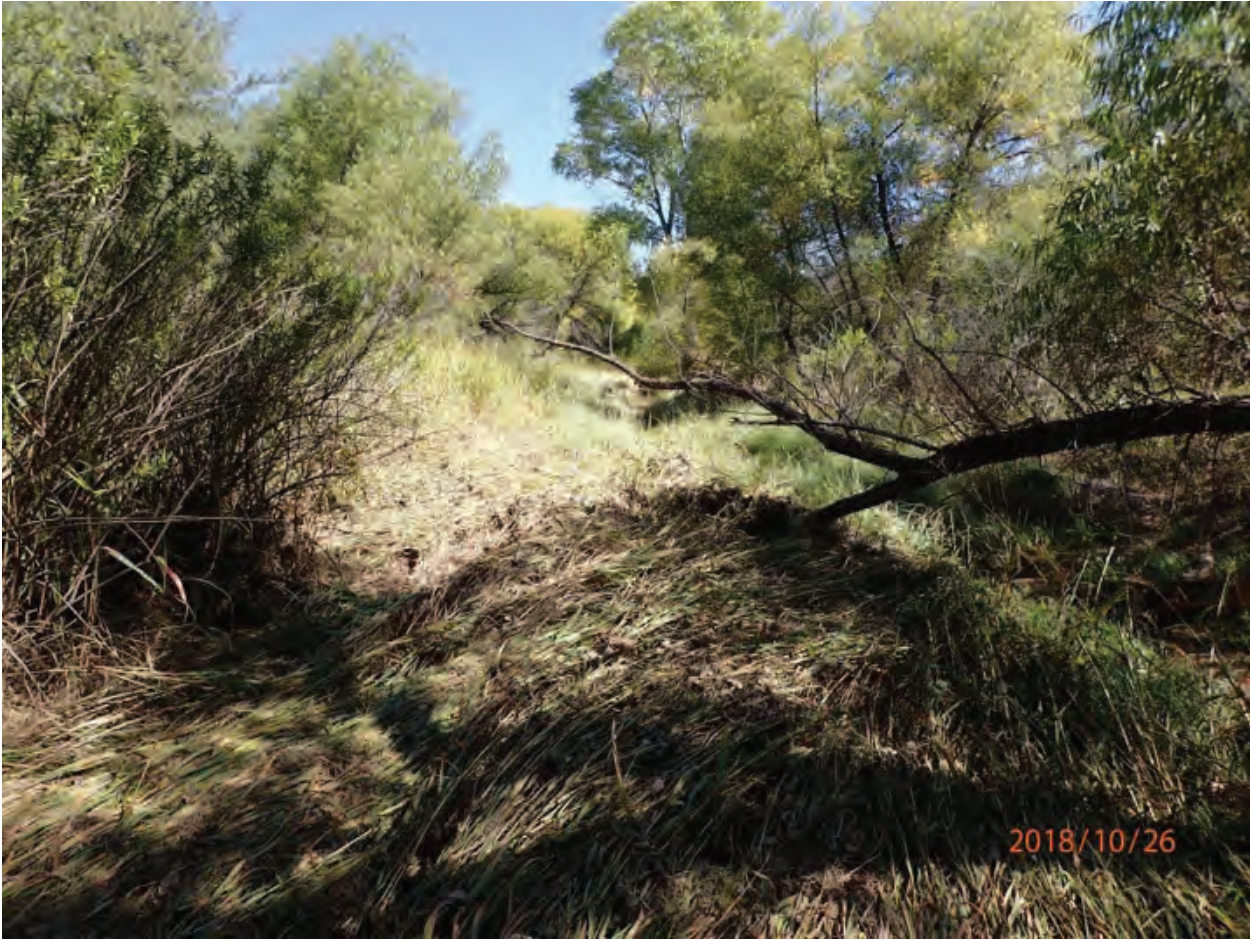
Figure 13. Grasses on flood plain laid down by flood protect floodplain surface from erosion.

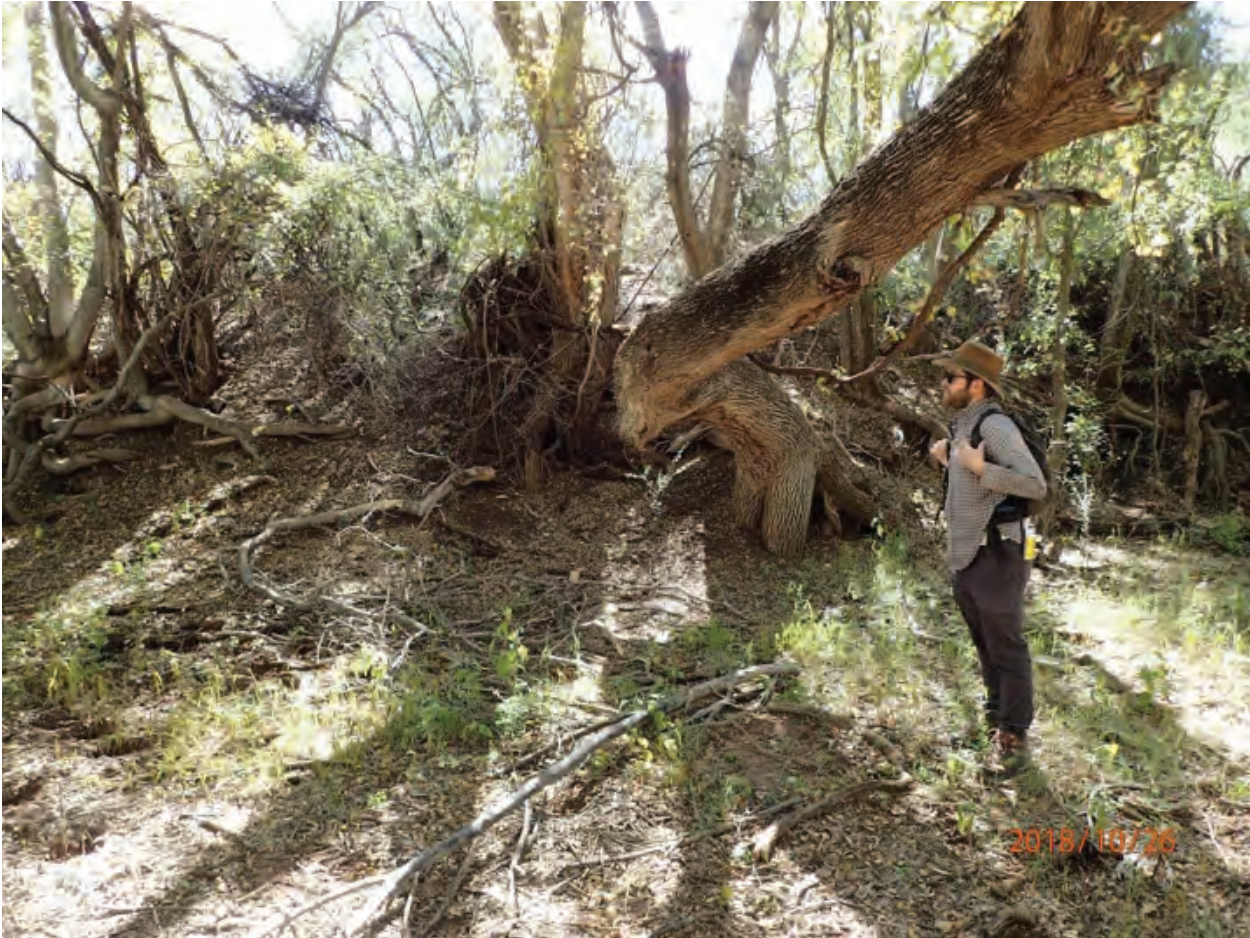
Figure 14. Floodplain widening slowly through erosion of adjacent slope.

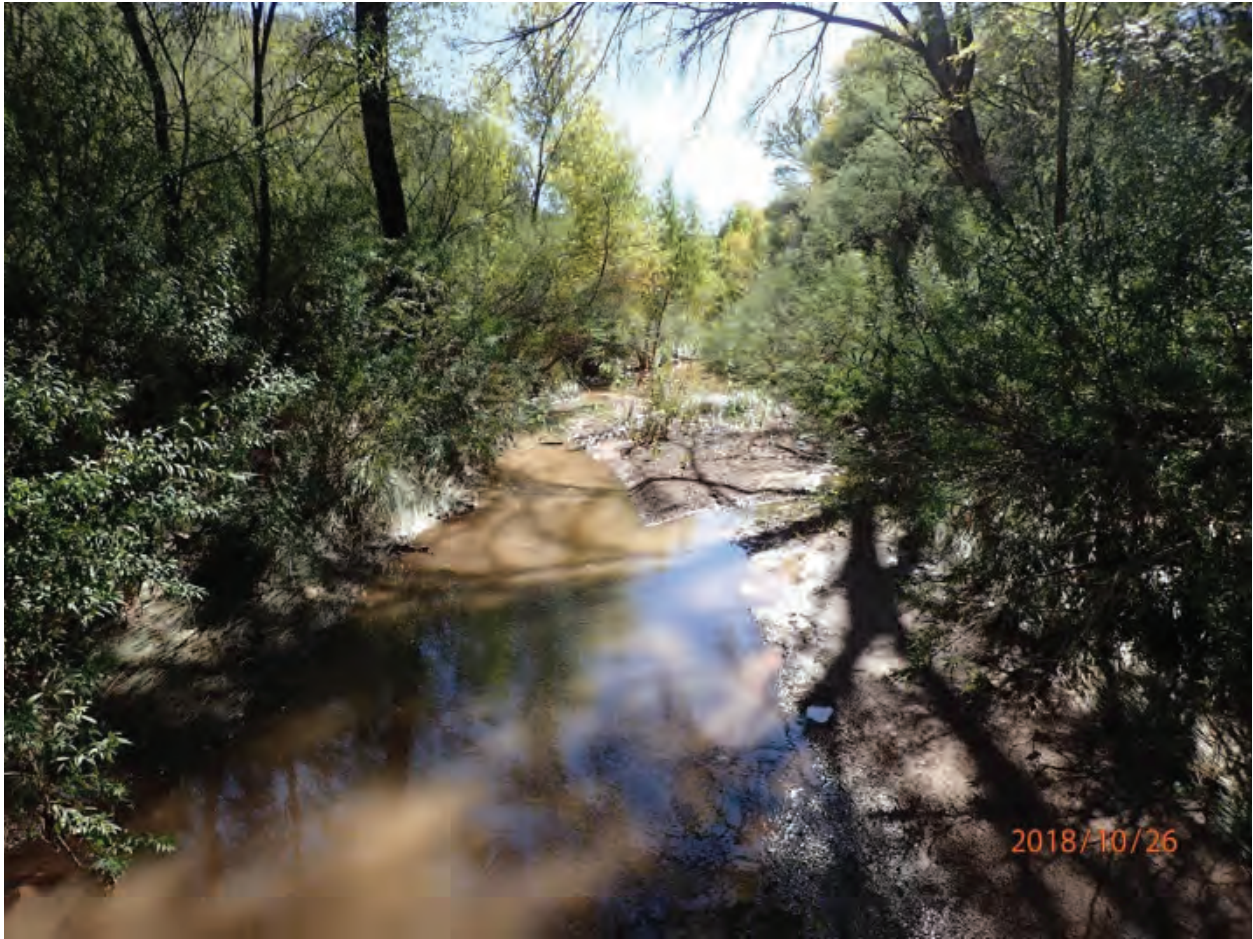
Figure 15. Sediment bars being colonized by deer grass and trees. This process results in narrow and deepening of channel (decreased width/depth ratio).

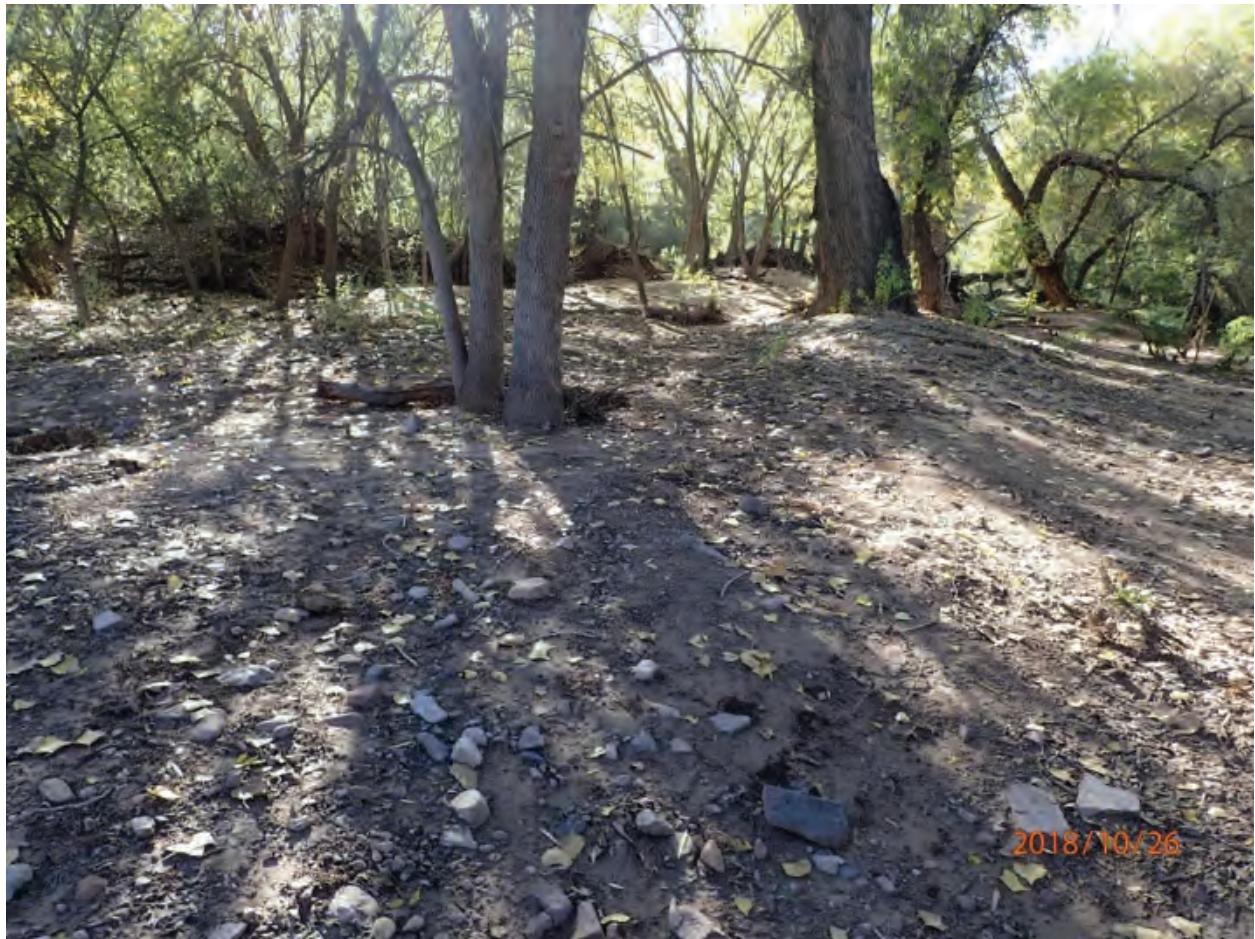
Figure 16. Floodplain inundated with excess sediment from discharge from upstream tributary that occurred earlier in the week.
