# Final Report

On August 25, 1997 a Decision Memo was signed by Frank A Hayes, District Ranger, on the Clifton Ranger District, Apache-Sitgreaves National Forest that would begin the Coal Creek Corridor Enhancement Project (CCCEP), along State Highway 78 (Hwy 78).

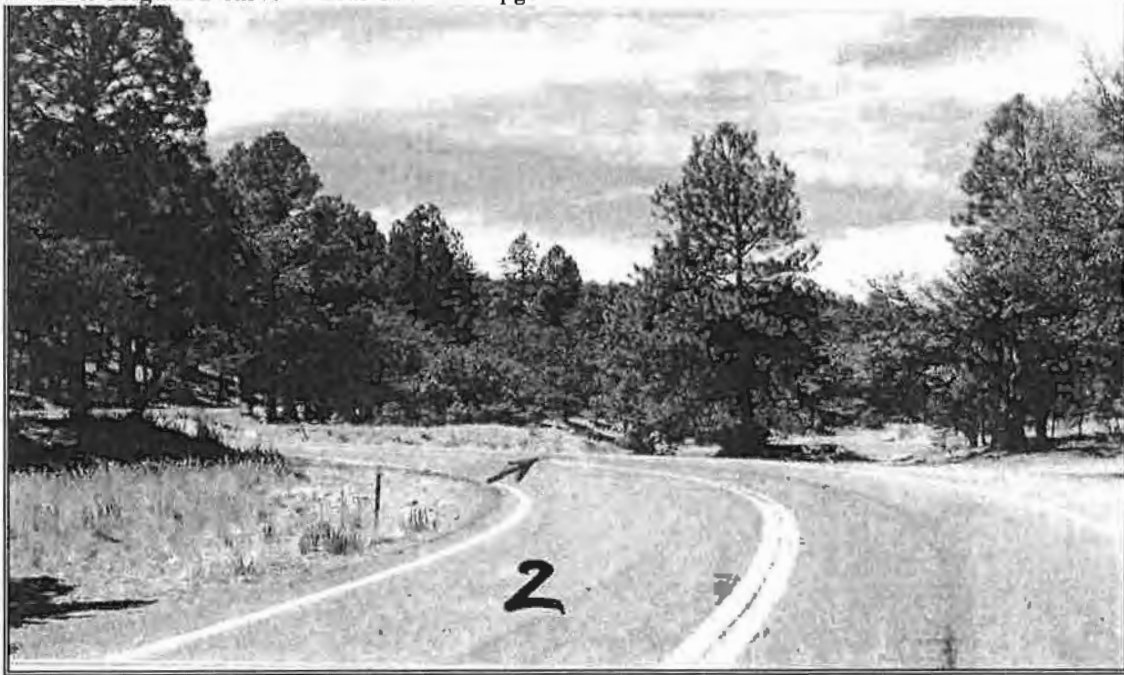
One section of Highway 78 within the corridor was re-aligned for motorist safety and to align culvert battery with natural gradient of Coal Creek. The realignment consisted of straightening the S-curve near Coal Creek Campground.

**Photo 4. Original S-curve at Coal Creek Campground**

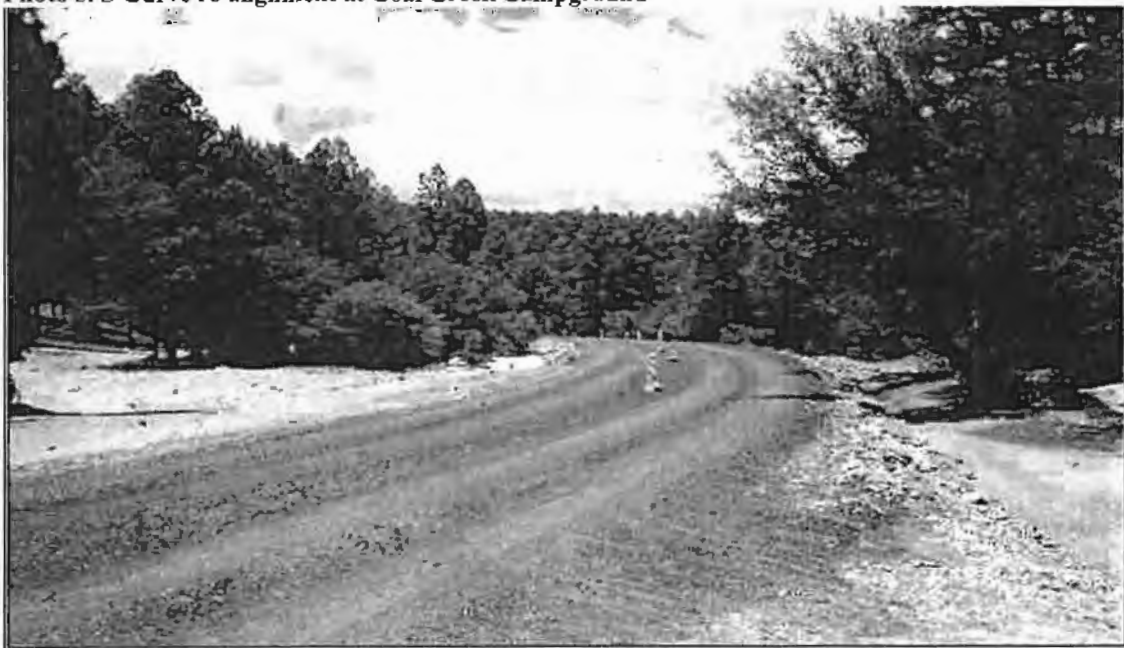
**Photo 5. S-Curve re-alignment at Coal Creek Campground**

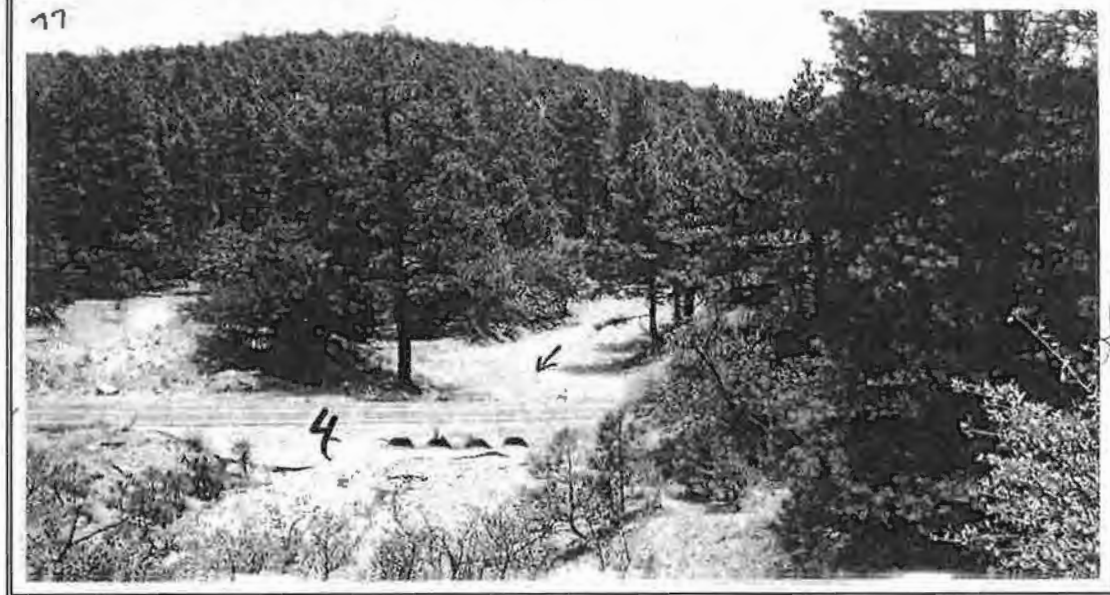
Original culvert batteries shown below provided for low flow movement under the roadway and created a low water crossing in high water events. The original culvert batteries do not allow for normal high-runoff events to carry down canyon without depositing aggregate material and overtopping both side ditches and the roadway. These conditions create costly and unsightly maintenance work for ADOT, and often result in the highway being closed for several days each year.

Photo 6. Original Culvert Battery at Coal Creek (1997)

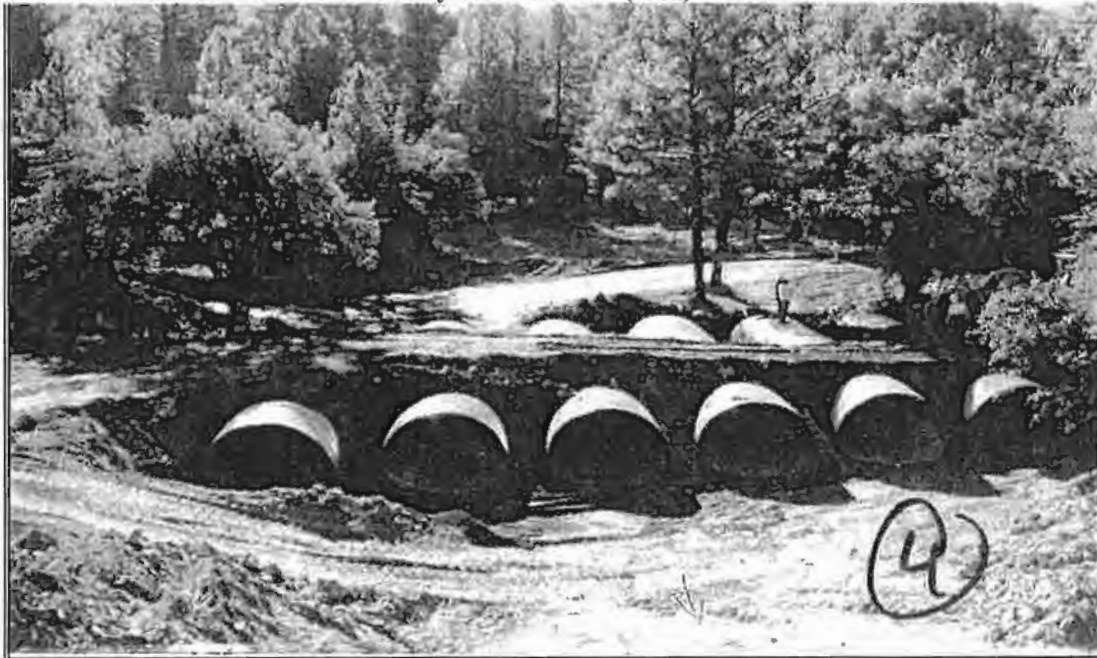
Photo 7. Construction of Culvert Battery at White Mule (1998)

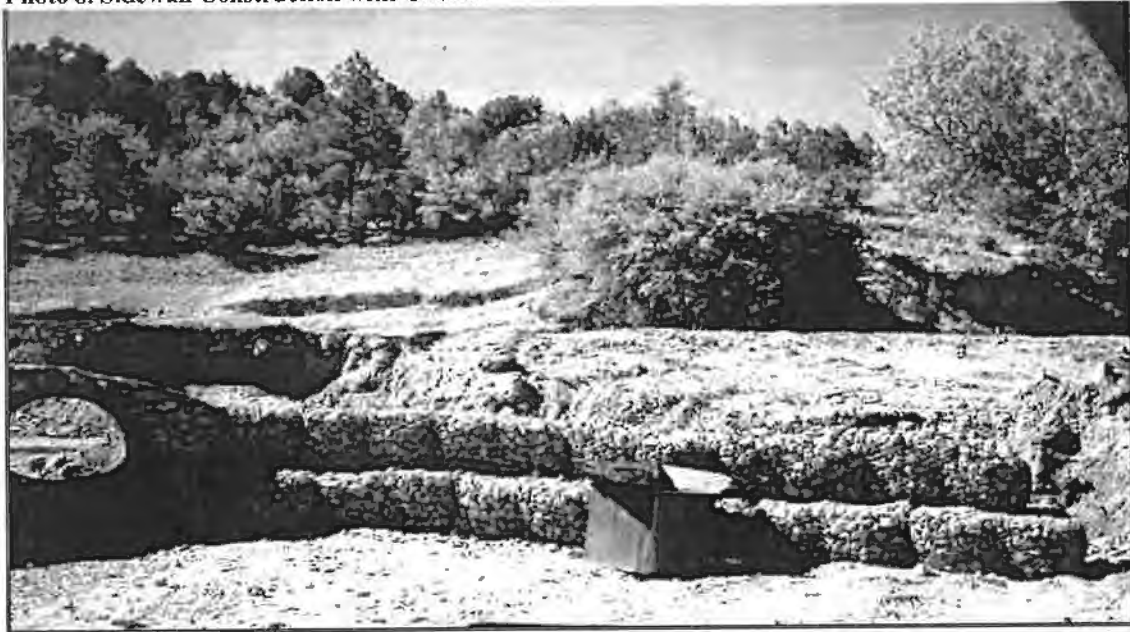
Following culvert battery placement and road realignment, ADOT Three-Way Maintenance personnel supervised and completed headwall and sidewall construction. Sidewall construction involved placing three tiers of rock gabion baskets, set one complete tier below the culvert depth. Headwalls consisted of rock-masonry wall construction both upstream and downstream on each culvert battery. This latter work was supervised and completed entirely by ADOT Three-Way Maintenance personnel, over a period of 1 year from completion of the culvert battery placement.

**Photo 8. Sidewall Construction with Gabion baskets**

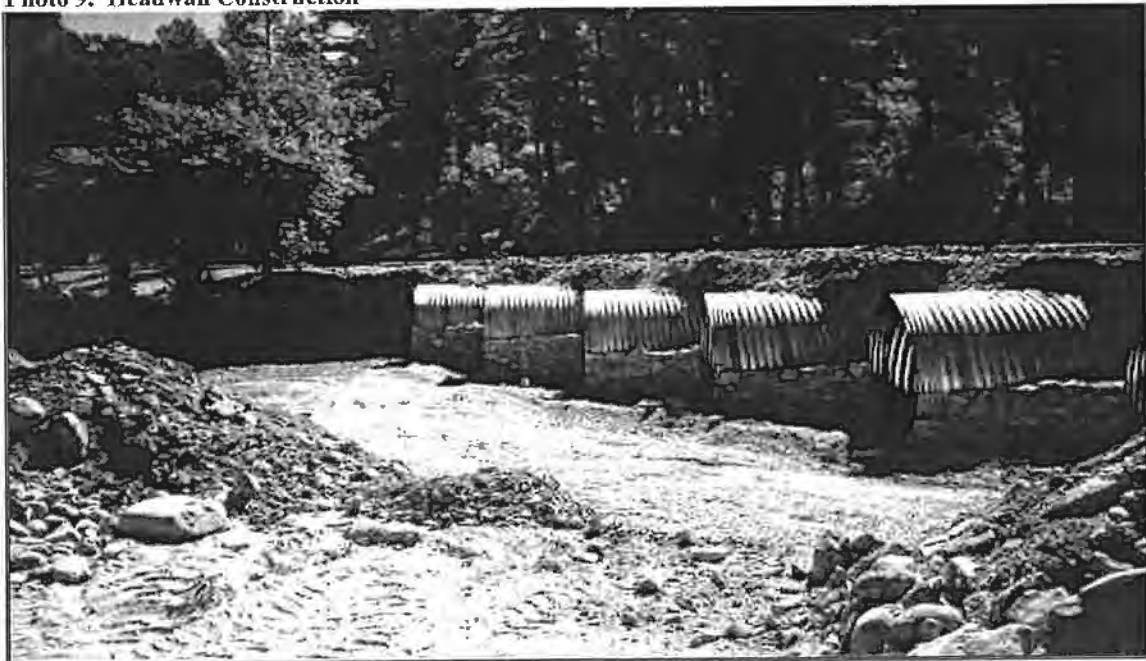
**Photo 9. Headwall Construction**

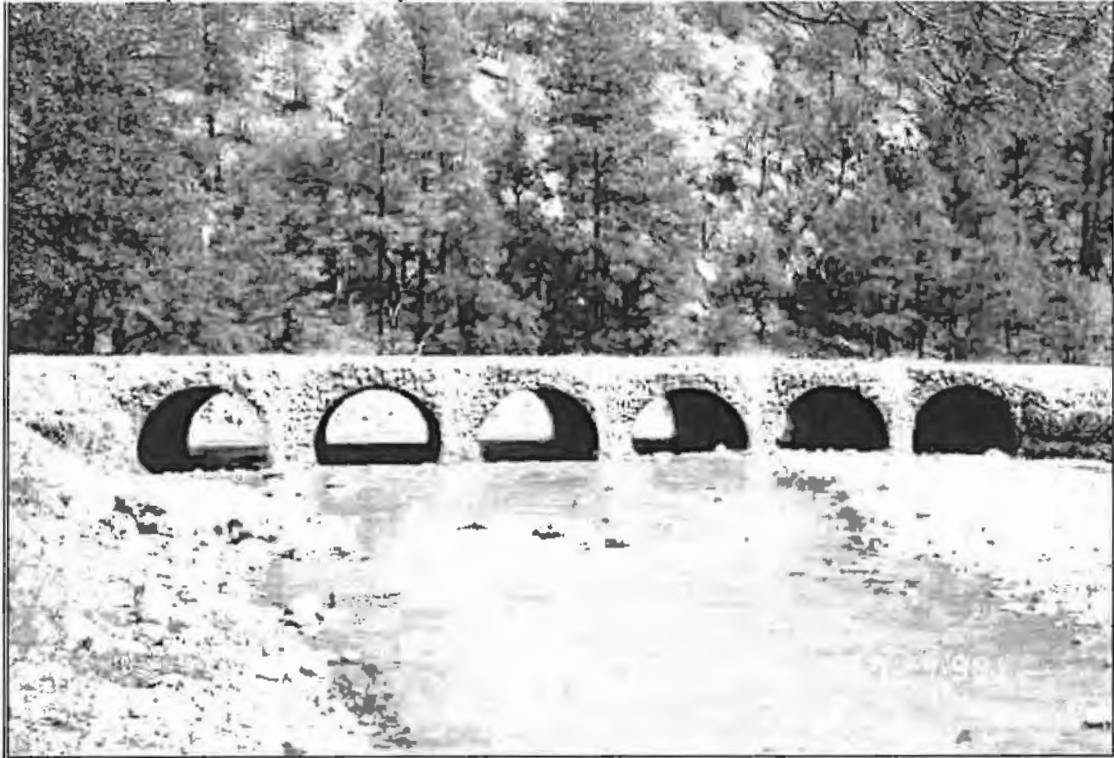
**Photo 10. Completed Culvert Battery at White Mule**

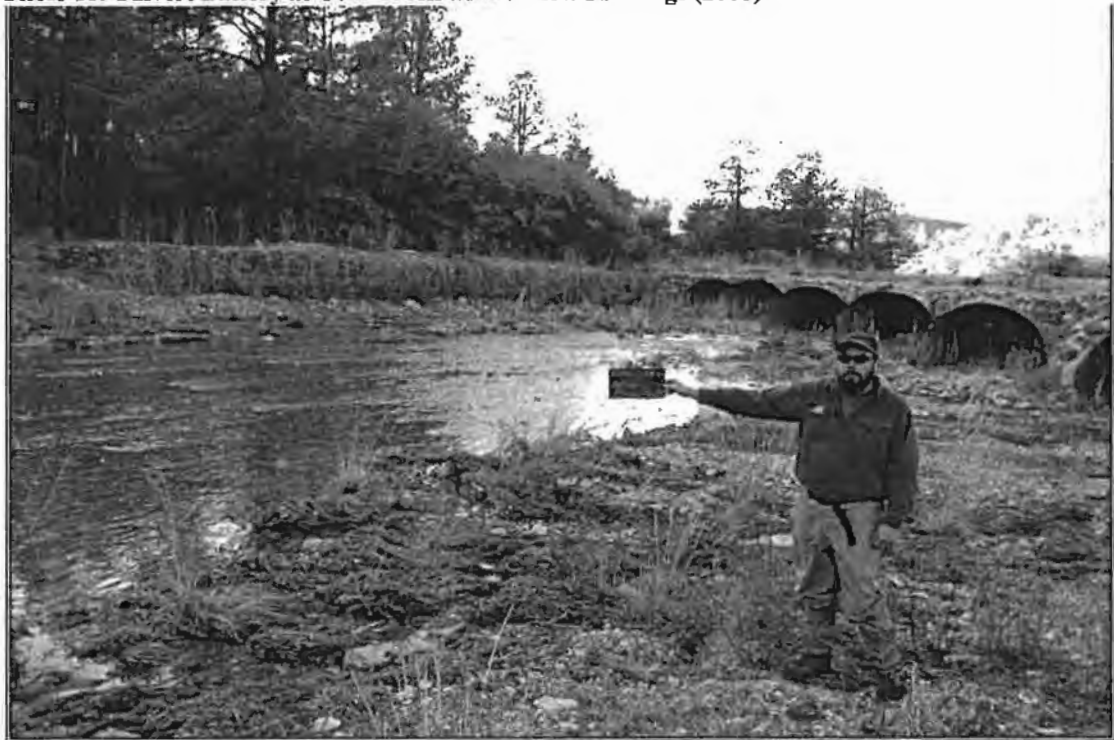
**Photo 11. Culvert Battery at Coal Creek with Willow Plantings (2005)**

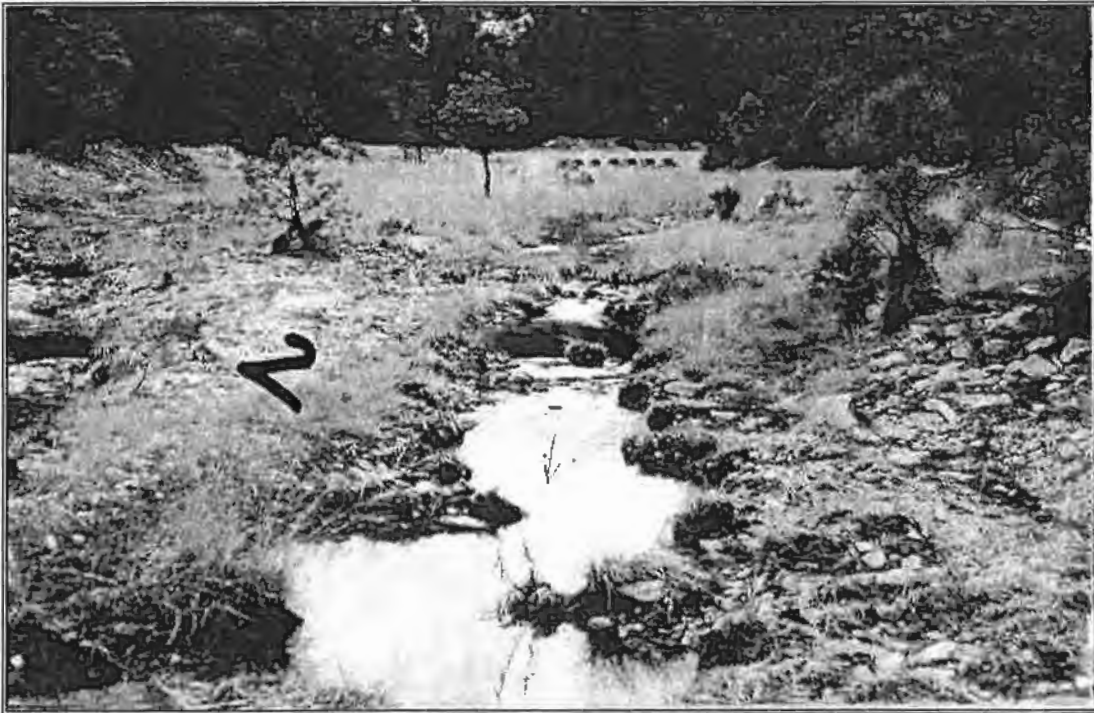
Since completion of culvert placement and gradient re-establishment, a minimal number of flows have occurred re-setting gradient conditions within the corridor, most notable within the White Mule drainage between the culvert battery and the confluence with Coal creek below the campground. Even during very dry winters in 2000-2003, wetland and riparian herbaceous vegetation began to develop below this confluence. Most recently, volunteer willows have expanded their occupancy of the corridor (from 2 miles upstream) initially becoming established at the confluence of the two drainages.

Photo 22. Downstream from Crossing 2 in 1997

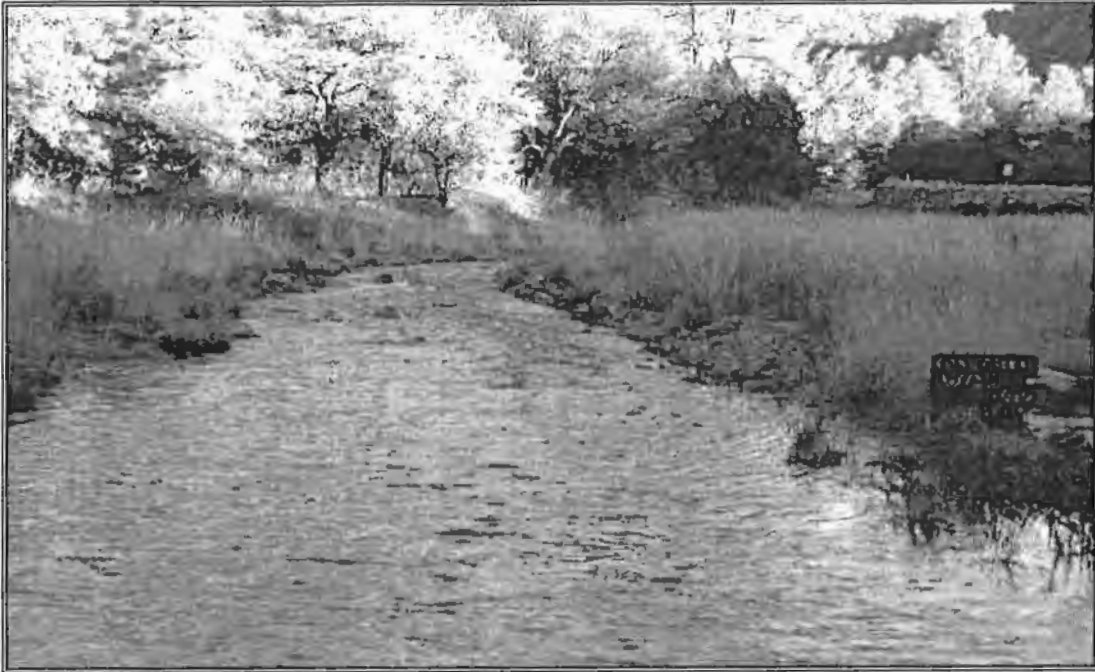
Photo 23. Downstream from Crossing #2 in 2005

This short ½ mile stretch of Coal creek below culvert battery #2 became perennial during 2002, even with drought conditions during winter months. Field inspections for additional thinning needs during 2003 revealed the presence of native leopard frogs in this stretch of perennial stream. Initial field observations during that summer by District bio-technicians indicated that these were likely Chiricahua leopard frogs, *Rana chiricahuaensis*. A subsequent survey, late in that summer confirmed Chiricahua leopard frog presence. Field observations in October 2004 during corridor fence construction noted leopard frogs in abundance downstream from crossing #2 in Coal Creek. Chiricahua leopard frogs were re-confirmed in 2004.
