**Upper Verde River Wildlife Area Turbidity Reduction  
Water Quality Improvement Grant  
FINAL REPORT**

**Arizona Game and Fish Department**  
ADEQ GRANT # 6-003

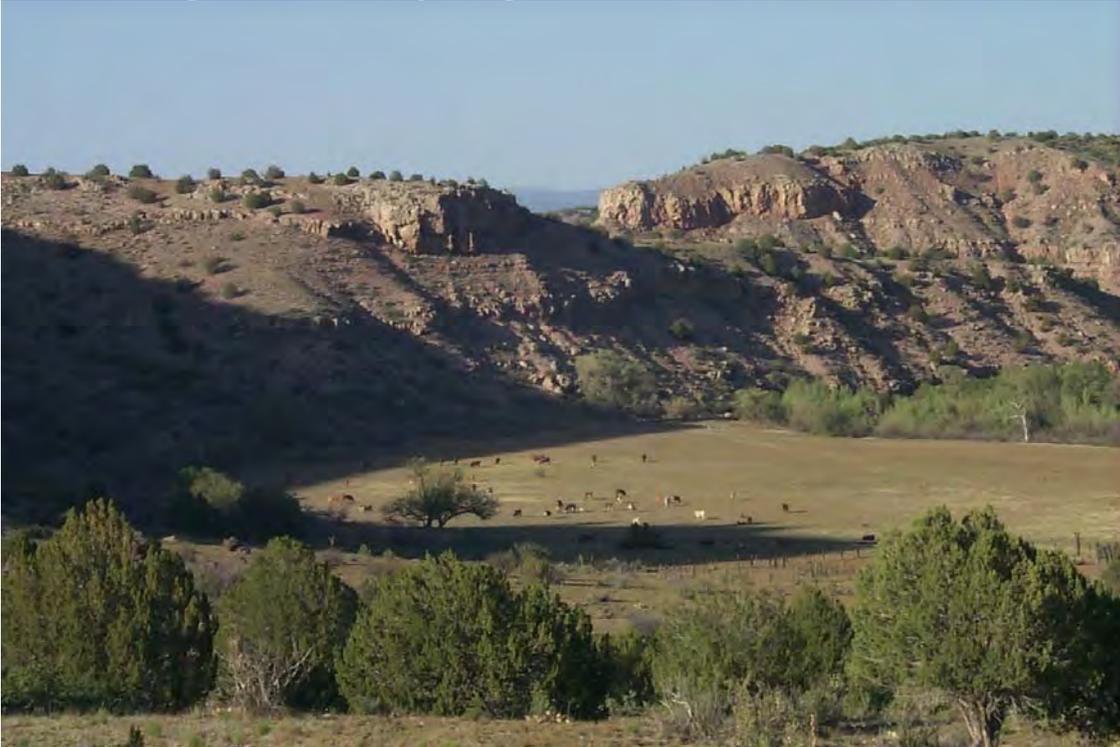
and impaired nutrient cycling. Within the project area, steep slopes and canyons lead down to floodplain terraces immediately adjacent to the Verde River. These floodplain terraces are important for infiltration and slowing the velocity of runoff. Trespass cattle use these terraces heavily because of forage, easy access, and proximity to the riparian corridor. Many of these areas have been severely overgrazed.

Photo 1. Trespass cows utilizing floodplain terrace

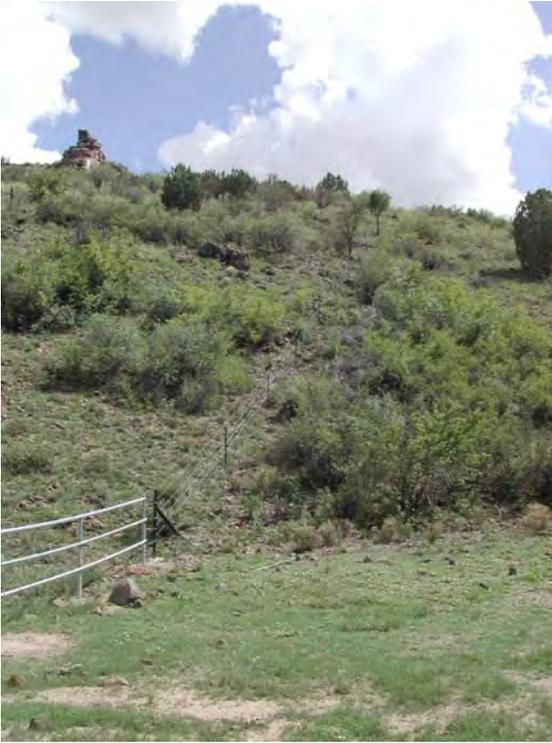
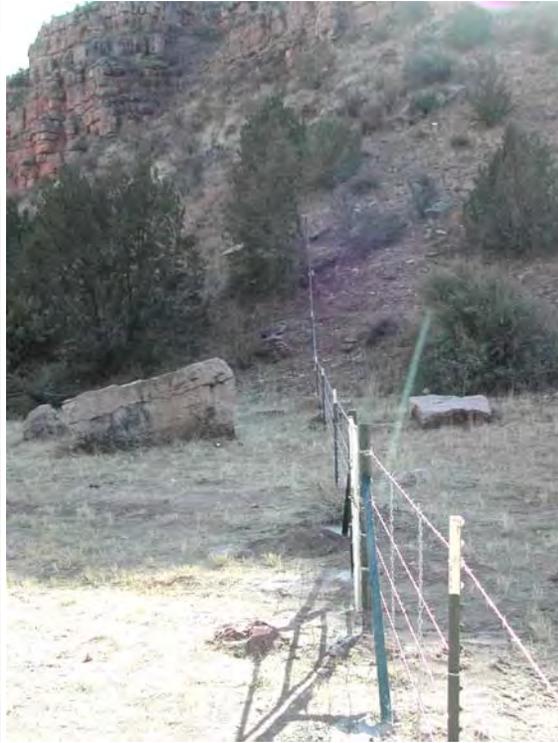
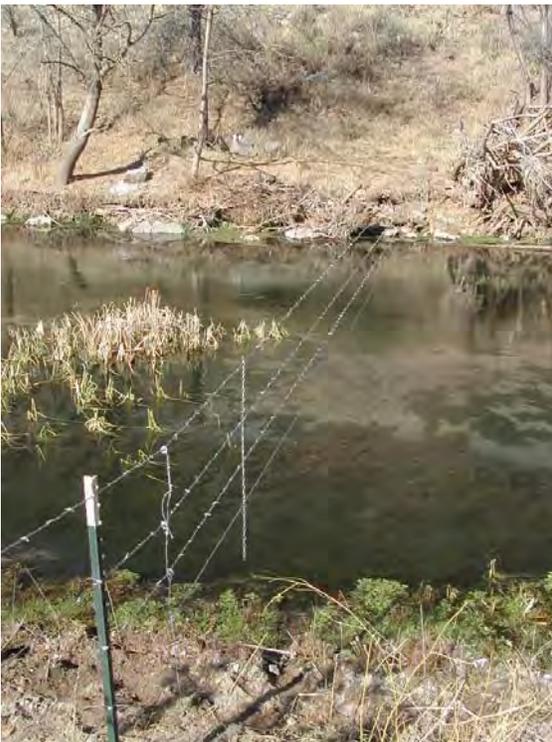
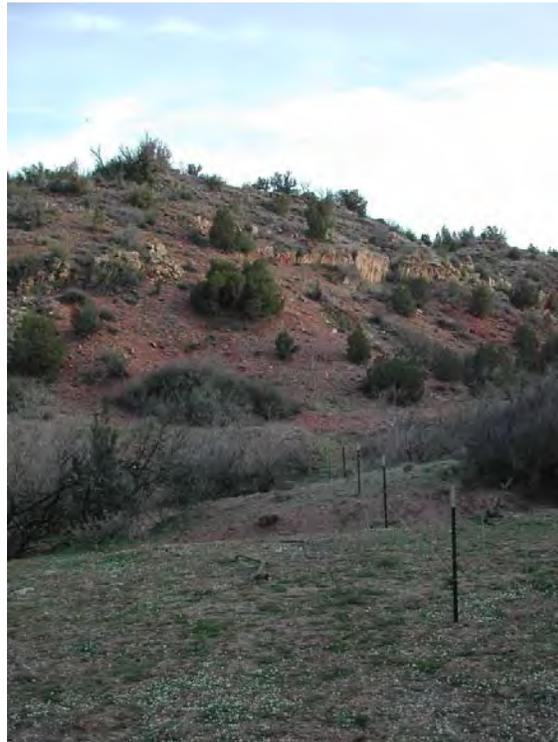
Photo 2 through 5. Fence Construction

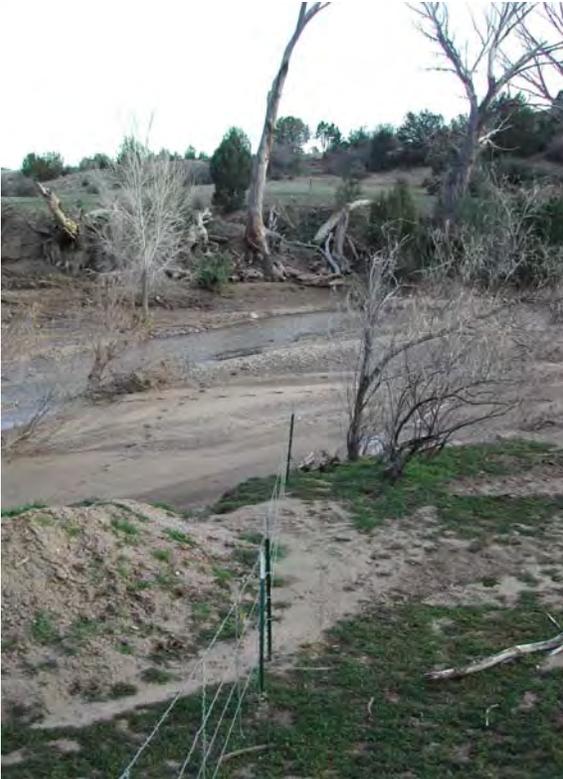
Four large flood events occurred between September 2004 and March 2005. Four Verde River crossings and 1 Granite Creek crossing were required to fence out private land sections. Portions of fence that cross the river or creek are designed to break-away during flood events to minimize the amount of fence that is damaged. Two crossings had to be rebuilt after they were destroyed by flooding (Photo 6). High water levels in the river during this period delayed construction of the fence due to poor access (Photo 7).

Photo 6. Flood Damage to Granite Creek Fence

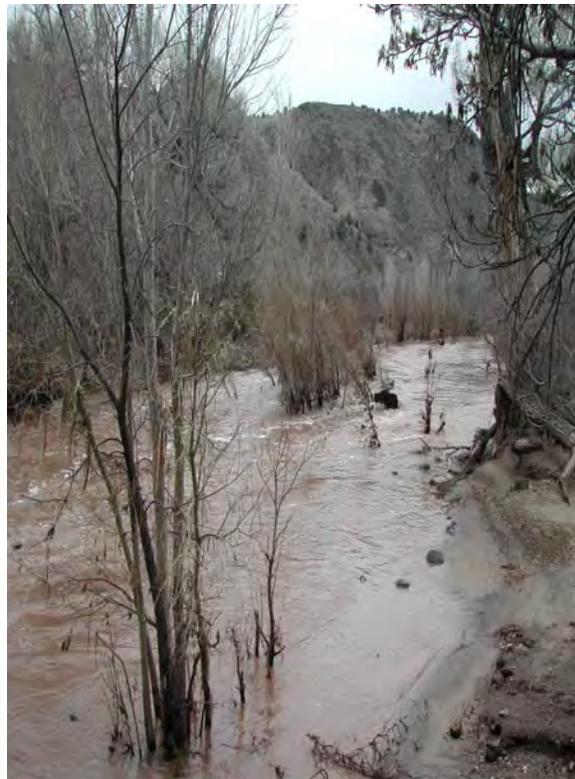
Photo 7. Verde High Water Flows

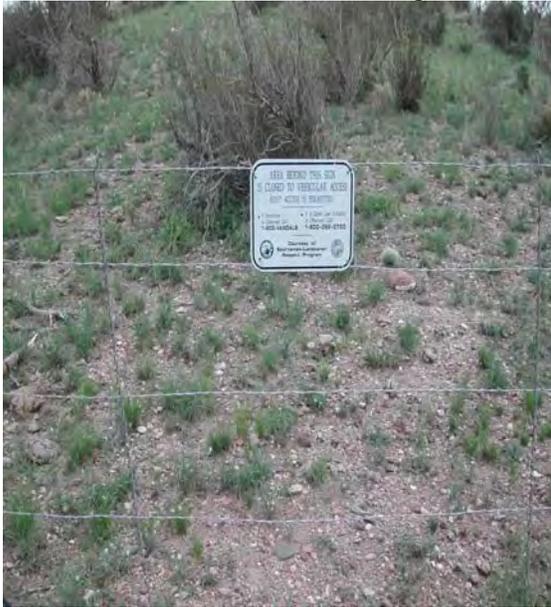
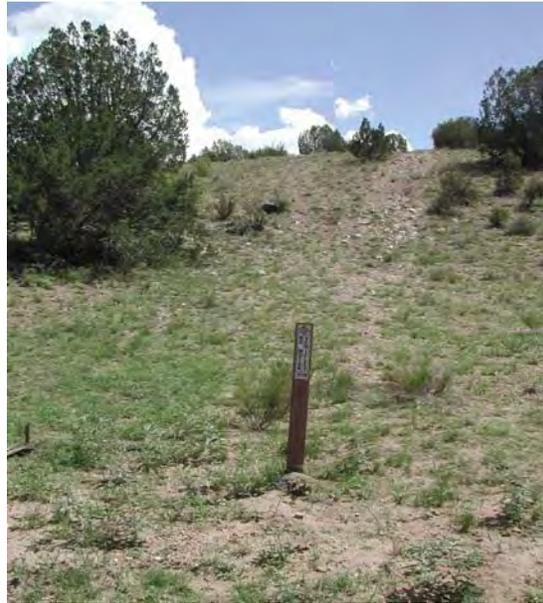
Photo 8 and 9. Road Closure Signs

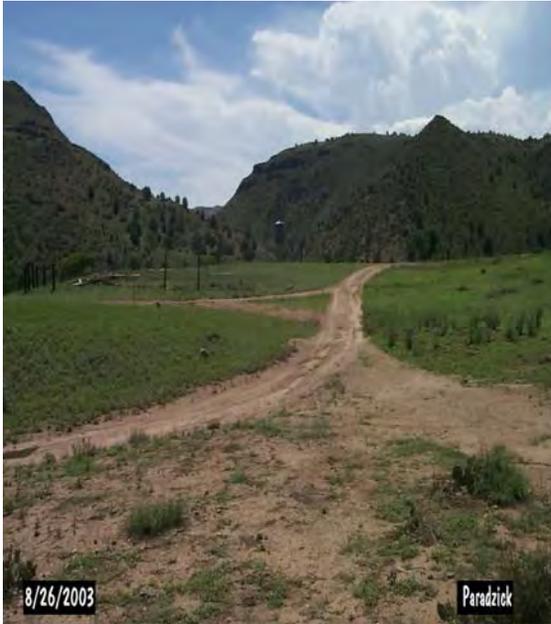
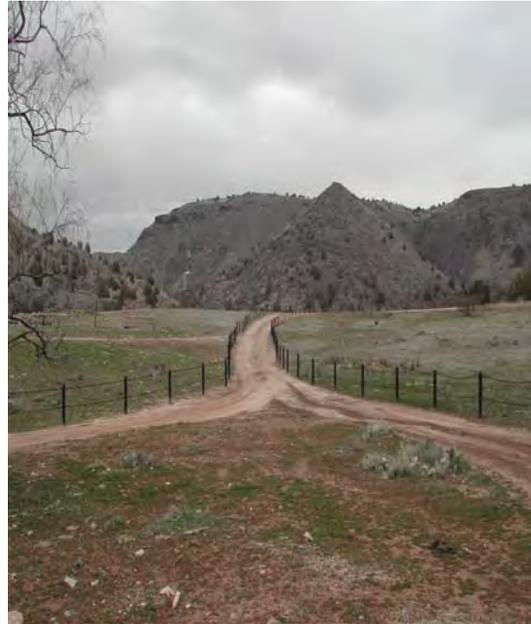
Photo 11 and 12. Post-and-Cable Fence

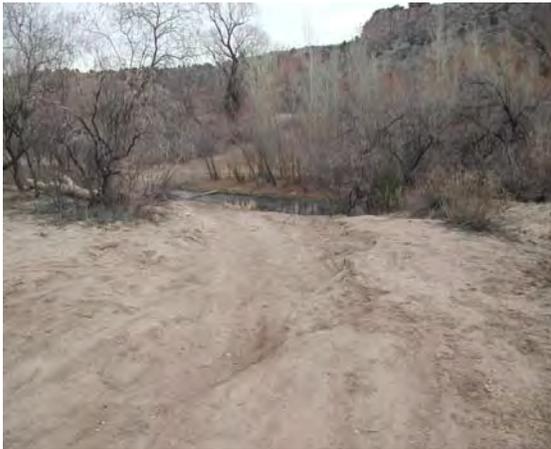
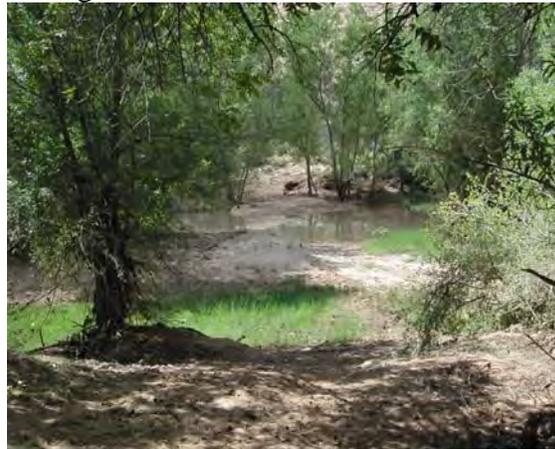
The length of all roads was calculated (using GPS) at the beginning of the project and at the end of the project to compare the amount of roads closed. Total length of all roads surveyed is 5,506m (3.42 miles) (Figure 3). All of the roads are currently closed except for 200m of the main access road and approximately 150m of a new wildcat road that was started illegally around the end of the post-and-cable fence. This new road is scheduled to be closed using boulders by October 2006. An additional 350m of road will be kept open for administrative use to access the Salt River Project low flow monitoring gauge and AGFD maintained facilities. Many of the roads and river crossings are now starting to revegetate and show signs of healing (Photos 12-13).

Photos 12 and 13. Before and After River Crossing

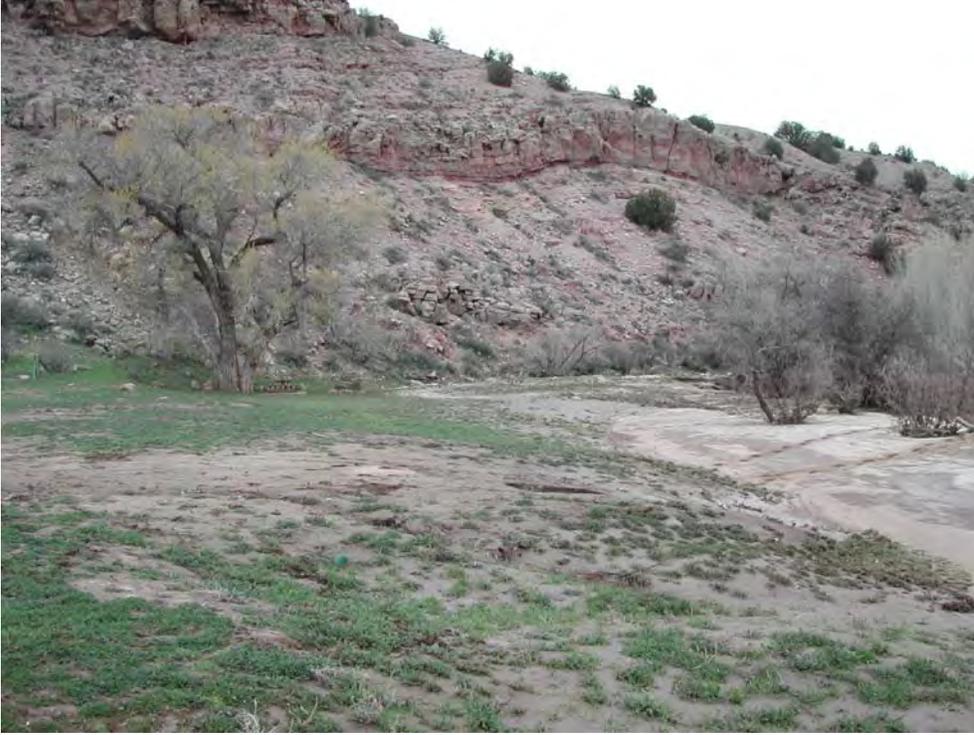
reshaped and contoured most of the eroding banks that were scheduled for restoration. No additional mechanical work on these banks was deemed necessary following the flood events.

Photo 14. Sediment deposition adjacent to floodplain terrace

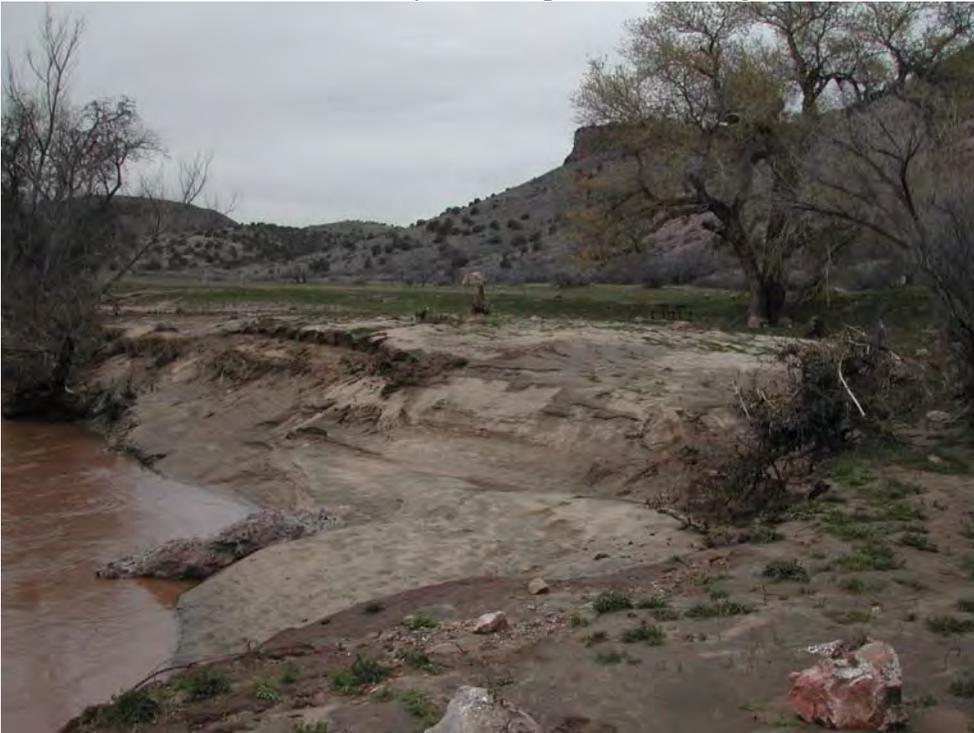
Photo 15. Area that was severely headcut prior to flooding

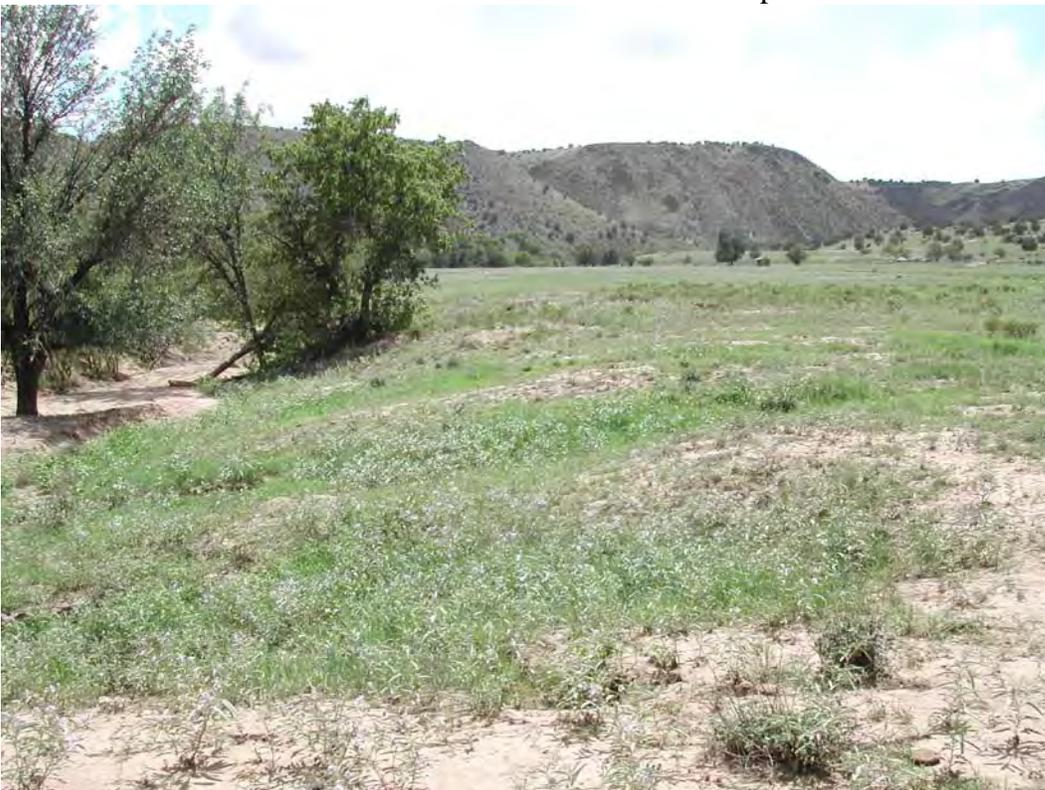
Photo 17. Grass and Forb establishment on banks and floodplain terrace

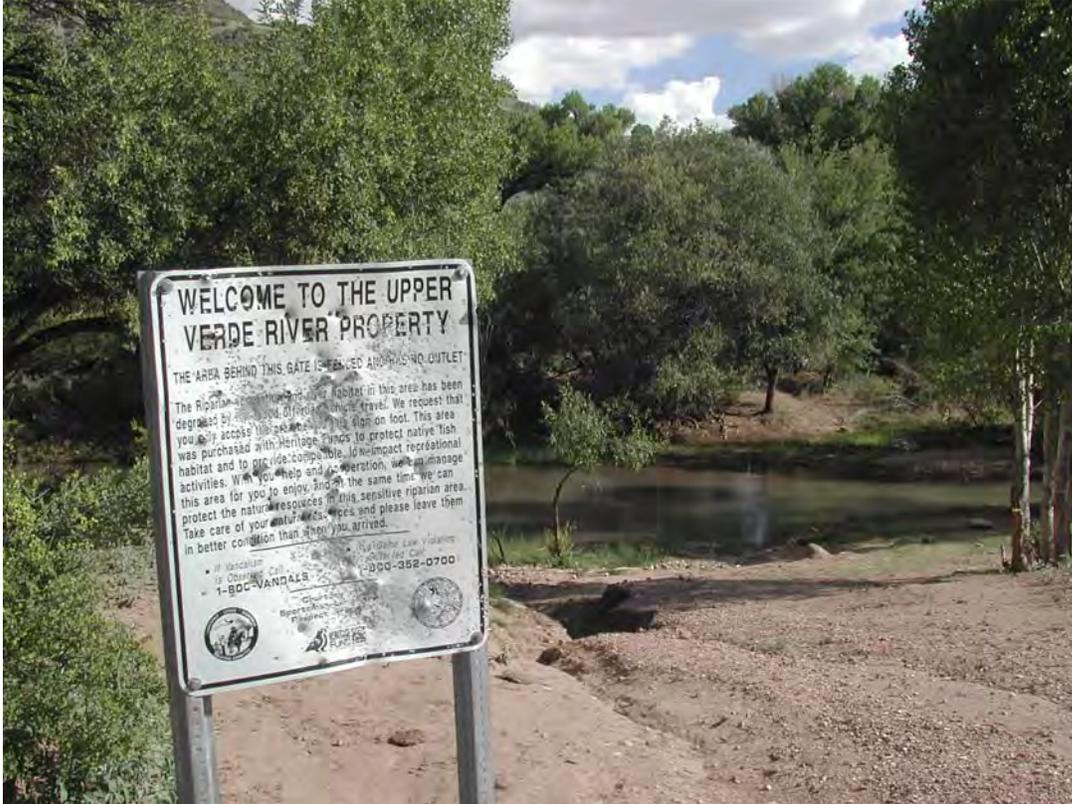
Closing of non-essential roads and reduction of illegal OHV use has been successful. Of the 5,506m of roads surveyed on the project, all but 750m have been closed to motorized vehicles. Eliminating vandalism is the major factor limiting the project's success. A lock on the main gate was removed with a cutting torch allowing vehicles into the closed area for a brief period. During this time, vehicles crossed the river on numerous occasions and damage to the main floodplain terrace occurred when vehicles doing high speed "brodies" destroyed native vegetation. Illegal OHV users cut one new section of fence to allow passage into a closed area. Someone also tried to shoot the lock off the main gate leaving holes in the housing but was unsuccessful. Signs have been largely ineffective in preventing illegal OHV use. Most of the signs installed at the wildlife area have been damaged or destroyed (Photo 20). Recommendations include support and maintenance of a full-time host/caretaker to monitor and prevent illegal activity.

Photo 20. Sign vandalism
