Borderlands Restoration Network

**Groundwater Recharge on
Working Lands by Local Youth
to Enhance Ecosystem Services**

Santa Cruz AMA

WMAP Groundwater Conservation Grant Application Cover Page

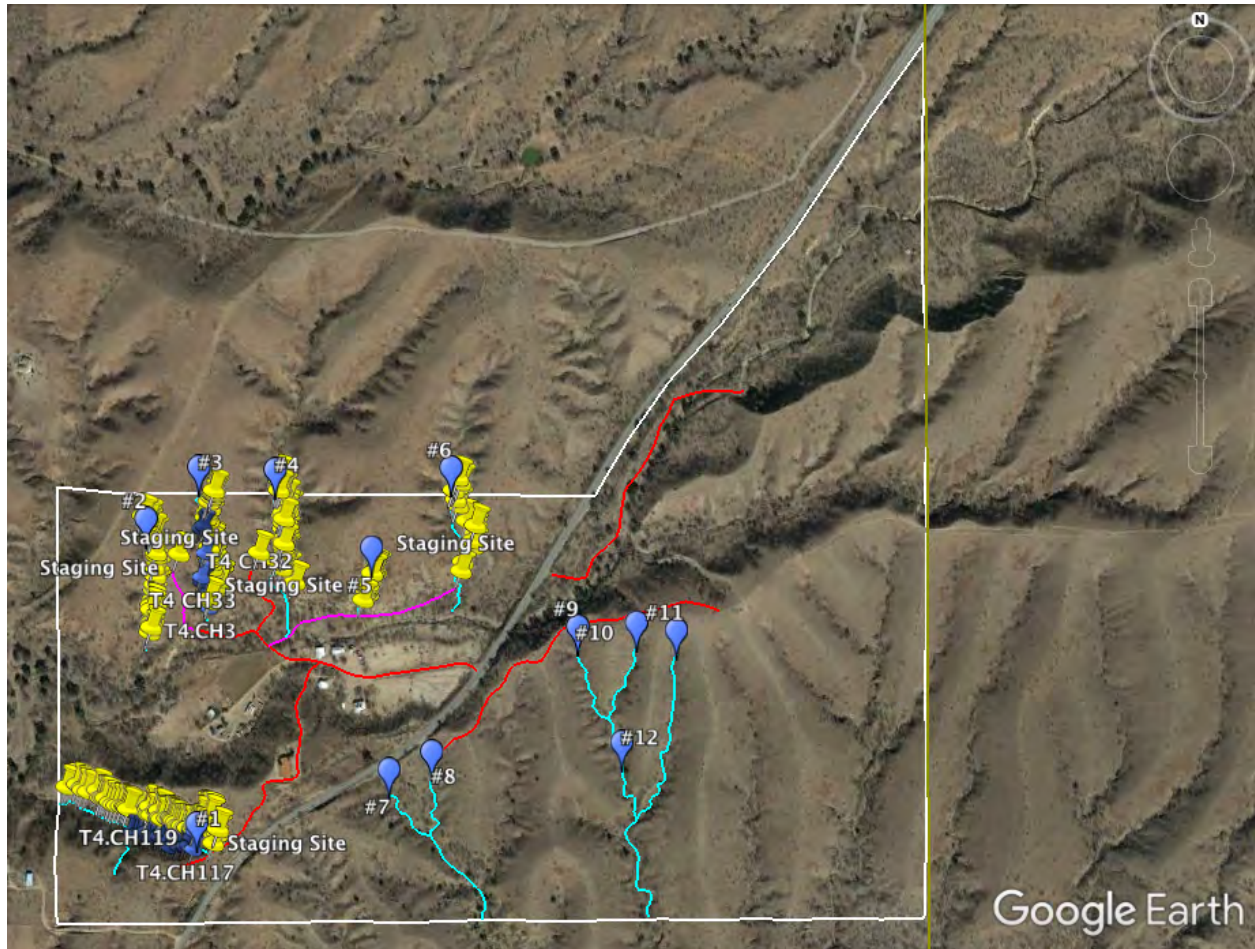
Map 2: Boundary of 300-acre T4 Ranch (white), cleared drainages (blue), cleared roads (red), and 200 existing erosion-control structures (yellow pins)

In 2018, Borderlands Restoration Network collaborated with T4 Ranch to install loose rock structures in six eroding, denuded drainages across the ranch. Borderlands Earth Care Youth interns installed 205 loose rock structures, which cumulatively retained an estimated 30 tons of sediment on the property according to preliminary data courtesy of the Arizona Department of Environmental Quality. The loose rock structures also aided in revegetating the landscape, which was denuded prior to the restoration treatment installation. Combined with sustainable ranching practices, the loose rock structures stimulated the return of many native grasses, such as *Bouteloua curtipendula*, *Bouteloua gracilis*, *Bouteloua barbata* var *rothrockii*, *Bothriochloa barbinodis*, *Heteropogon contortus*, and other grasses and native forbs. This provided forage for T4 Ranch cattle and increased soil stability within the drainages, forging a healthier watershed. Anecdotally, the ranch manager also noticed periods after rain events where water was temporarily detained behind loose rock structures. This short term surface water not only temporarily alleviated the pressure on groundwater for watering cattle, it also extended the hydro-period for the watershed, promoting infiltration (Norman et al., 2015). Over the course of two years, the loose rock structures installed in 2018 have quantitatively and qualitatively exhibited their efficacy for watershed restoration.

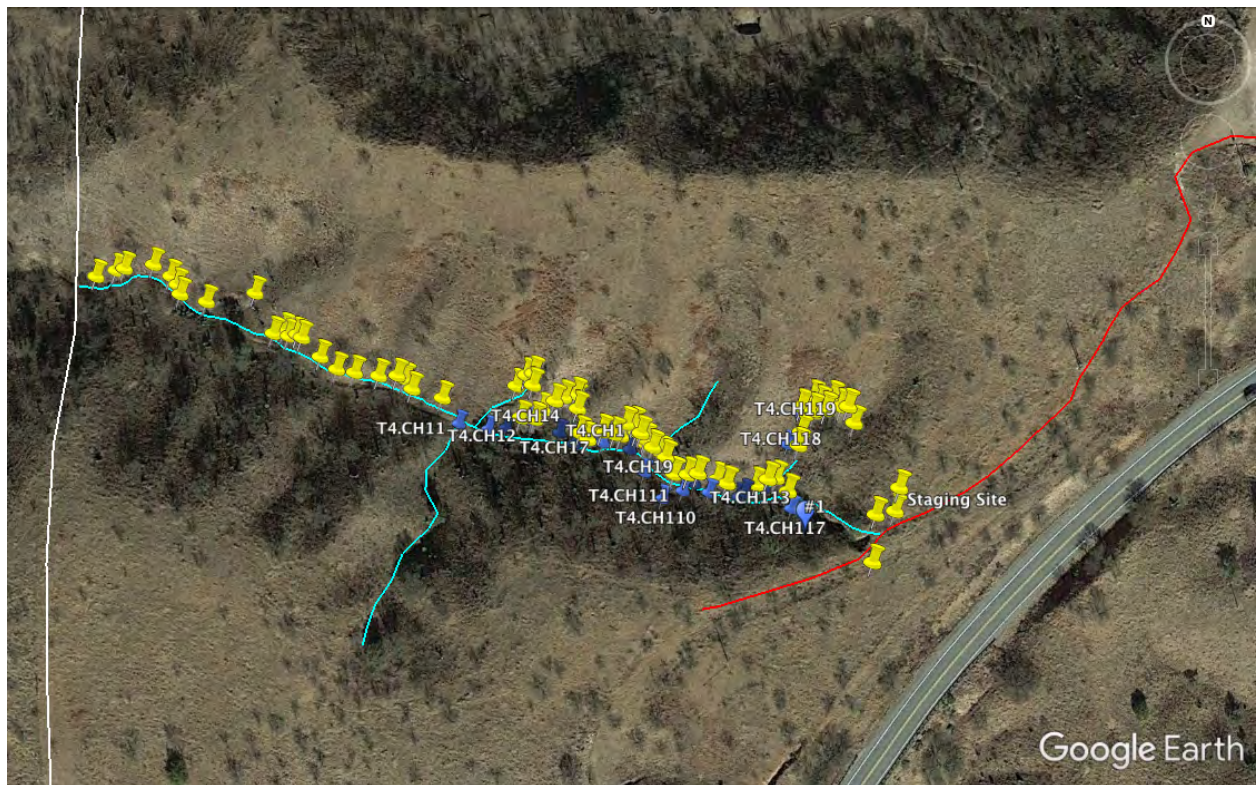
Map 3: Detail view of Channel #1 at T4 Ranch and the structures within

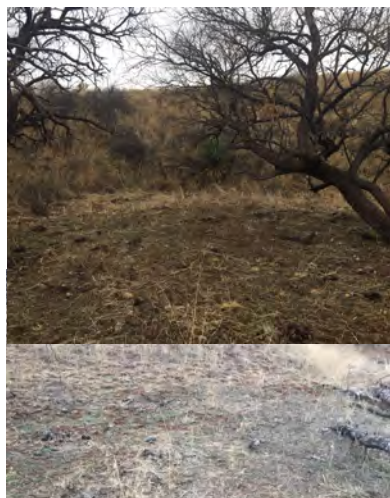
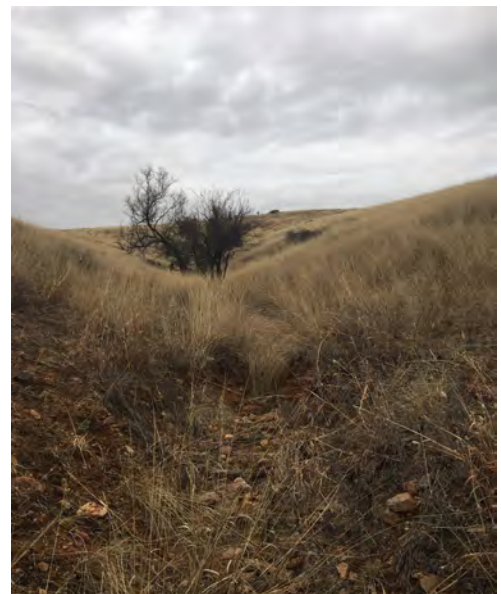
Figure 1. Untreated drainages in T4 Ranch with bare ground and channelization issues.

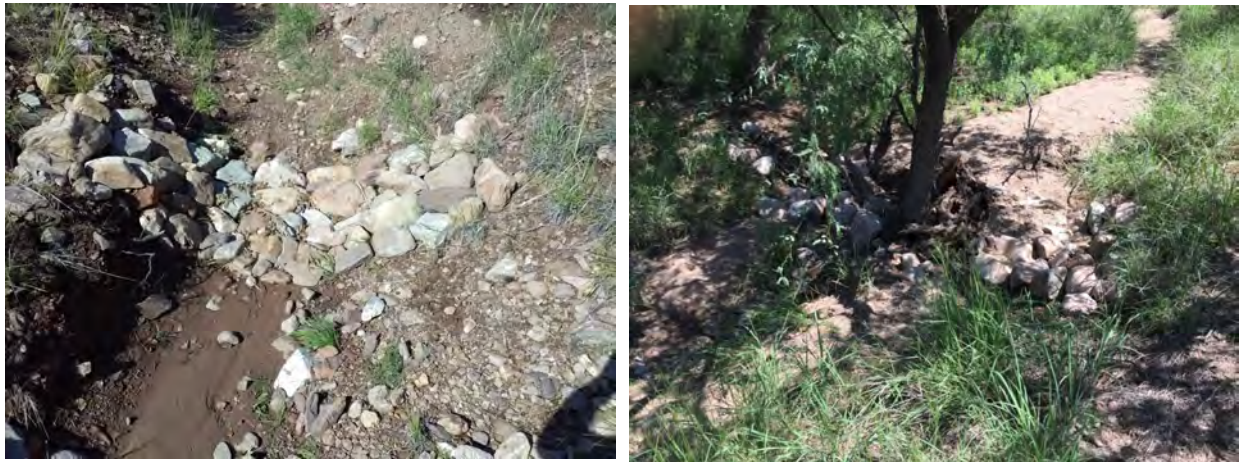
Figure 2. (Left) With flow direction from bottom of image to top, fine sediment is retained along with organic material that builds soil, while the passive structures allow water to continue flowing downstream. Structures become part of the system's ecological infrastructure and prevent further down-cutting and hydrologic draw-down that de-waters entire watersheds if left unabated. (Right) Approximately 18 inches of sediment and organic material (upper right) captured behind a low structure built into an existing tree and channel banks that were compromised.

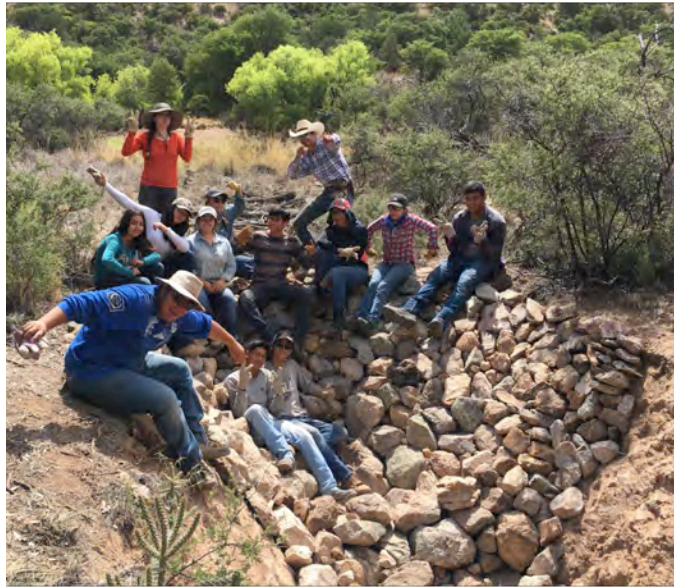
Figure 3. BECY interns proud of their loose rock structure, healing an 8-foot headcut.

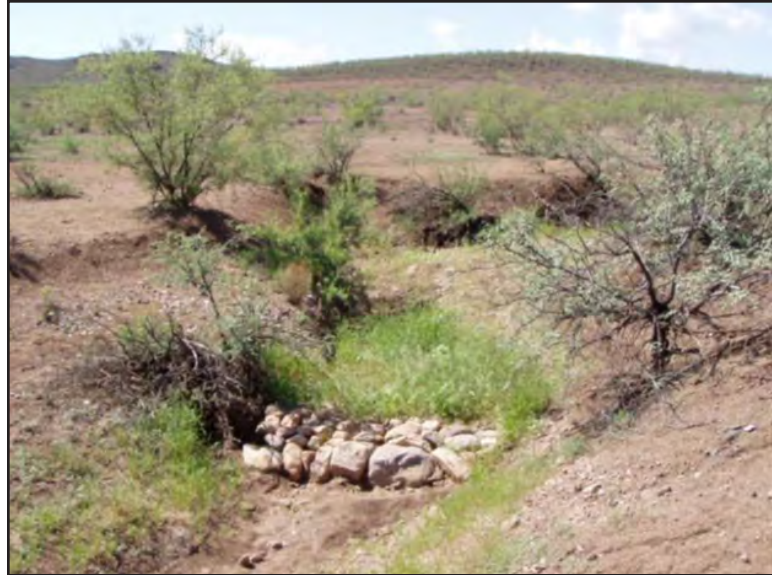
Figure 3. Photograph of an example erosion control feature (courtesy of Borderlands Restoration).

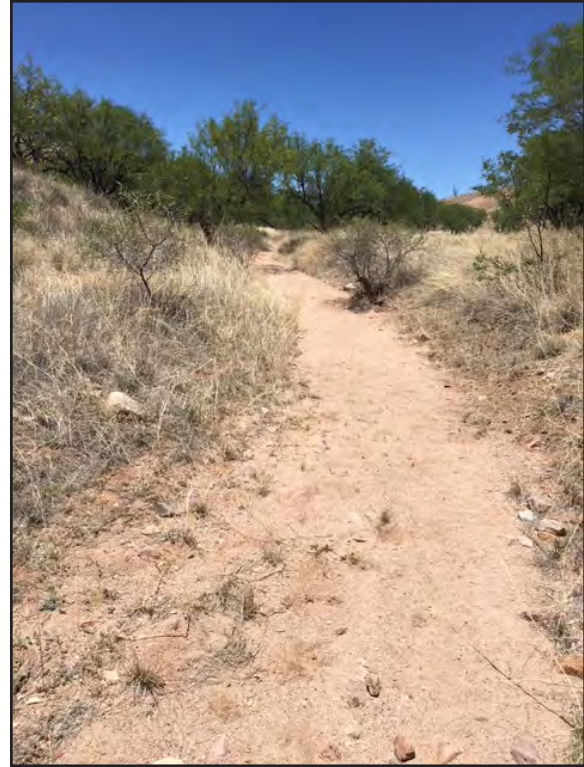
Figure 7. Photograph of drainage 4.

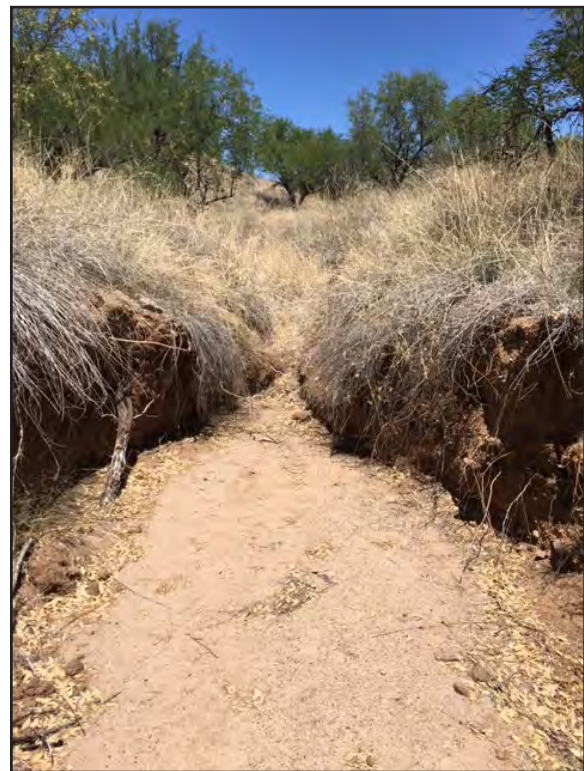
Figure 8. Photograph of vegetation along drainage 6.

Within the survey area, ground visibility was limited (Figure 8). All open areas were examined. No archaeological resources were found in the project area.
