PAKOON WASH AND PAKOON SPRINGS  
RESTORATION AND ENHANCEMENT PROJECT  
FINAL REPORT

AWPF GRANT CONTRACT #11-180WPF

Jennifer Fox  
Ecologist  
Grand Canyon-Parashant National Monument

**August 31, 2016**

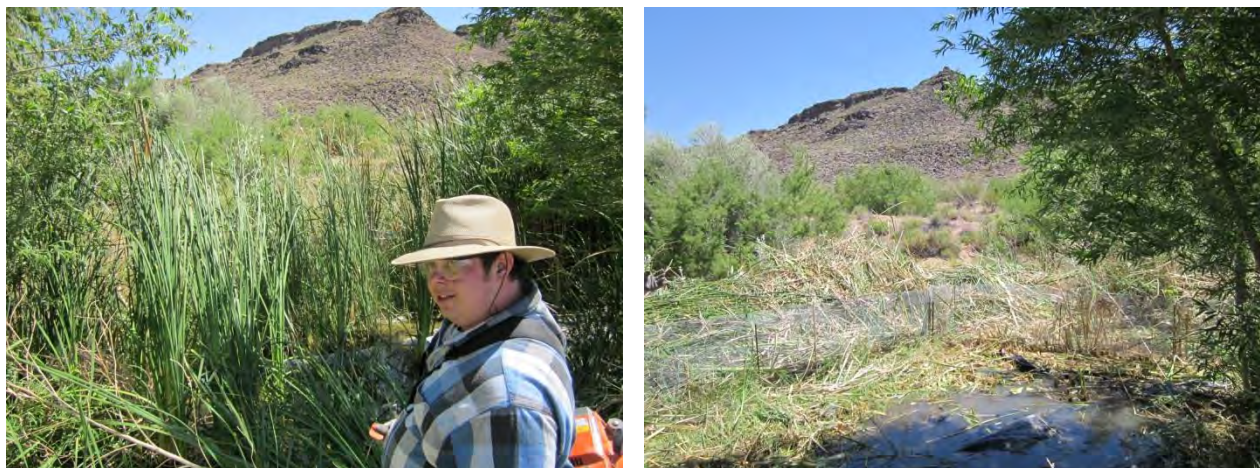
Figure 8. Arena 4E before (left) and after (right) cattail removal, early summer 2013. Pictured: IIC Intern Cory Litson.

Cattails were periodically removed as needed from Arena 4 and 4E throughout the project (Figure 8). In May 2013, during a site visit with AGFD, Parashant and GCWC personnel, it was decided that the most useful modification to Pakoon Springs would be to keep the pond drawn down as much as possible. This would decrease the newly available habitat in the wash/creek, retard the growth of cattails in Arenas 4 and 4E and decrease the available deep water habitat necessary for successful bullfrog recruitment. In addition, habitat restoration including the transformation of standing water areas formerly dominated by cattail to alkali meadow and spring/seep habitat has resulted in a decrease in habitat suitable for bullfrogs.

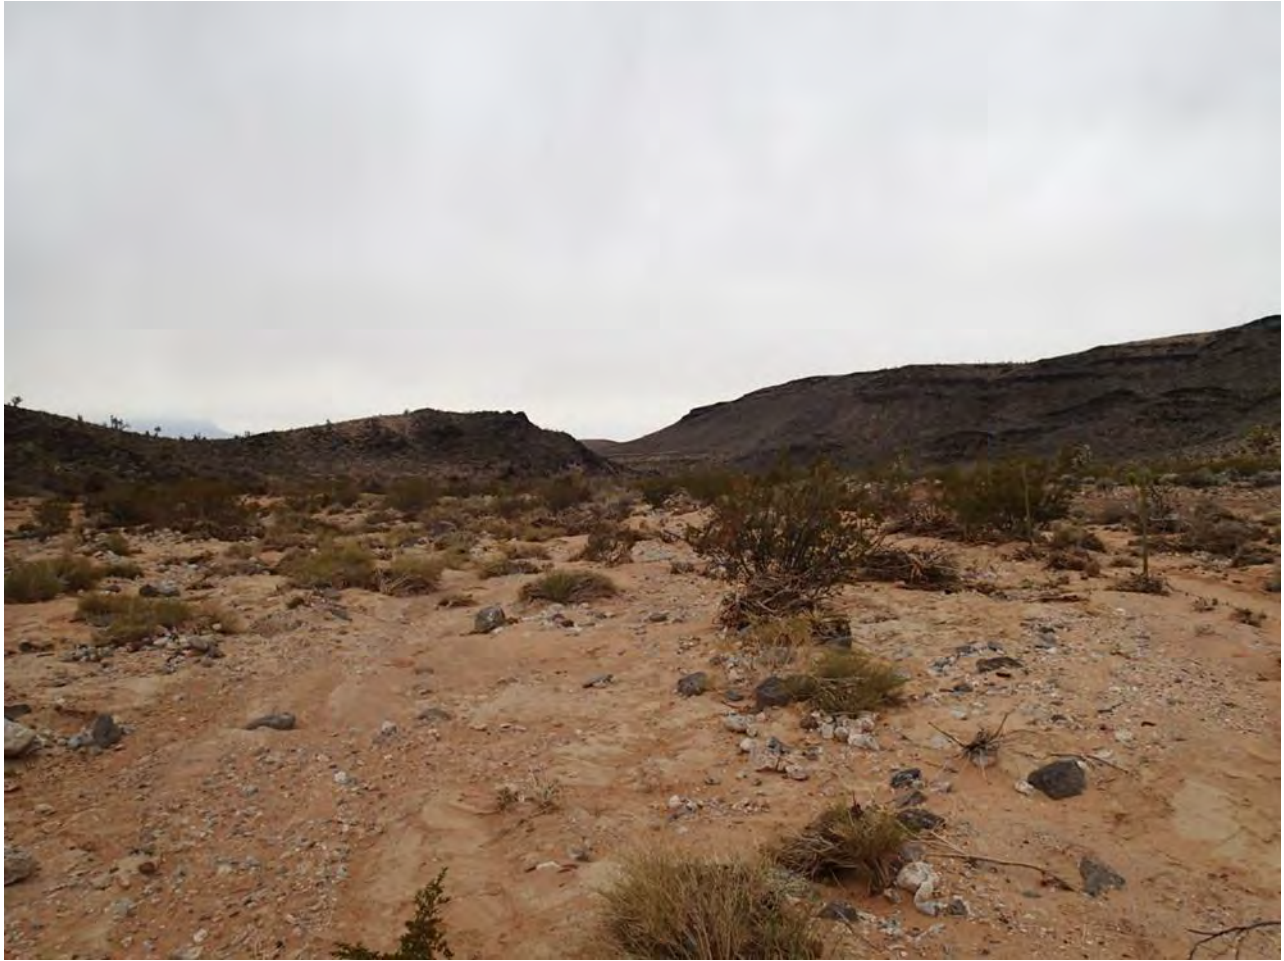
Figure 10. Area west of Arenas 1-3 after September high water event. Note, even with scouring flood, native shrubs are a diverse cross-section of Mojave Desert species.

The upper agricultural field area (north and west of Arenas 1-3) that has not been modified except for initial site cleanup following property acquisition by the BLM in 2004 show a mix of native shrub species (Figure 10). Passive revegetation has also successfully colonized the new linear springbrook of Arena 4.

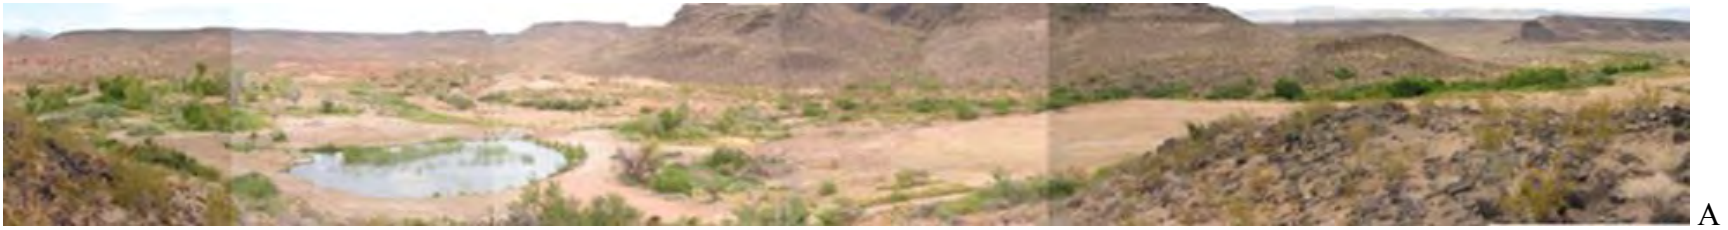
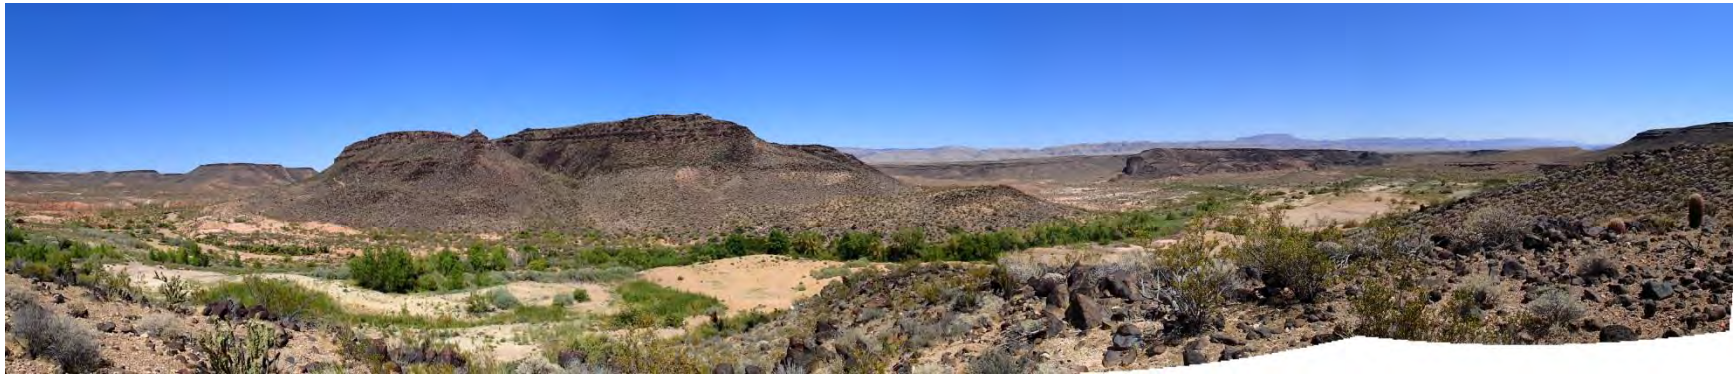
Figure 11. Panoramic view of Pakoon Springs from hill at Pakoon (Photopoint 2) on A) July 10, 2009, B) June 1, 2016. For images of intermediate stages, see Appendix E.

In general, the site photos over time demonstrate rehabilitation of native vegetation with rapid growth, increase in cover, and high survivorship. Figure 11 (view toward the northeast) illustrates this change. The changes are most noticeable near Arena 4 and 4E with an increase in surrounding vegetation, especially woody types.

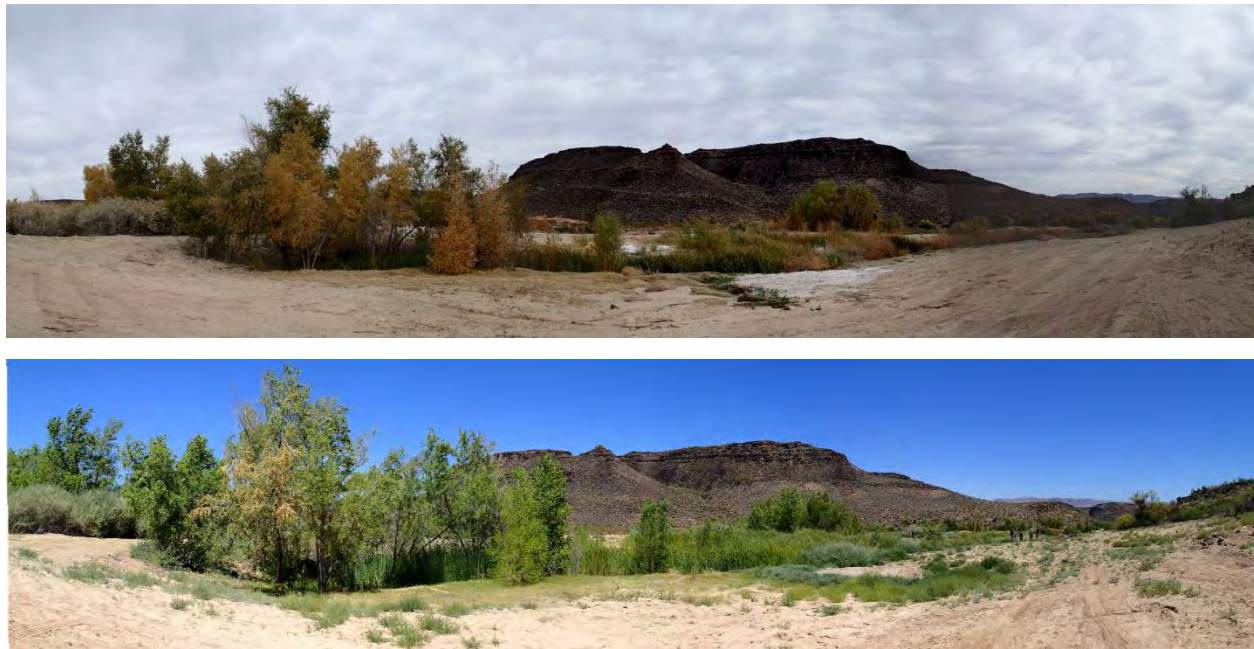
Figure 12. Photopoint 5. Top: December 9, 2015 (9 months after pond removal). Bottom: June 1, 2016.

Images taken at Photopoint 5 (Figure 12) show the gradual change in vegetation after removal of the pond from Arena 4. No plantings occurred in the recontoured areas, yet the vigorous colonization of bare soil by a full suite of upland, aquatic and riparian plants suggests the site maintains a sizable seed bank and the naturally occurring and planted vegetation are providing a continuing seed source.

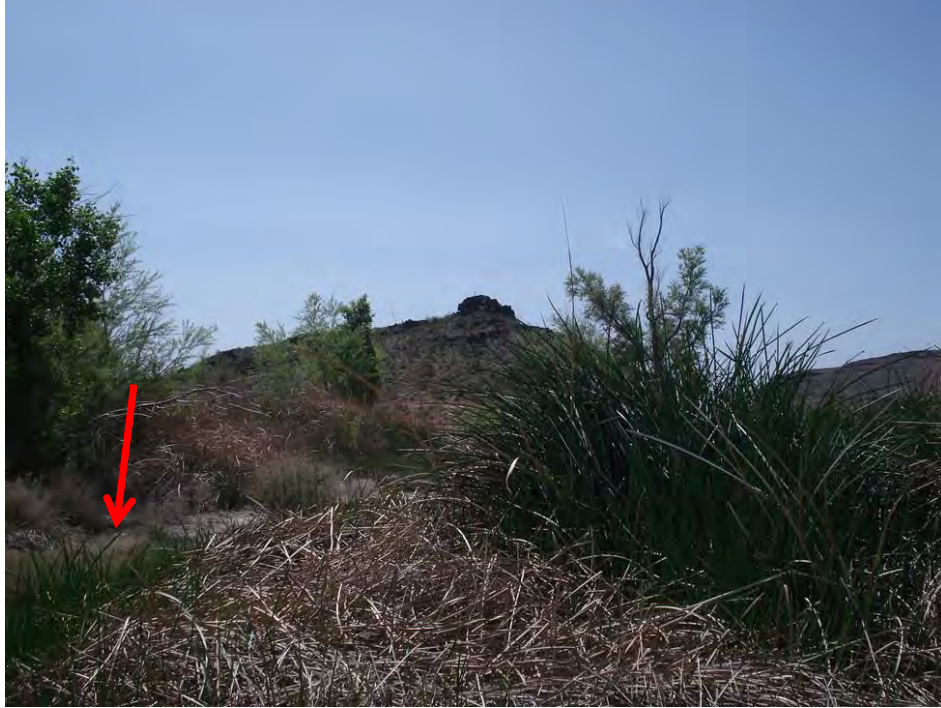
Figure 17. April 2011. Arena 3 &5. Note standing water indicated by red arrow.

The Pakoon Spring complex is undergoing rapid shifts in vegetation and flow as the site responds to rehabilitation work and natural successional processes (Figures 17-19). The site vegetation is becoming more complex as species react to increasing zonation in light and soil moisture by partitioning the site into areas of mixed species and monocultures based on acceptable environmental variables for each species. It is expected that this resource partitioning will continue.

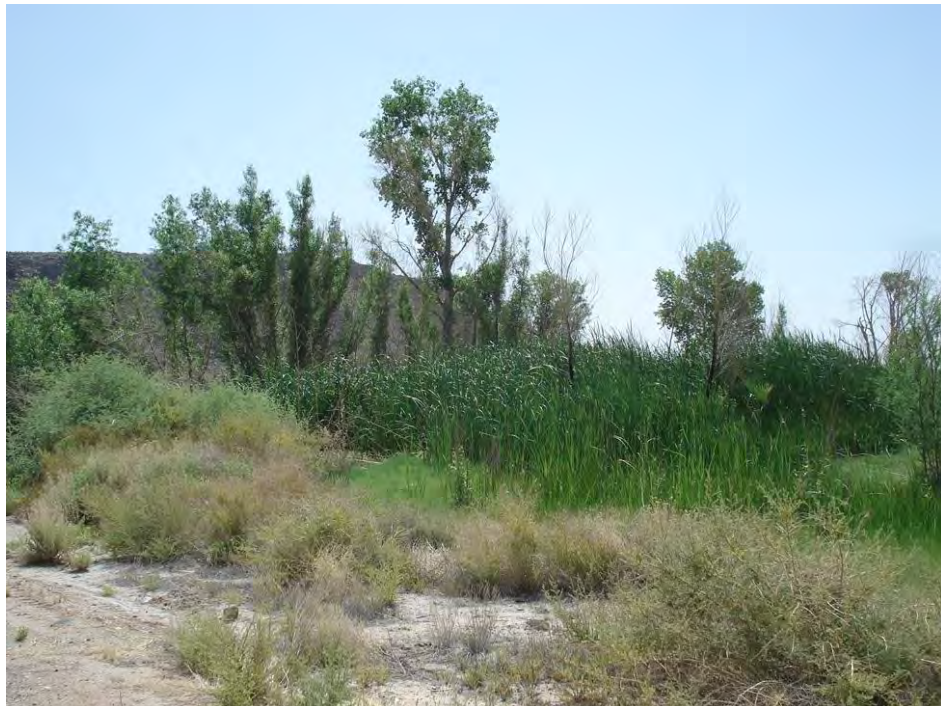
Figure 18. May 2012. Arena 3. No open standing water found in Arenas 1-3, 5. All surface water in those arenas dominated by *Typha*.

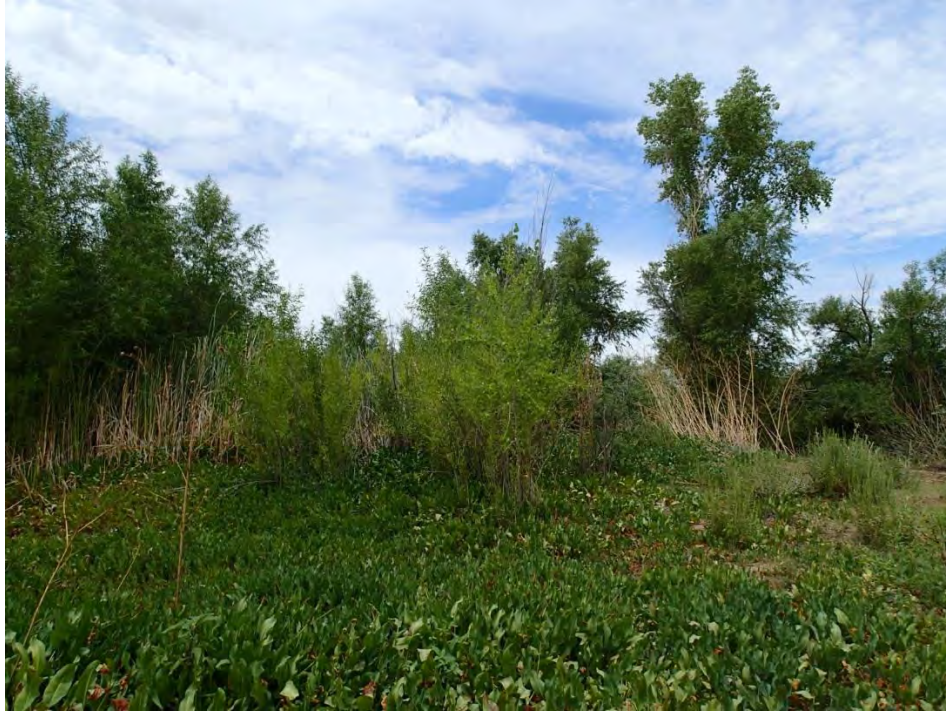
Figure 19. July 2014. Arena 2-3. No standing water found in Arenas 1-3, 5. Note shift to willow and *Anemopsis*-dominated landscape.
