# Arizona Department of Environmental Quality Water Quality Improvement Grant

## Erosion Control, Sediment Retention and Riparian Restoration in the Babocomari River Watershed

### EV16-0002 (18-006)

Borderlands Restoration Final Report May 2018

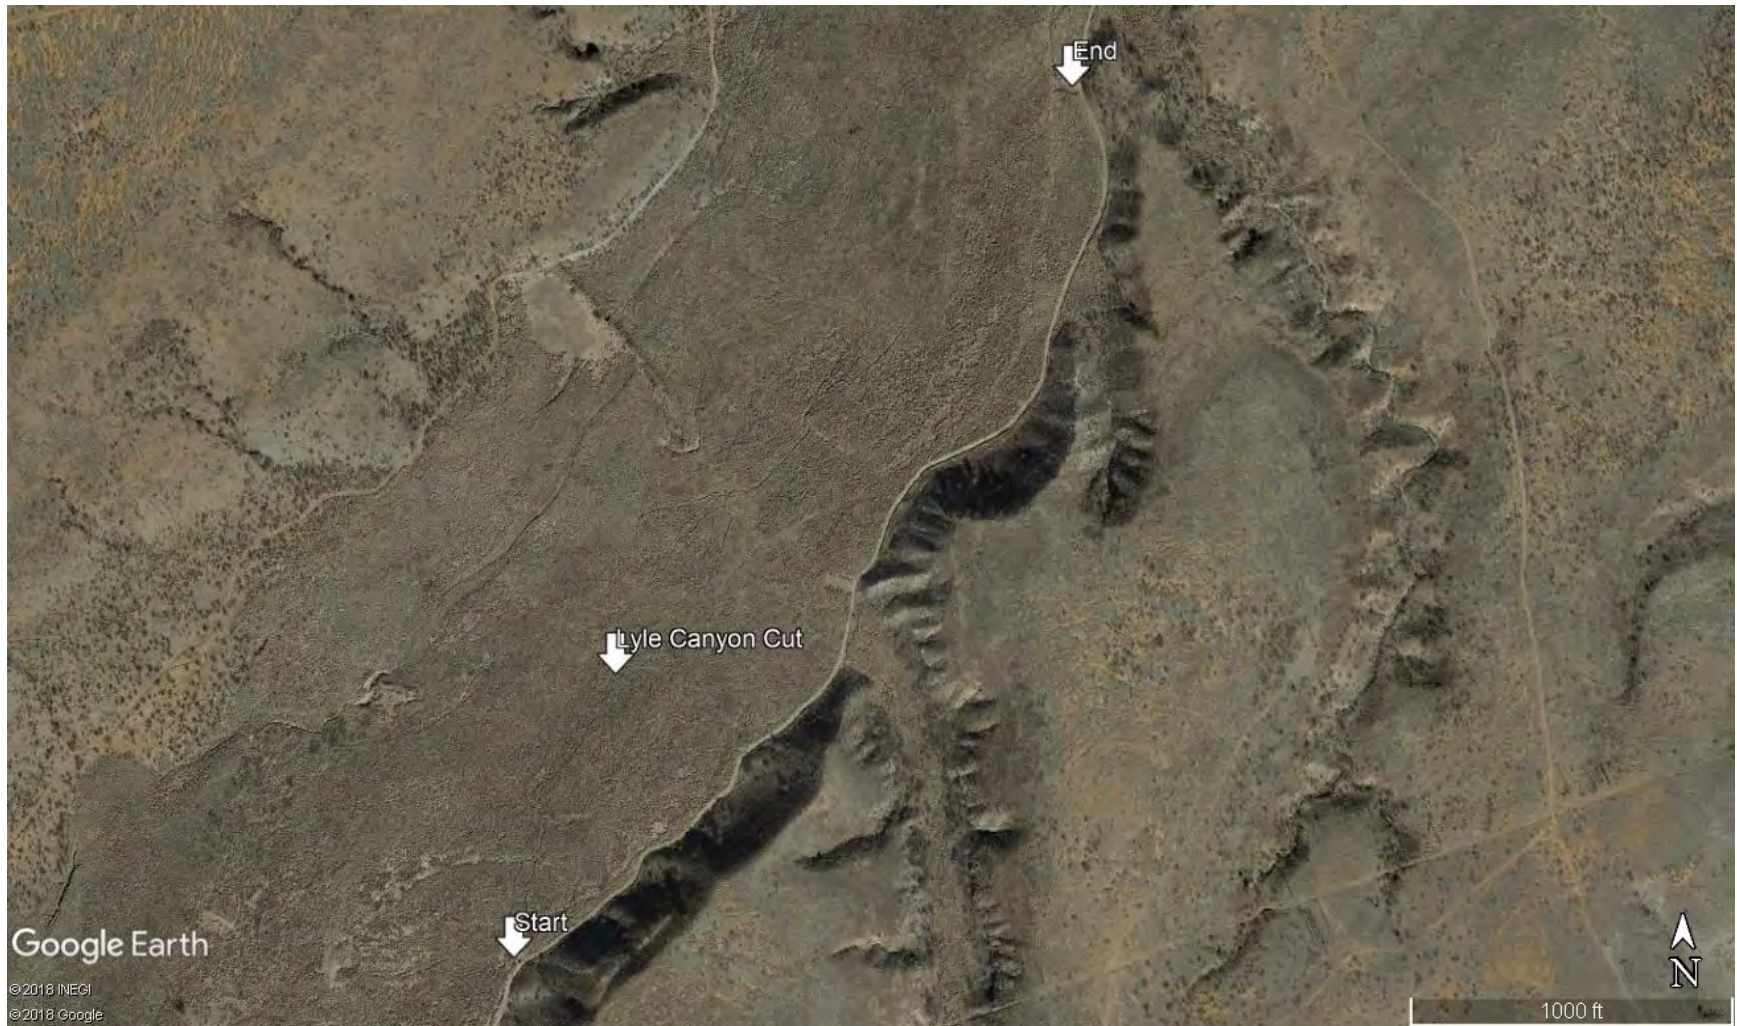
Lyle Canyon Worksite

The grant was awarded on 23 May 2016 and work commenced in July with three days in the field scouting work in Lyle, Hay and O'Donnell Canyons, Lyle Canyon had burned in March 2015 and revealed a large ~1 mile long cut, 2-4 feet deep and 2-4 feet wide. Walked this cut and determined spacing of structures and rock needs. The Babocomari Ranch owners had reported that they were concerned with a couple of spots in Hay Canyon and we walked the drainage from Babocomari Ranch Road to Canelo-Elgin Road and assessed needs there. Met with the Jelk's Ranch manager to discuss work in the ciénega just south of the Nature Conservancy's Canelo Hills Preserve. We agreed that removing parts of the berm and adding some Media Lunas above of the large headcut would be are best approach. This plan was written up and approved by ADEQ.

In October planning continued on Babocomari work. The crew finished up in Lyle Canyon on 21 October 2016 with over a mile of eroded gullies treated with over 100 tons of rock. Had 40 tons of rock delivered to Pacheco Springs and crew started structure installation.

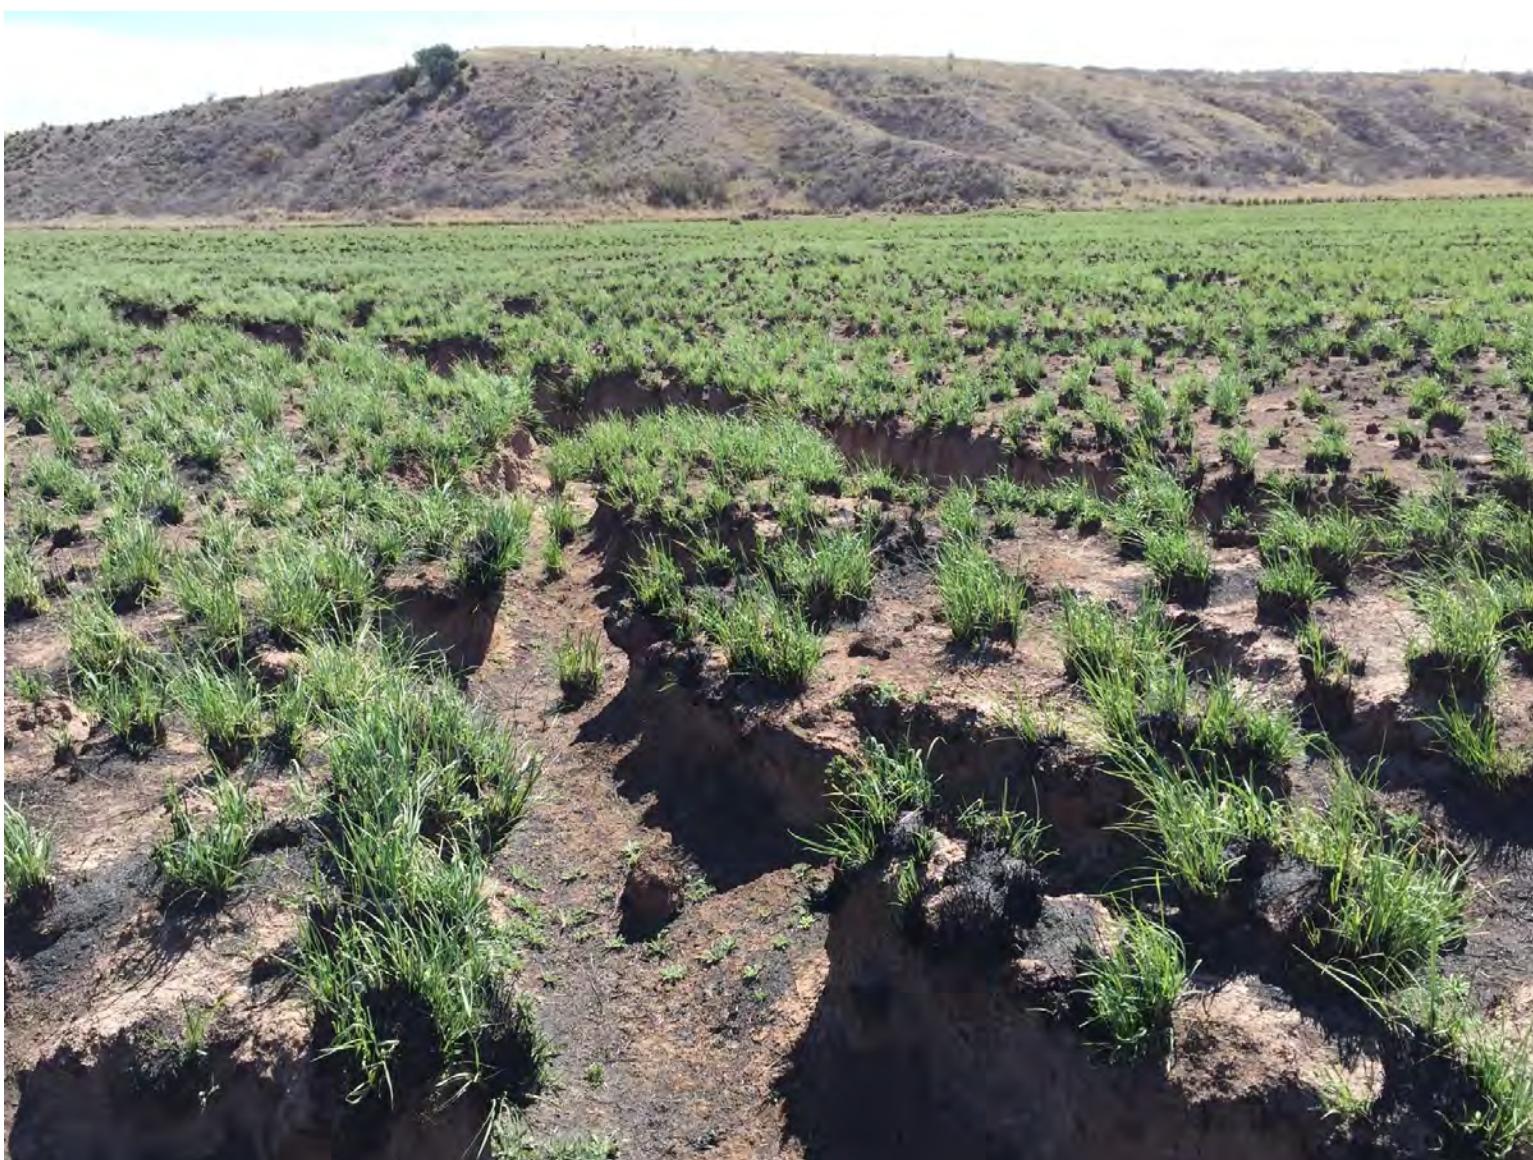
Gullying in Lyle Canyon

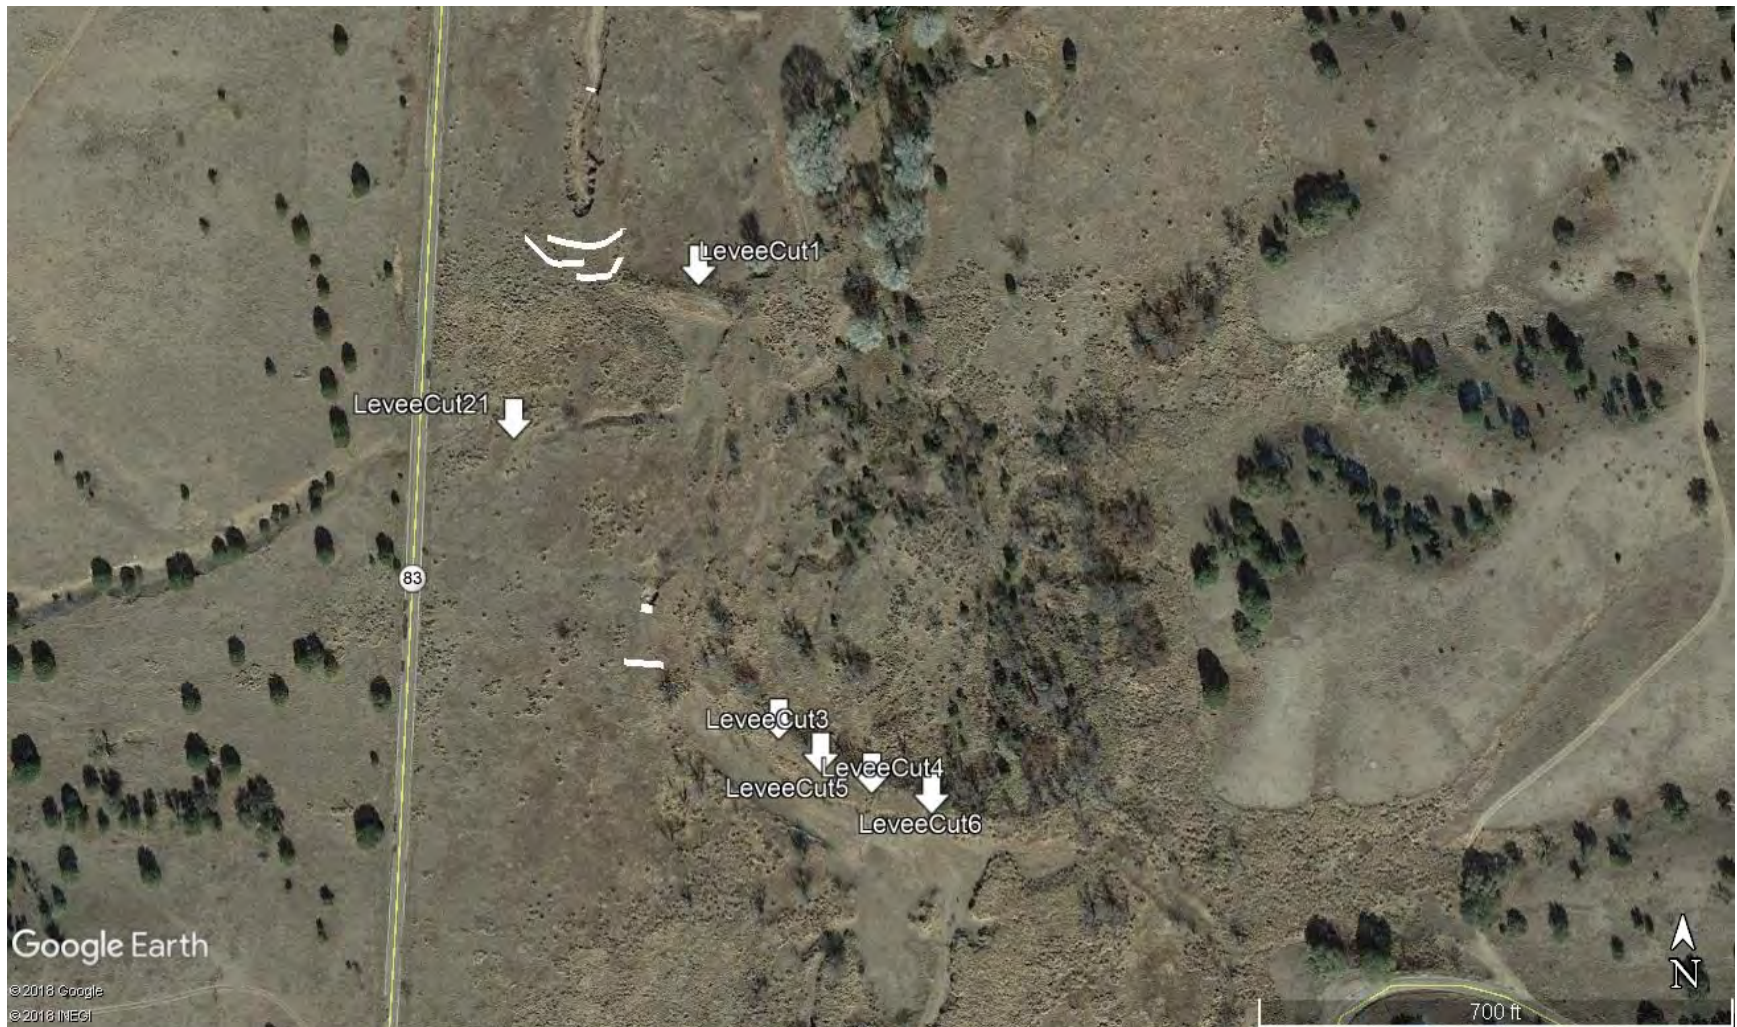
Diamond C Ranch-O'Donnell Canyon Ciénega worksite

In March we started work in O'Donnell Canyon on the Diamond C Ranch just above the Nature Conservancy's Canelo Hills Preserve. The work is to stop a large headcut in the Sacaton grasslands adjacent to the drainage and associated ciénega. Over three weeks we used approximately 36 tons of rock to install five media lunas (flow spreaders) above the large headcut and one above the smaller headcut. A loose-rock check dam was installed in the large headcut, and a rock rundown was installed in the smaller headcut. In addition a large loader was rented from Empire Caterpillar and was used for one week to remove five 8-foot sections from two levees that were pushing water out its natural flow path towards the headcuts.

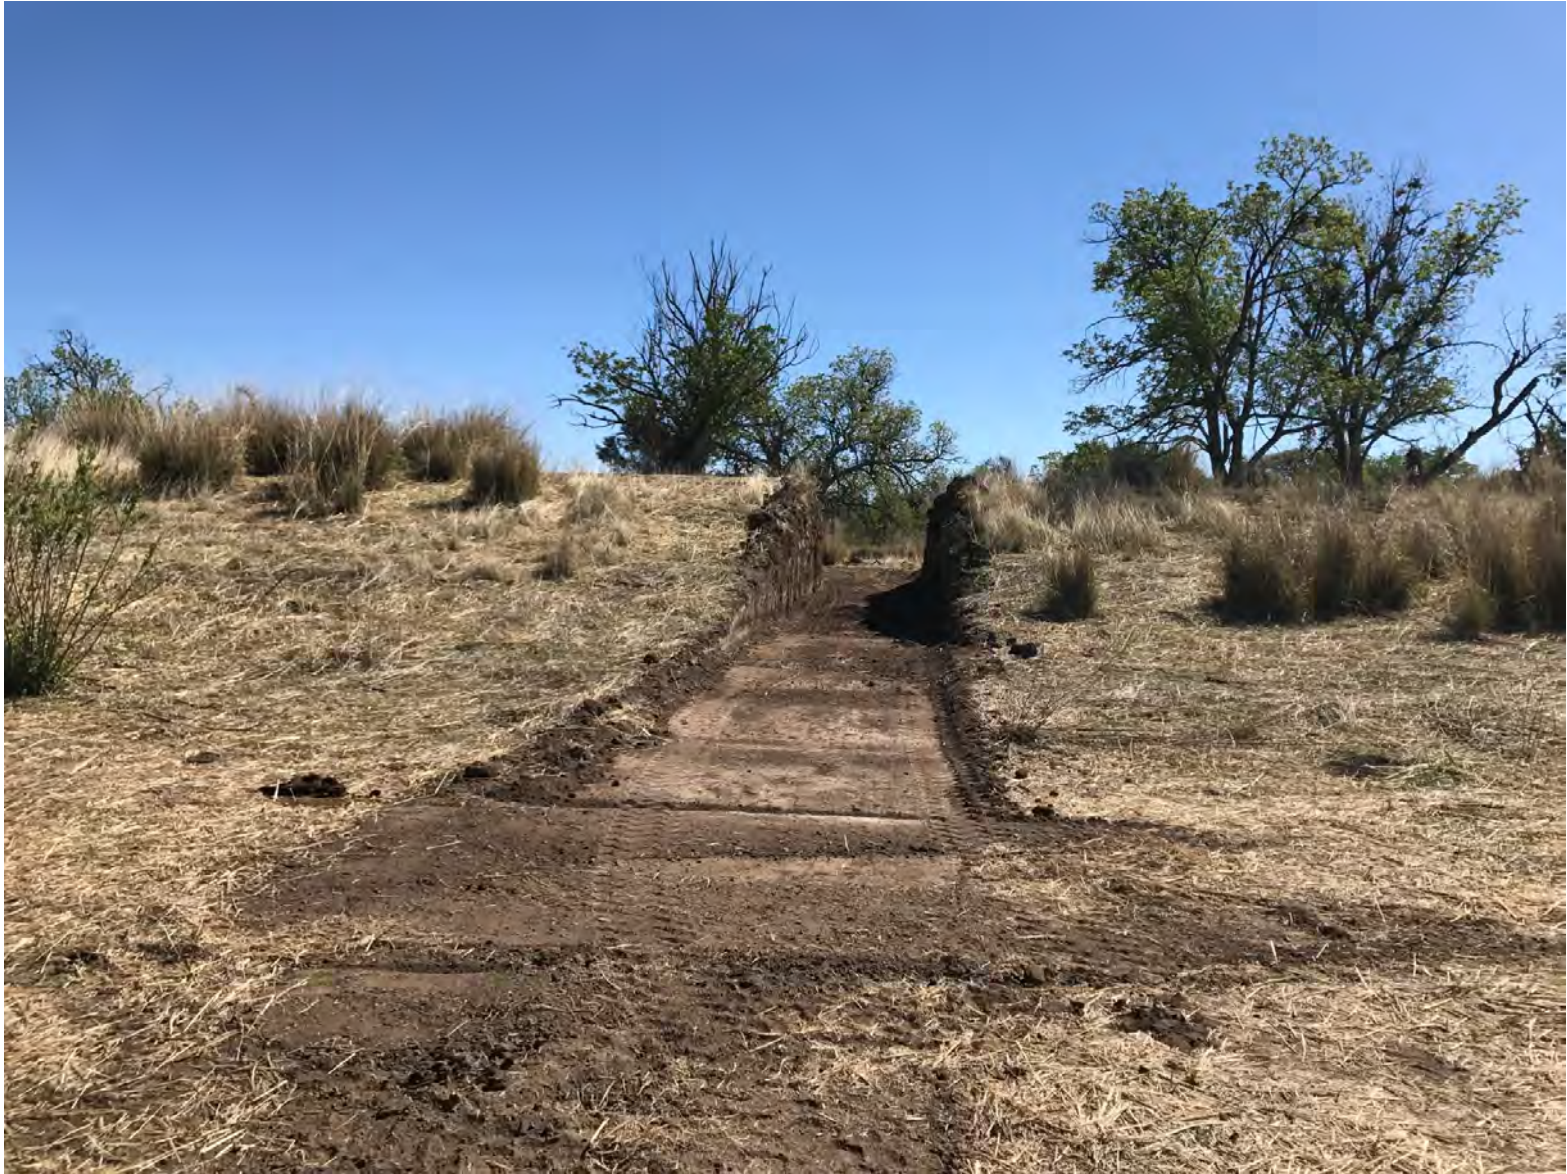
Levee cut on Diamond C Ranch-O'Donnell Canyon Ciénega

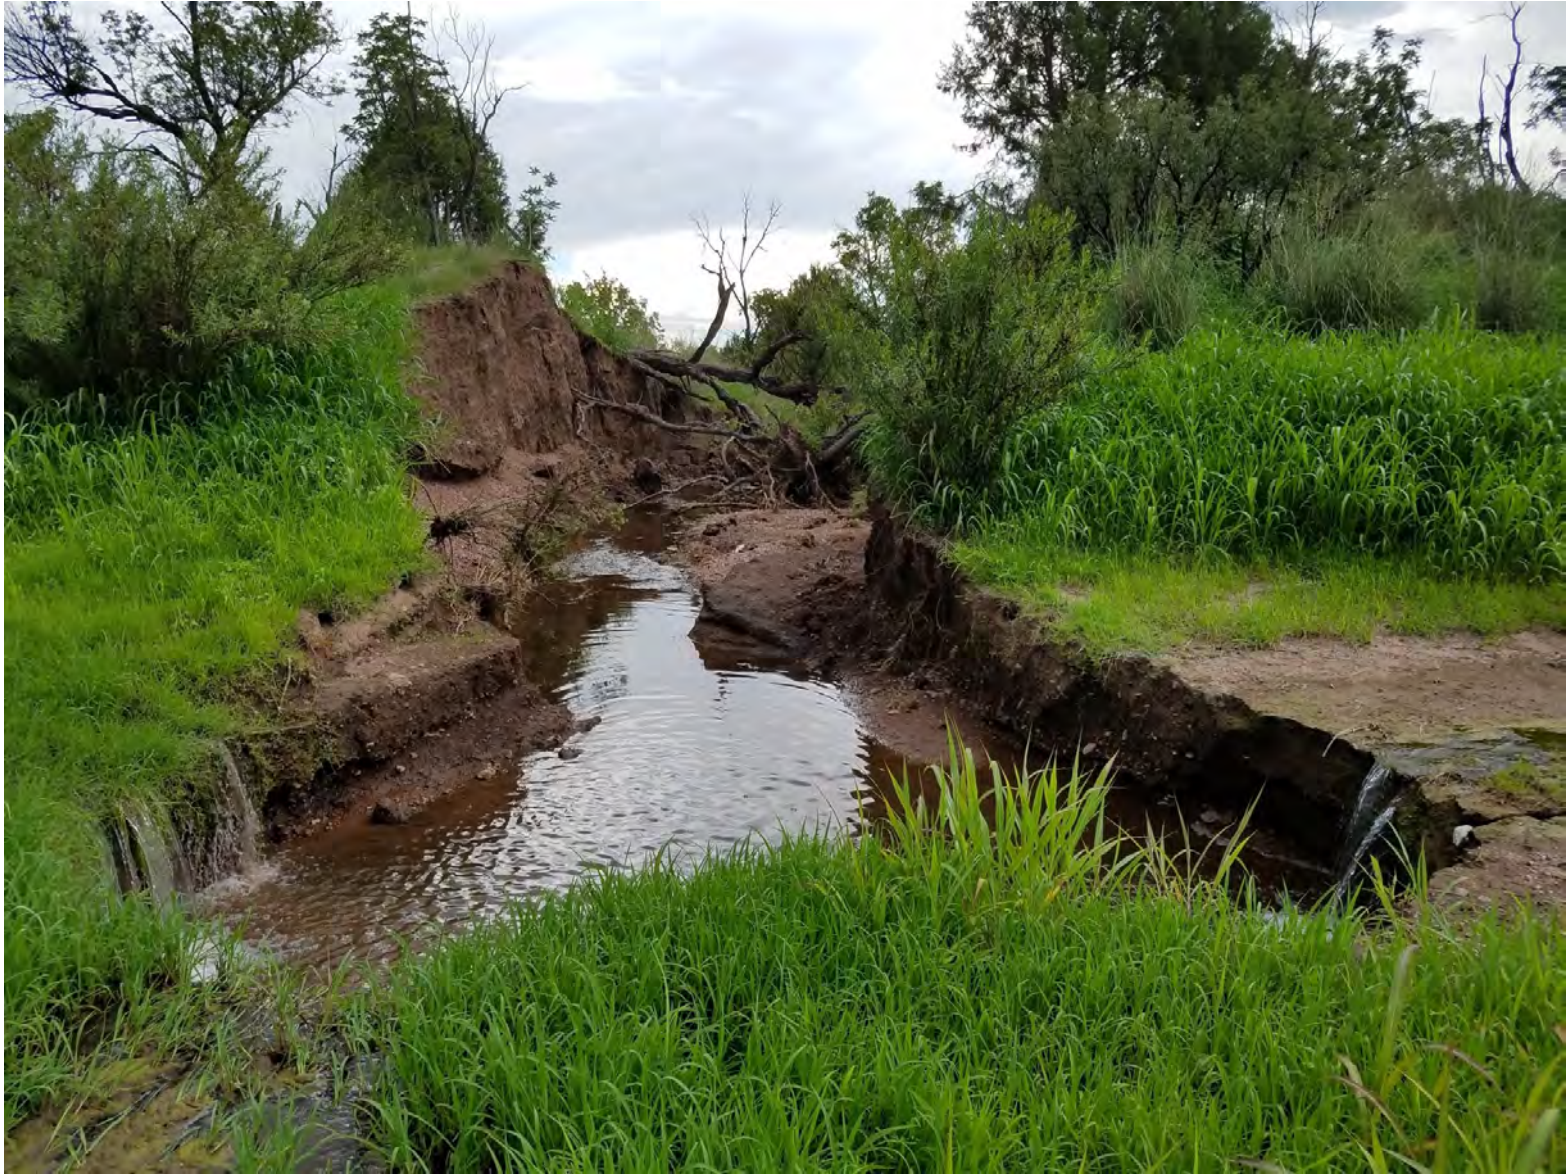
In August a large storm sent flood water into the first levee at an unexpected angle and widened the cut significantly and caused some erosion. Ron Tiller and Hans Huth made the first observations of this and Trevor Hare visited the site on 22 August to assess the damage and determine if we needed to do more work there. The conclusion agreed upon by all concerned including the landowner and manager was that no work was needed and the immediate site was stable. We will continue to monitor this site during and after the 2018 monsoon season.

Levee cut on Diamond C Ranch-O'Donnell Canyon Ciénega after large storm event

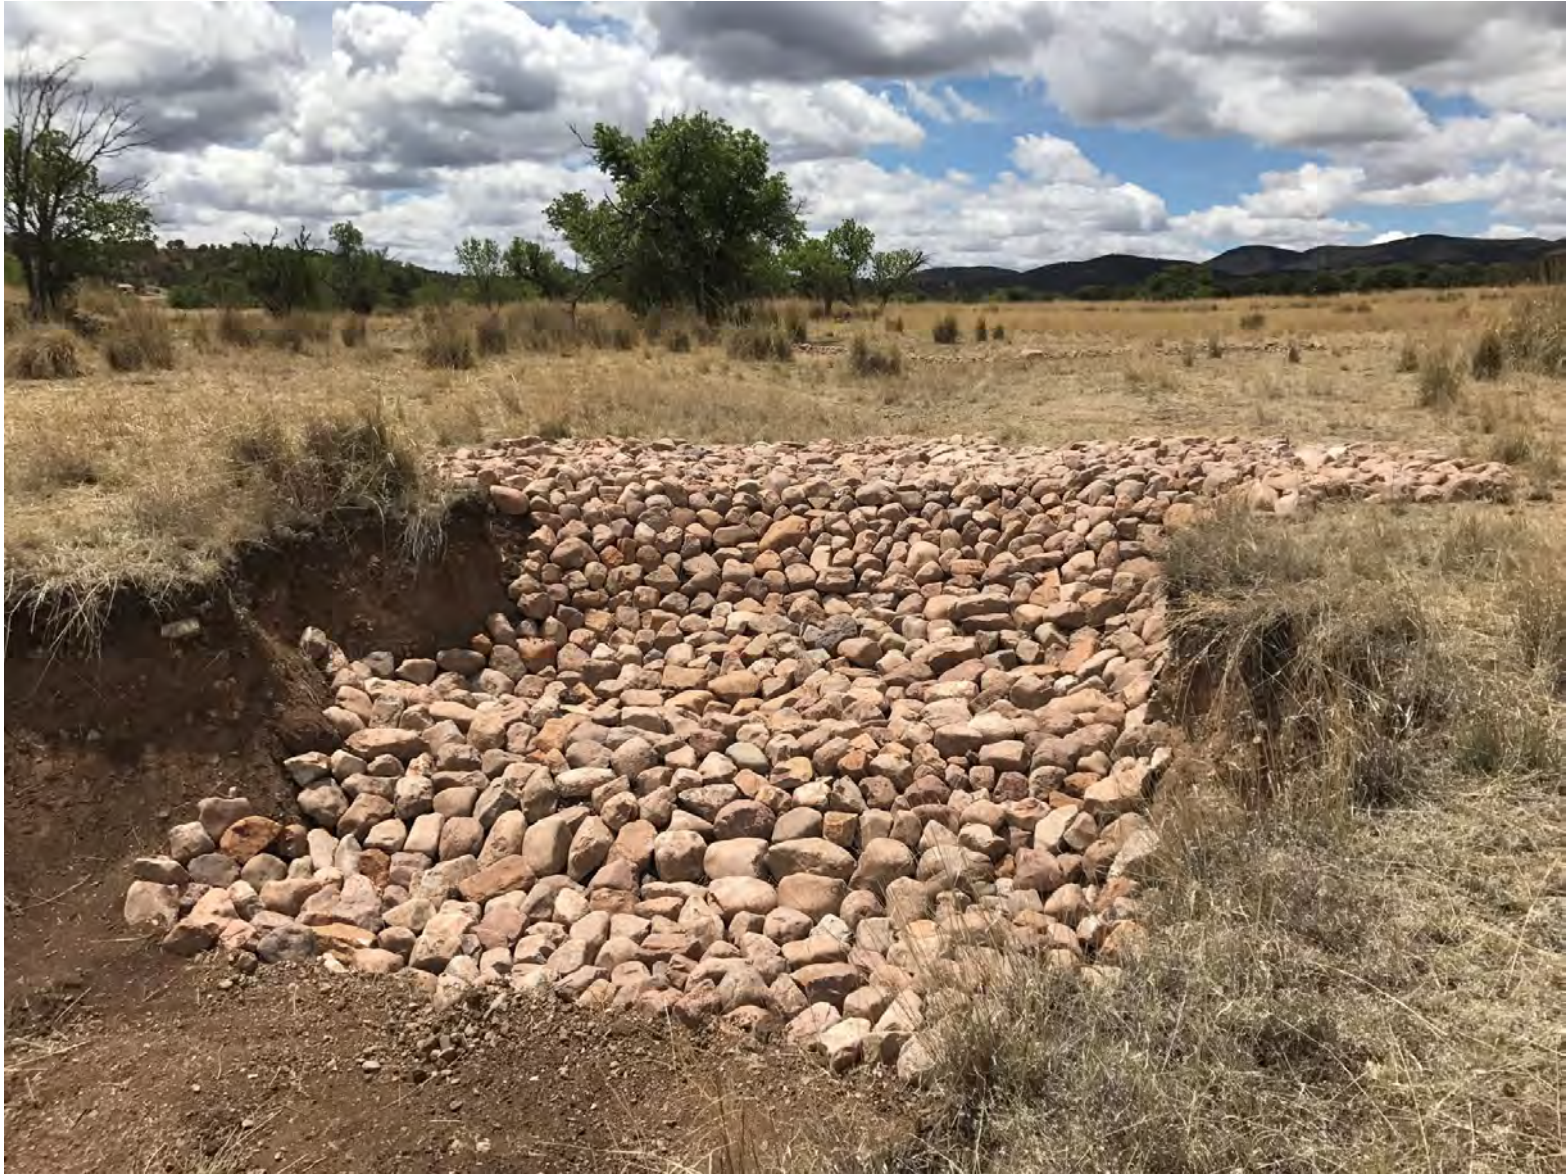
Zuni bowl on the Diamond C Ranch-O'Donnell Canyon Ciénega

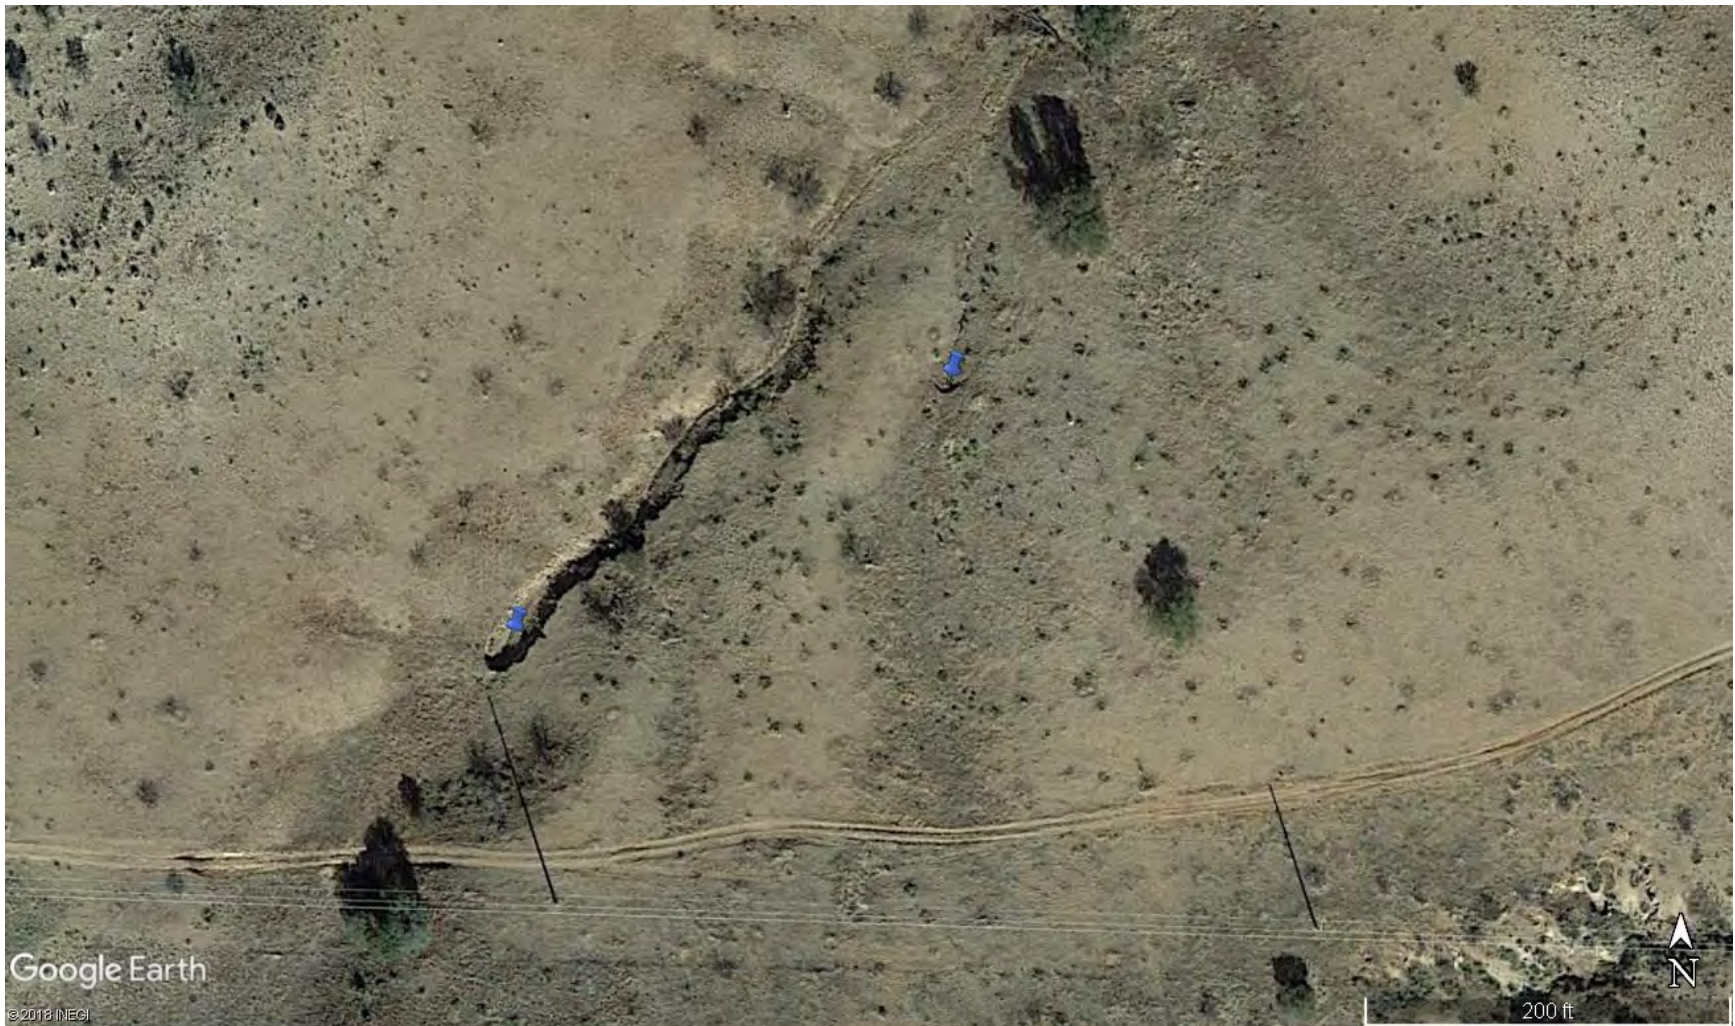
Boundary worksite

In January continued work on the Babocomari Ranch and finished the work in Vaughn Canyon with eight juniper-post weirs installed. Began the installation of two Zuni bowls and media lunas in an active headcut above Vaughn Canyon near the Research Ranch boundary.

In February we finished the Zuni Bowl work above Vaughn Canyon near the Research Ranch boundary. Started work in O'Donnell Canyon on the Babocomari Ranch adjacent to previous work near the southern boundary. This site was brought to our attention by the ranch manager and is a multi-headed headcut above a stock tank.

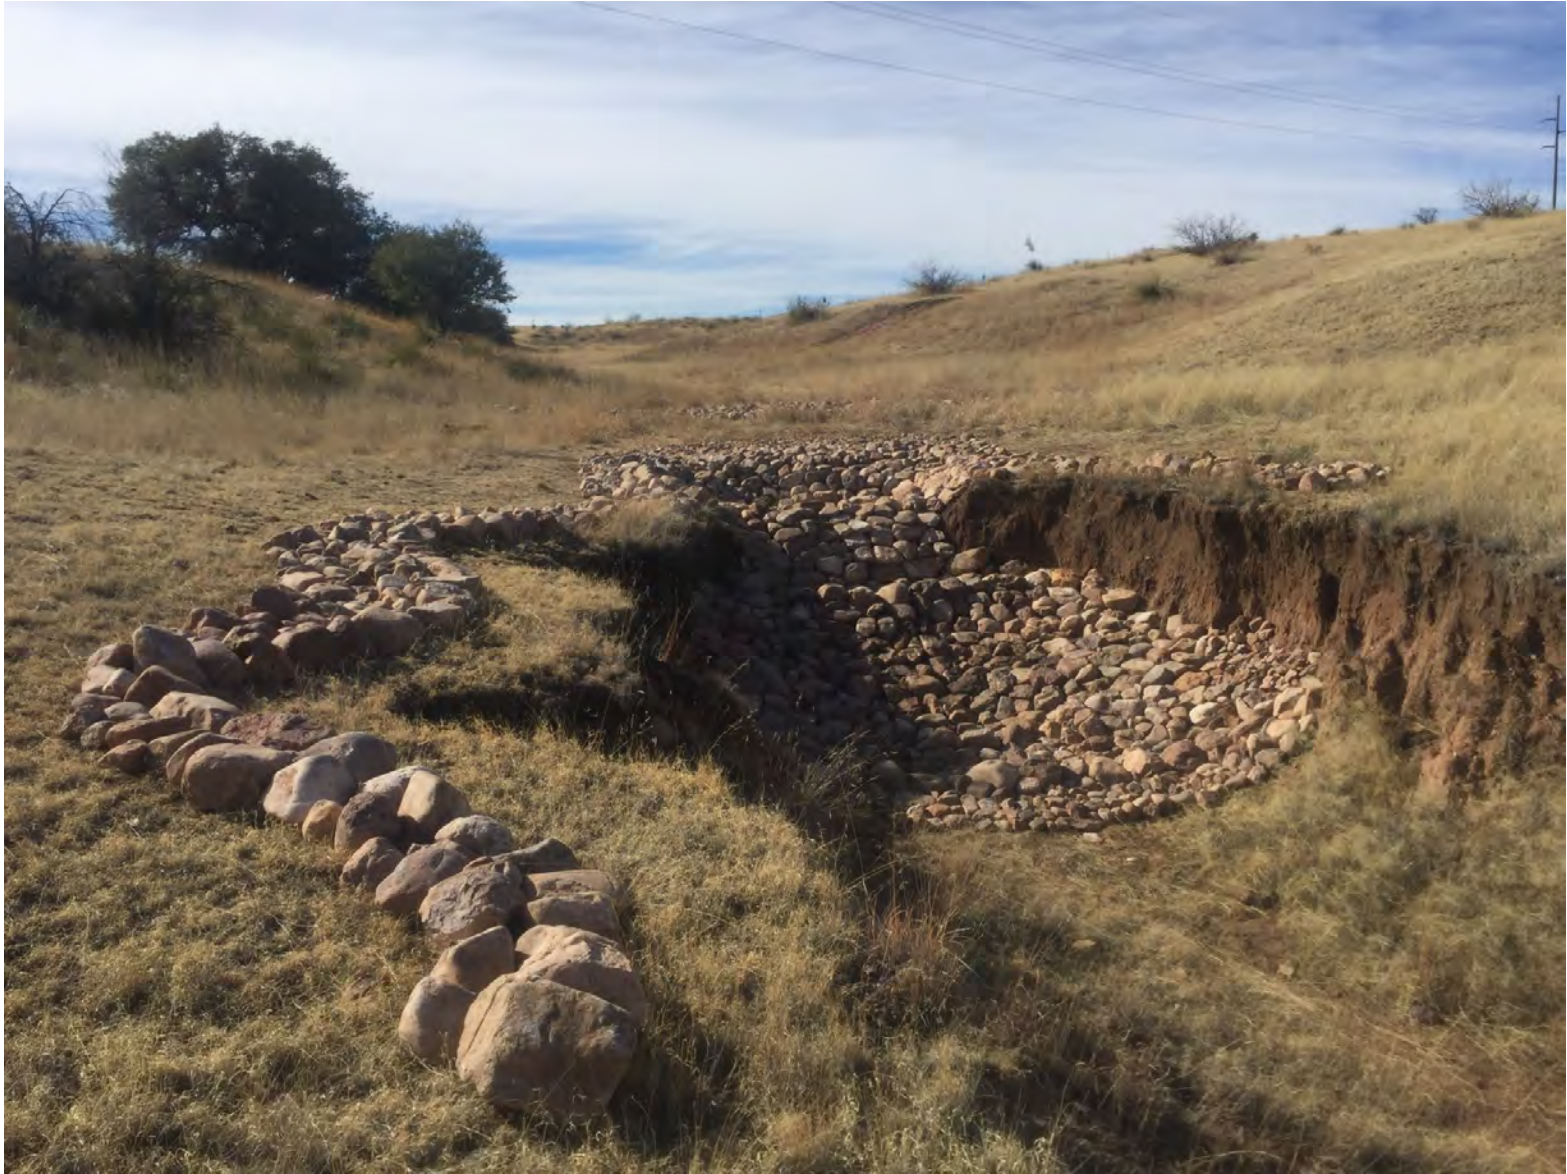
Zuni Bowl at boundary worksite

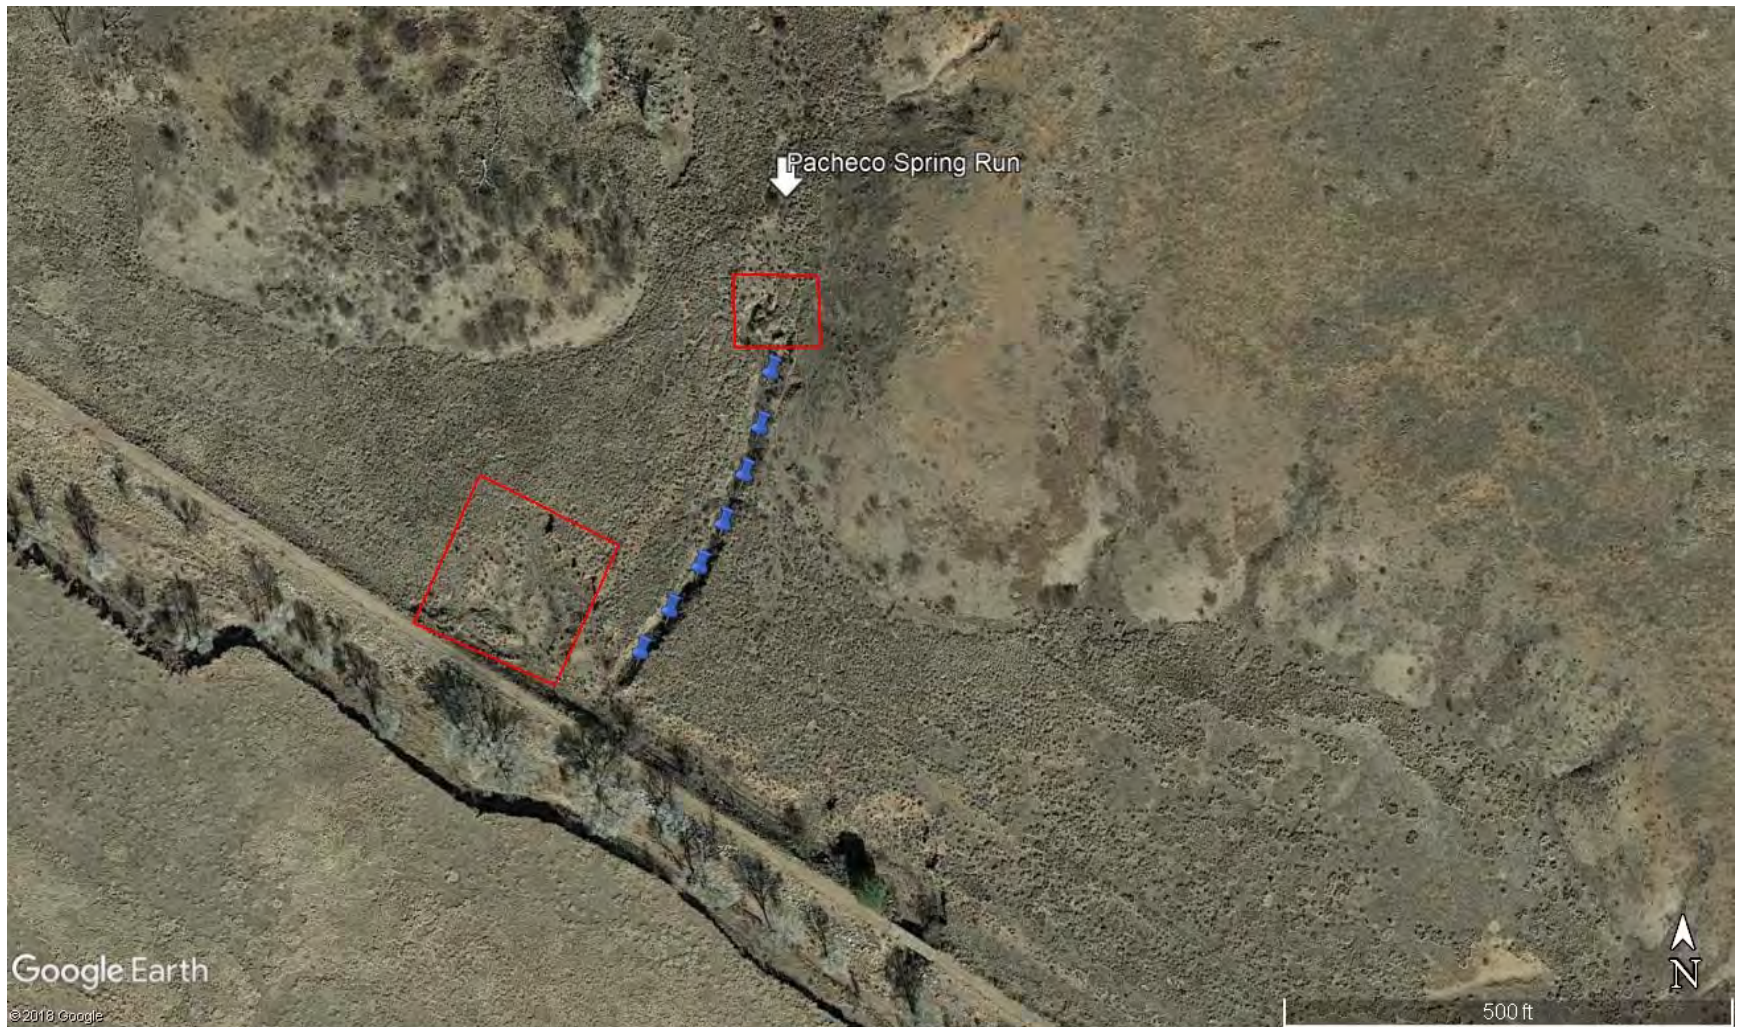
Pacheco Spring check dam locations and red polygons indicate previous work with media lunas and Zuni bowls

In November the crew finished work on the Pacheco Spring run at the end of the month and moved to a series of large headcuts in a tributary drainage to Vaughn Canyon that the ranch owners had concerns about.

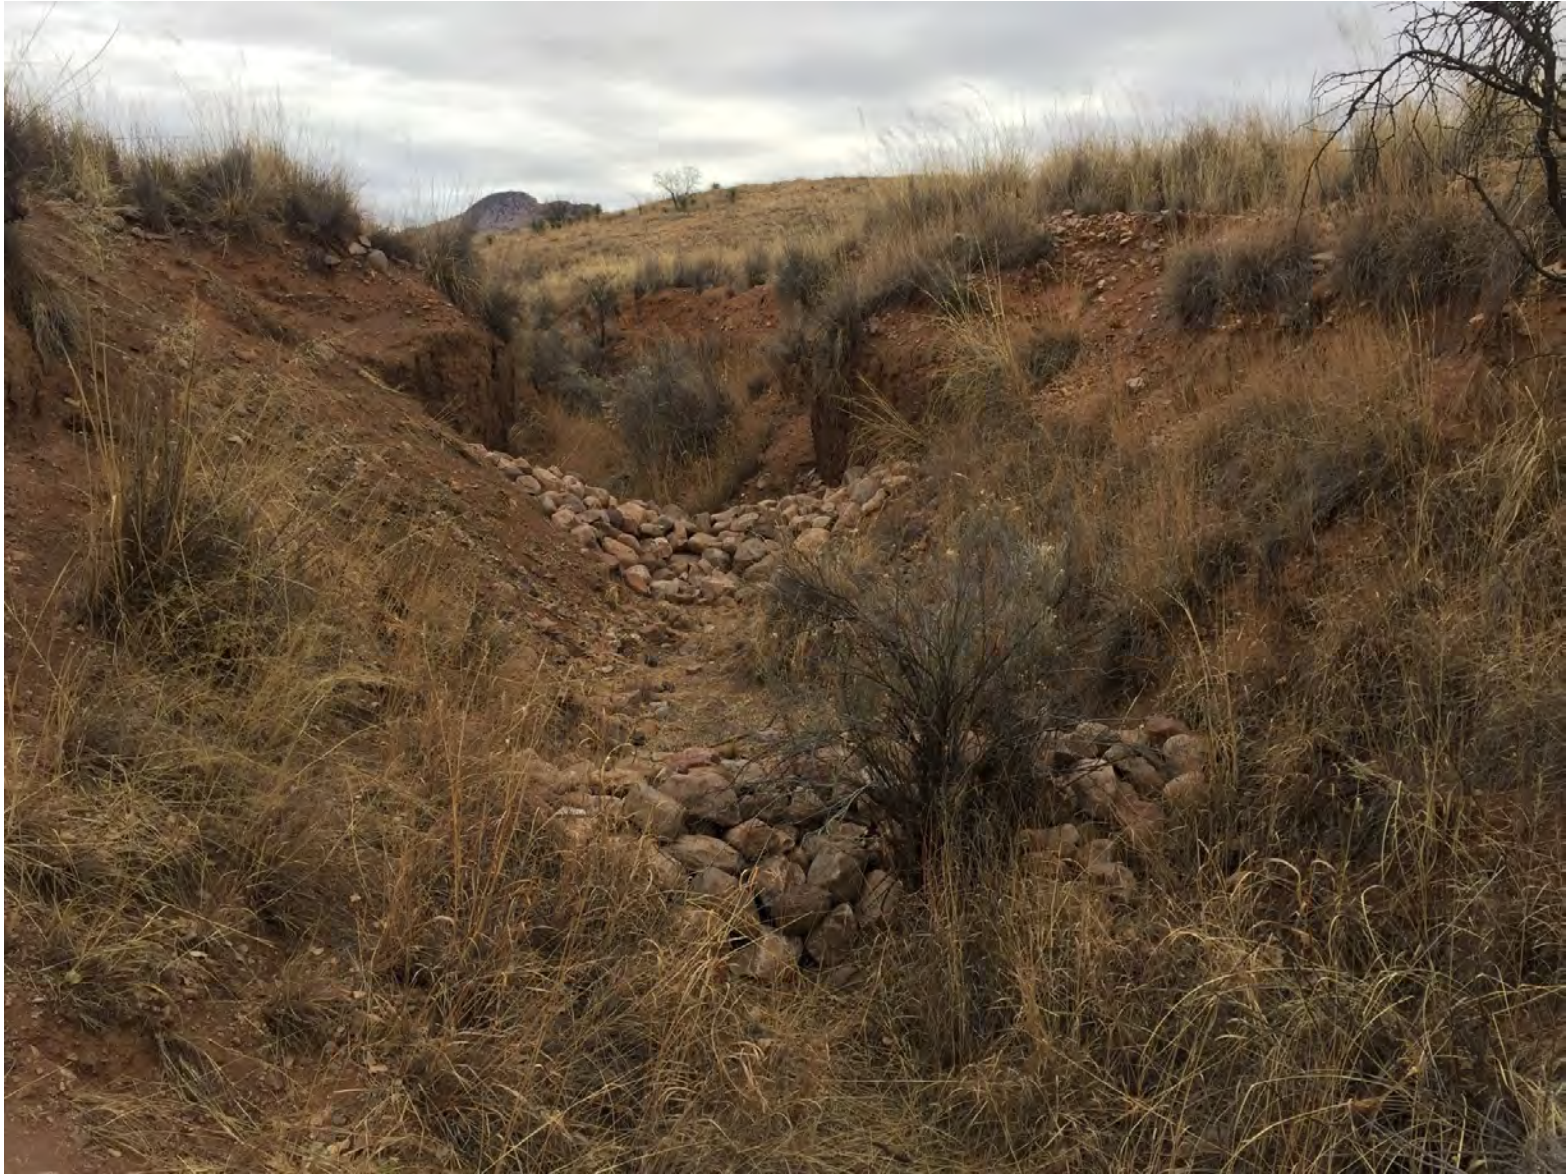
Loose rock check dams (trincheras) in the gully below Pacheco Spring

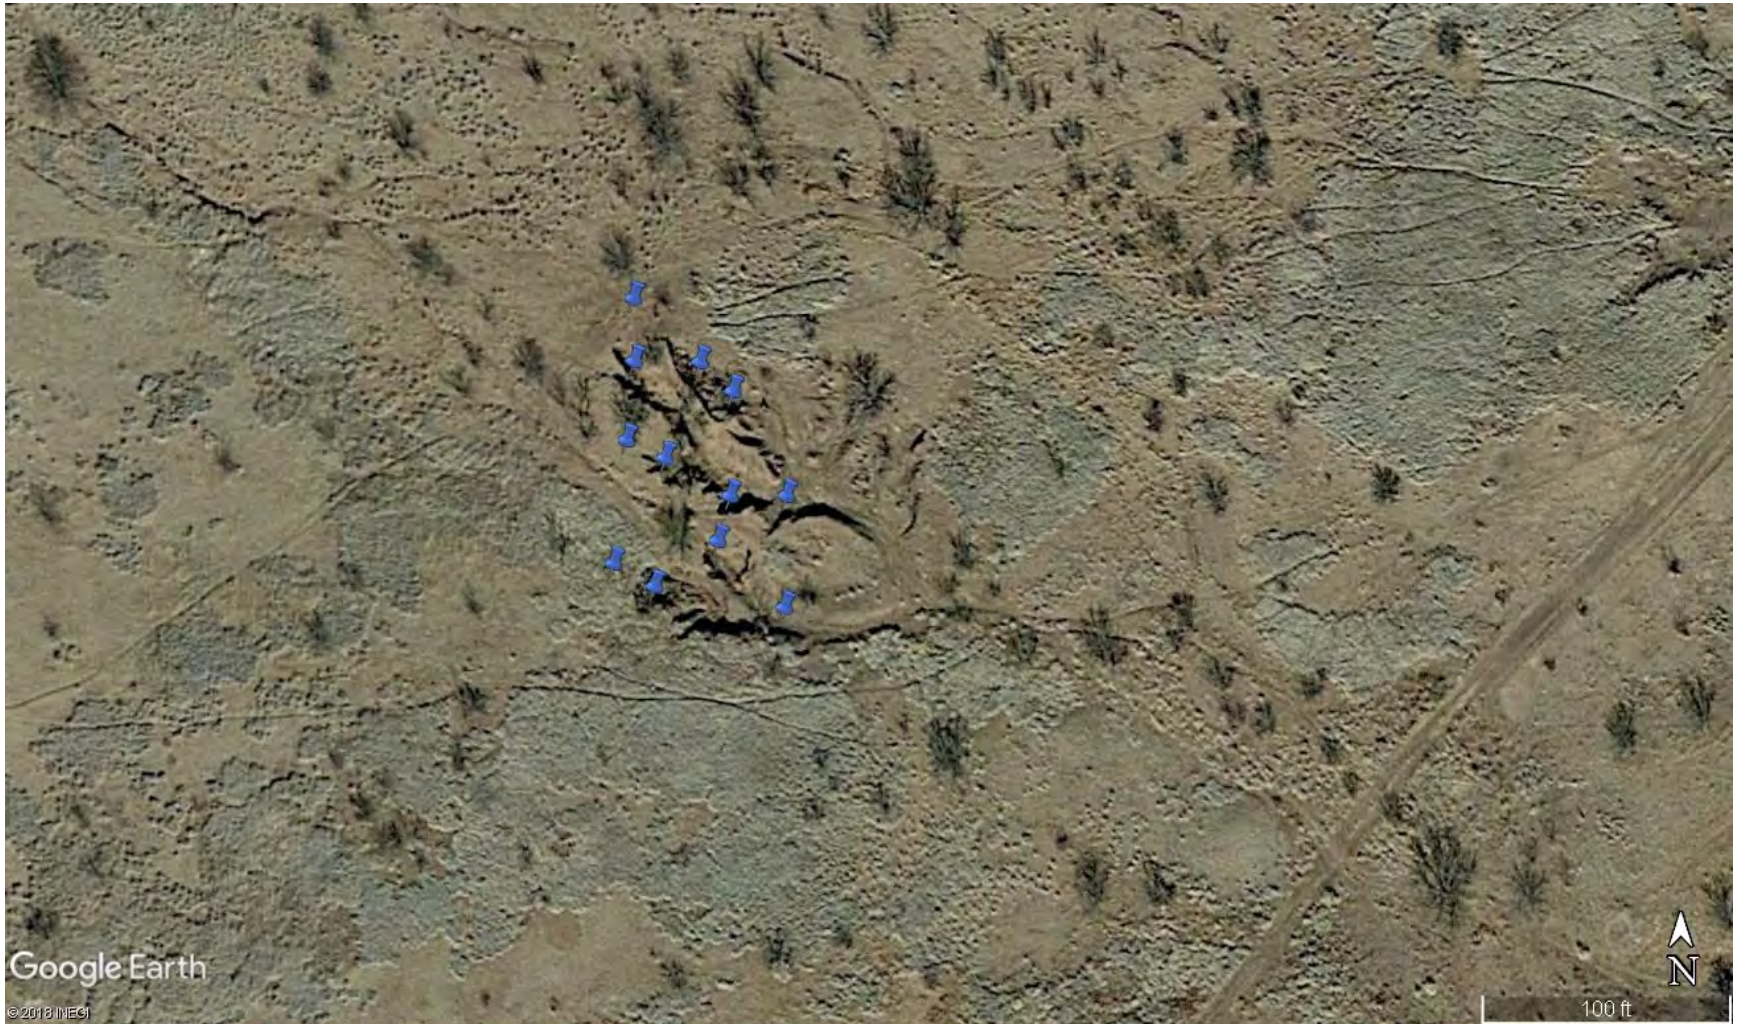
Babocomari Ranch O'Donnell Worksites

Finished work in O'Donnell Canyon on the Diamond C Ranch on 09 May. In June we went to the site to geolocate all the work and map it all in Google Earth for this report. Finished work in O'Donnell Canyon on the Babocomari Ranch adjacent to previous work near the southern boundary.

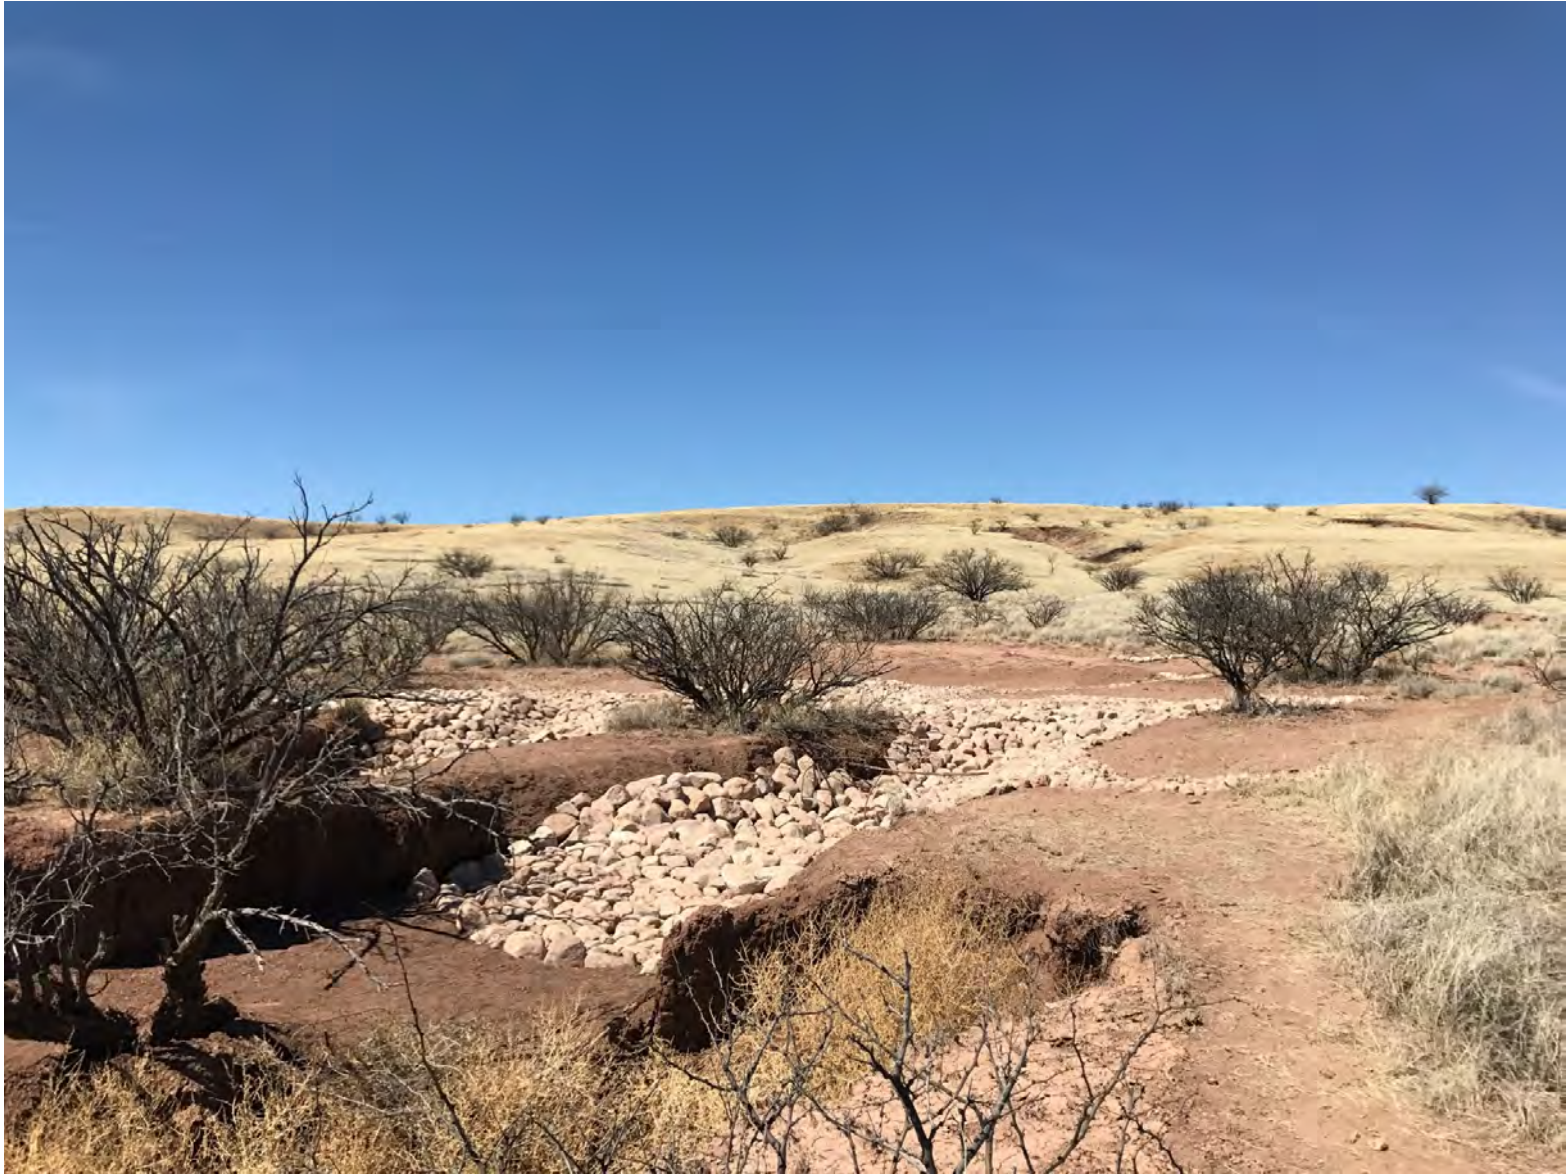
Zuni bowls and media lunas in O'Donnell Canyon on the Babocomari Ranch
