# Arizona Department of Environmental Quality Water Quality Improvement Grant

## Erosion Control, Sediment Retention and Riparian Restoration in the Babocomari River Watershed

### EV16-0002 (18-006)

Borderlands Restoration Final Report May 2018

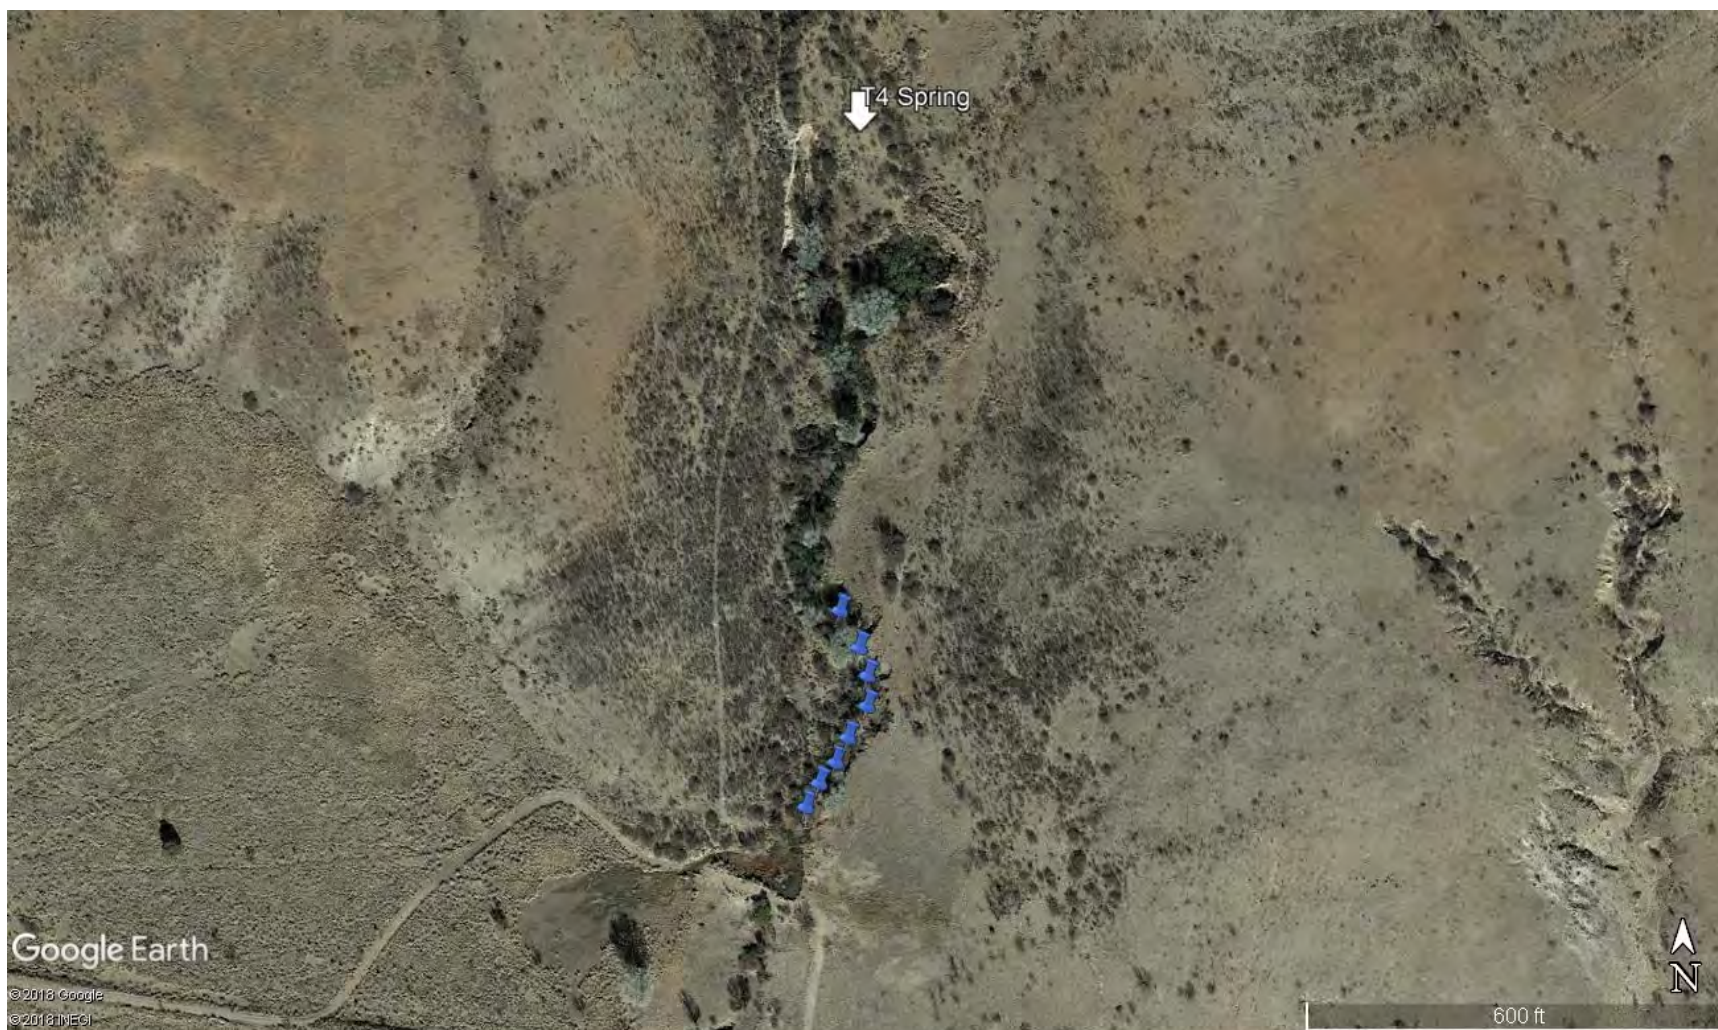
T4 Spring Worksites

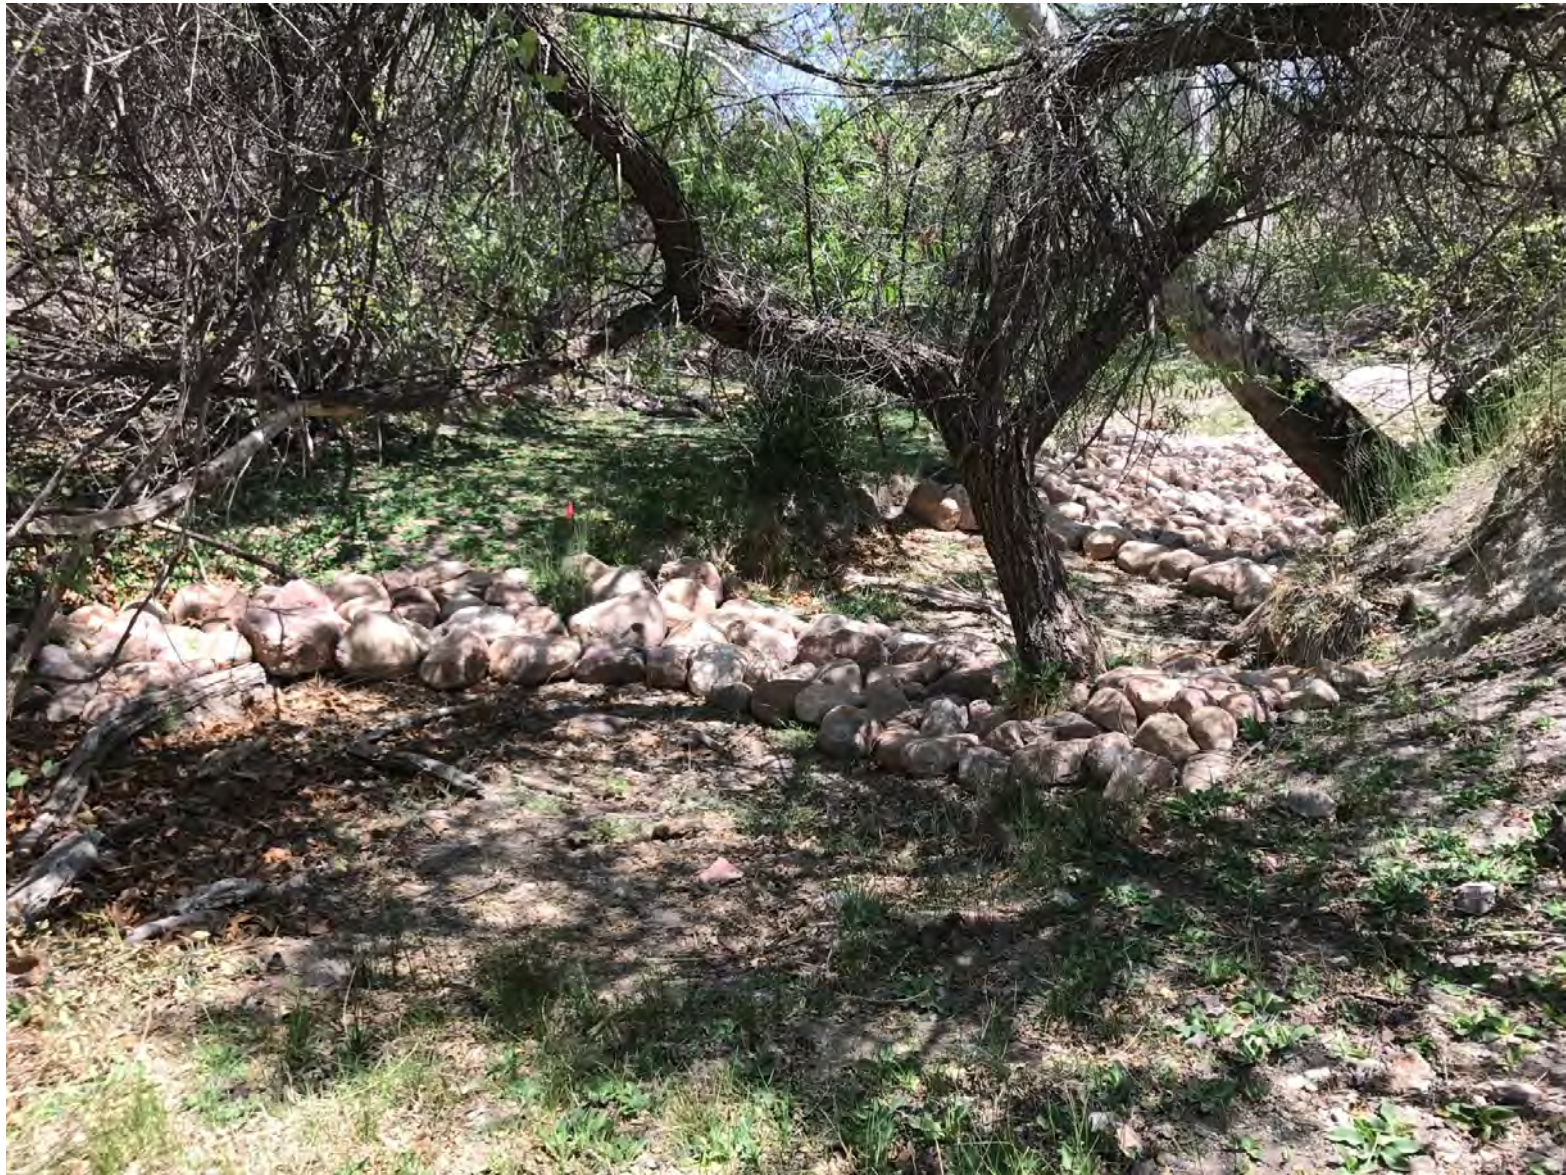
One-rock dams in the T4 Spring run

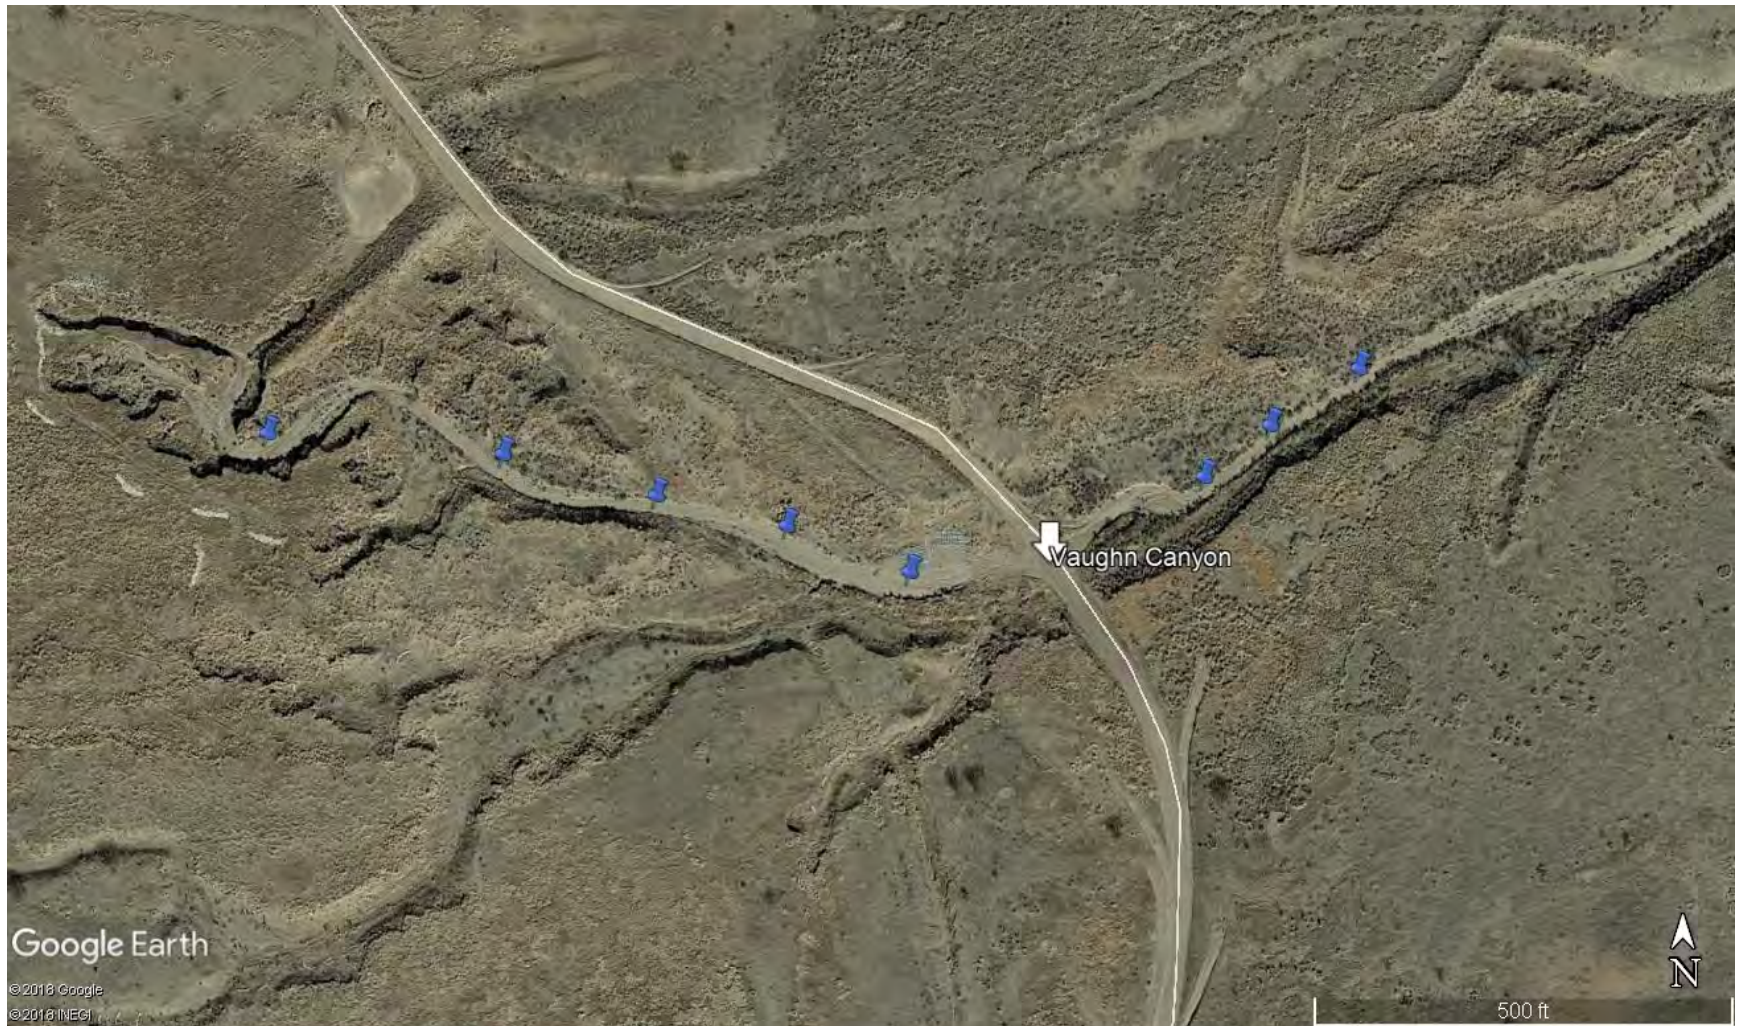
Vaughn Canyon juniper-post weir locations

In January continued work on the Babocomari Ranch and finished the work in Vaughn Canyon with eight juniper-post weirs installed. Began the installation of two Zuni bowls and media lunas in an active headcut above Vaughn Canyon near the Research Ranch boundary.

In summary we used over 530 tons of rock to install over 200 rock erosion control structures in six tributary drainages of the Babocomari River. In addition we installed 8 juniper/oak post weirs in Vaughn Canyon as grade control structures where previously installed sandbag weir were washed out. In O'Donnell Canyon we also breached two levees that were directing water towards a large headcut.

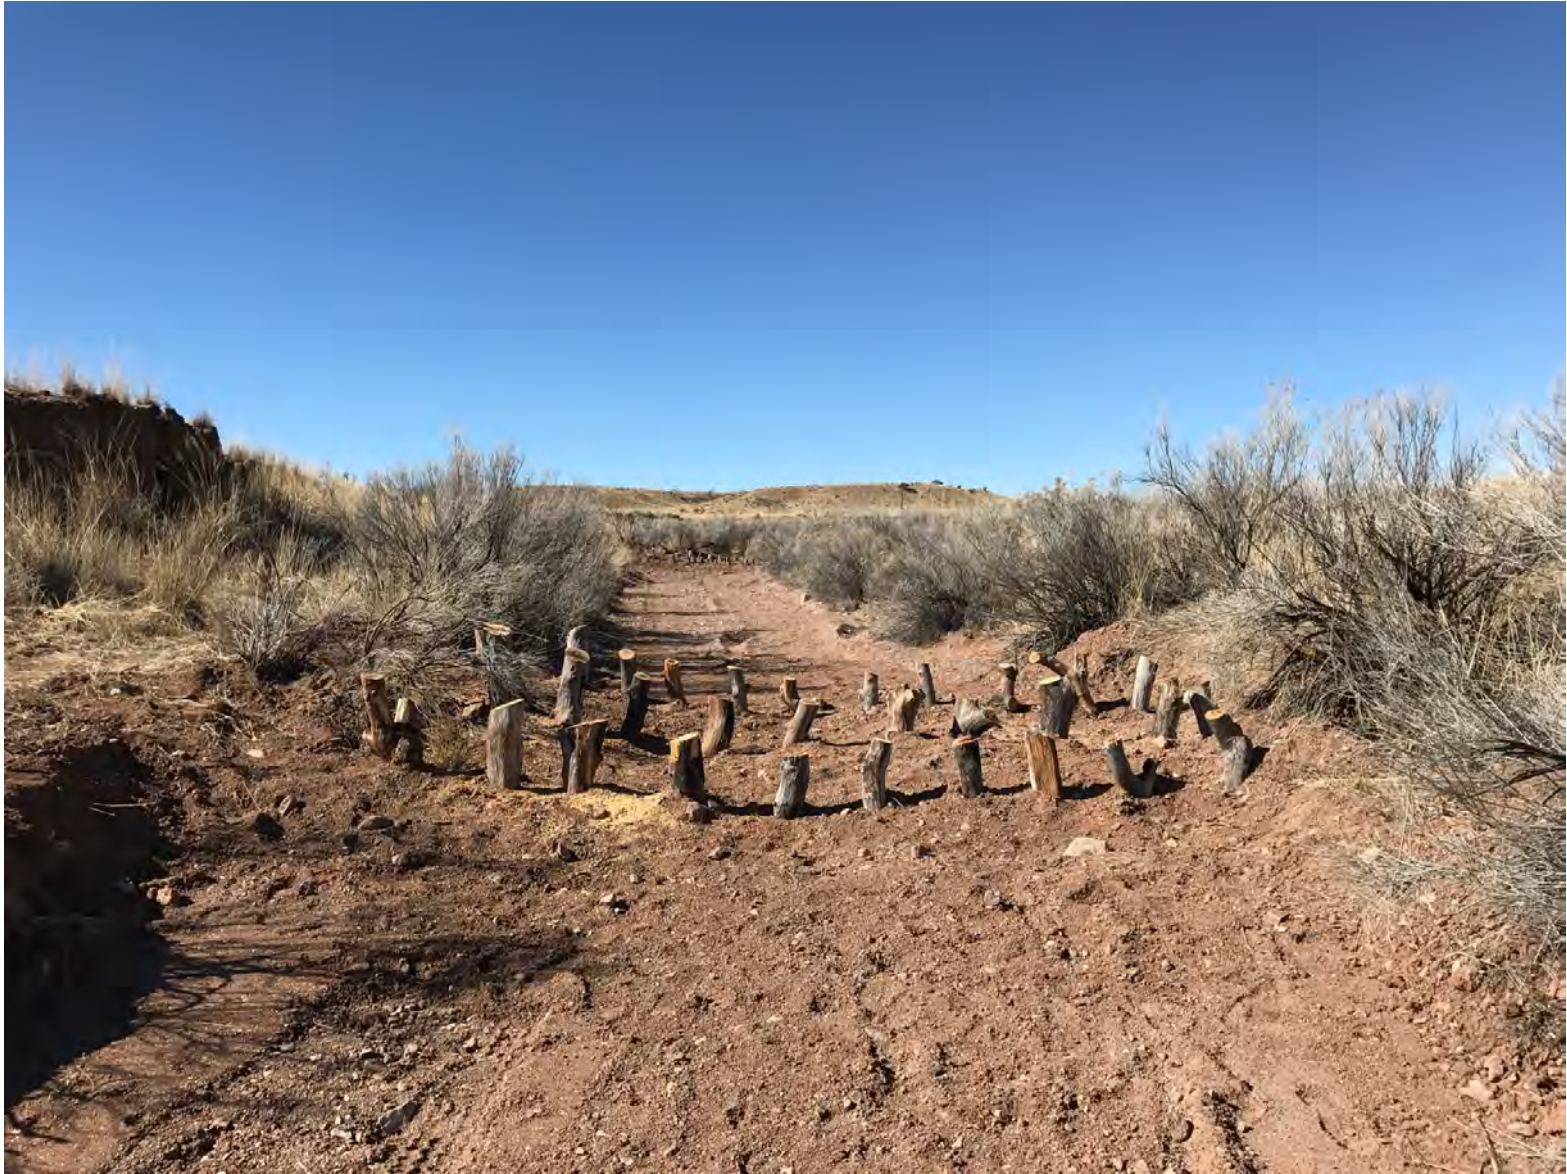
Juniper-post weir in Vaughn Canyon
