**1. Project Title:** Upper Verde Collaborative Watershed Restoration Project

## **FINAL REPORT**

Upper Verde Collaborative Watershed Restoration Project - #4-012, Grant ID# EV02-0047  
Grant period – March 2002 through June 2005

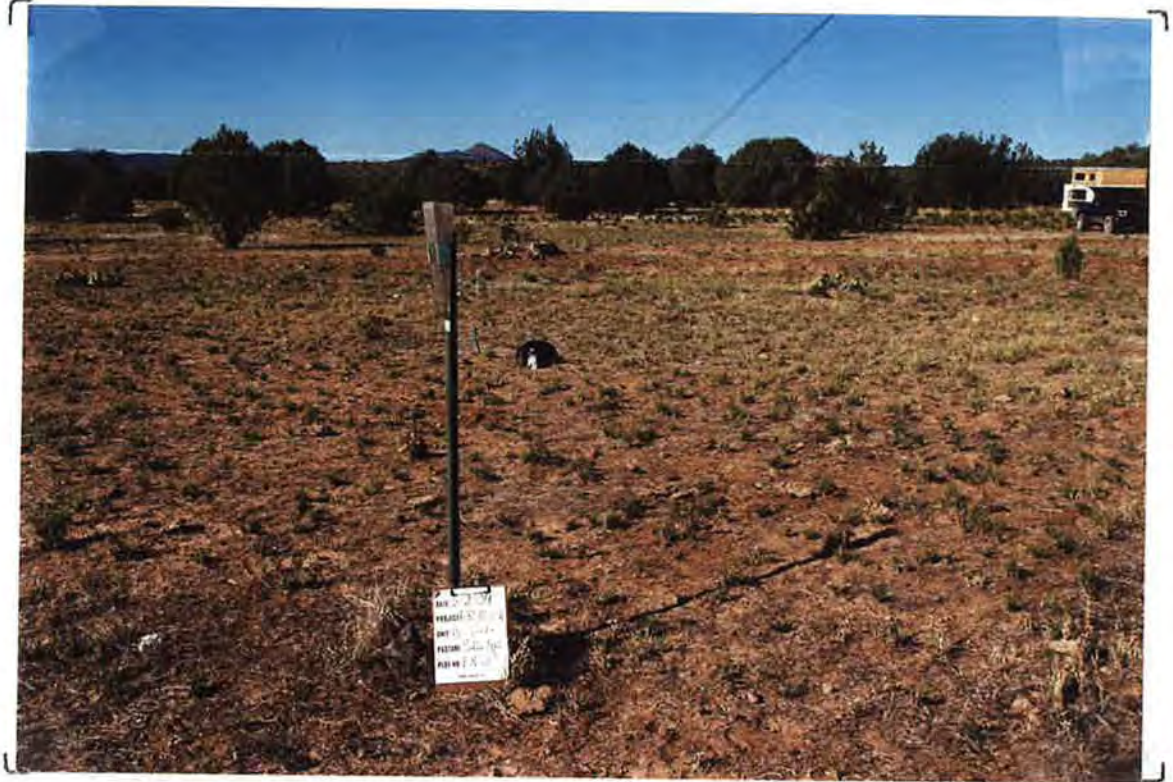
General View  
of 1st Transect leg

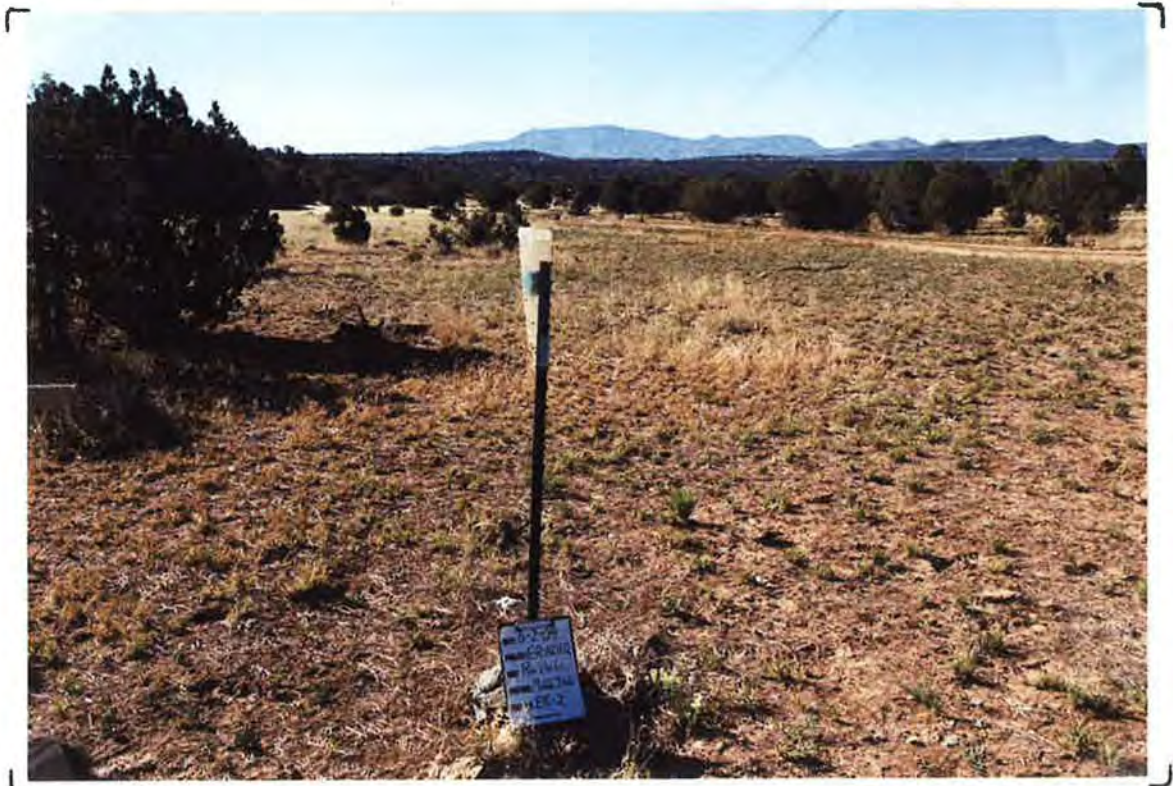
General view of  
all 3 transects in  
Meadow area

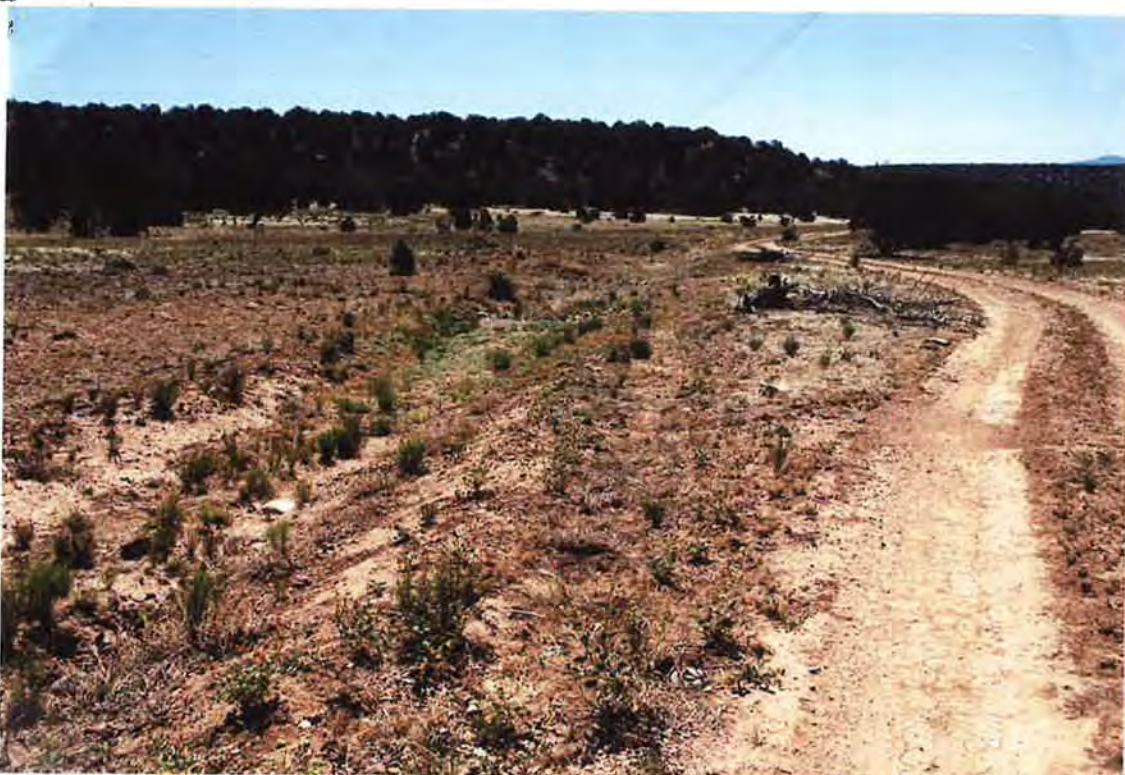
Gully to North of road.  
Note it is silting  
in and gully about  
half filled now. Dam  
at center is full.

- See Site #2 data above (Item 4.) for hay stomp results.
- The check dams filled up nicely. Another layering of rocks would fill the old road scar (gully) to the top within a couple of years. It is evident from the way the dams are filling that the sediment filling the dams is coming from above the meadow and not from the meadow itself.
- The rock riffle dams are clearly a cost effective method of healing gullies. Installed correctly (tied into soil gravel bars and aligned head to toe) they fill quickly, will not blow out, and can be built up over time to completely fill the gully and restore meadow water table function.

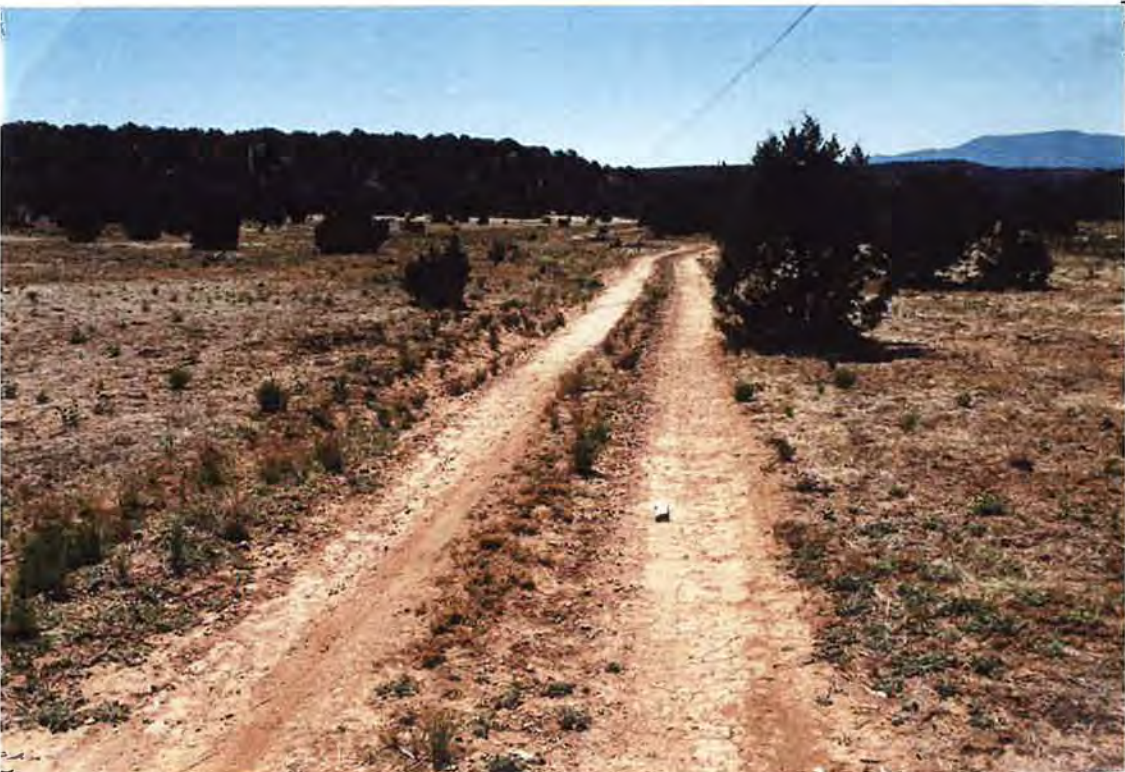
General view of  
meadow area from  
road

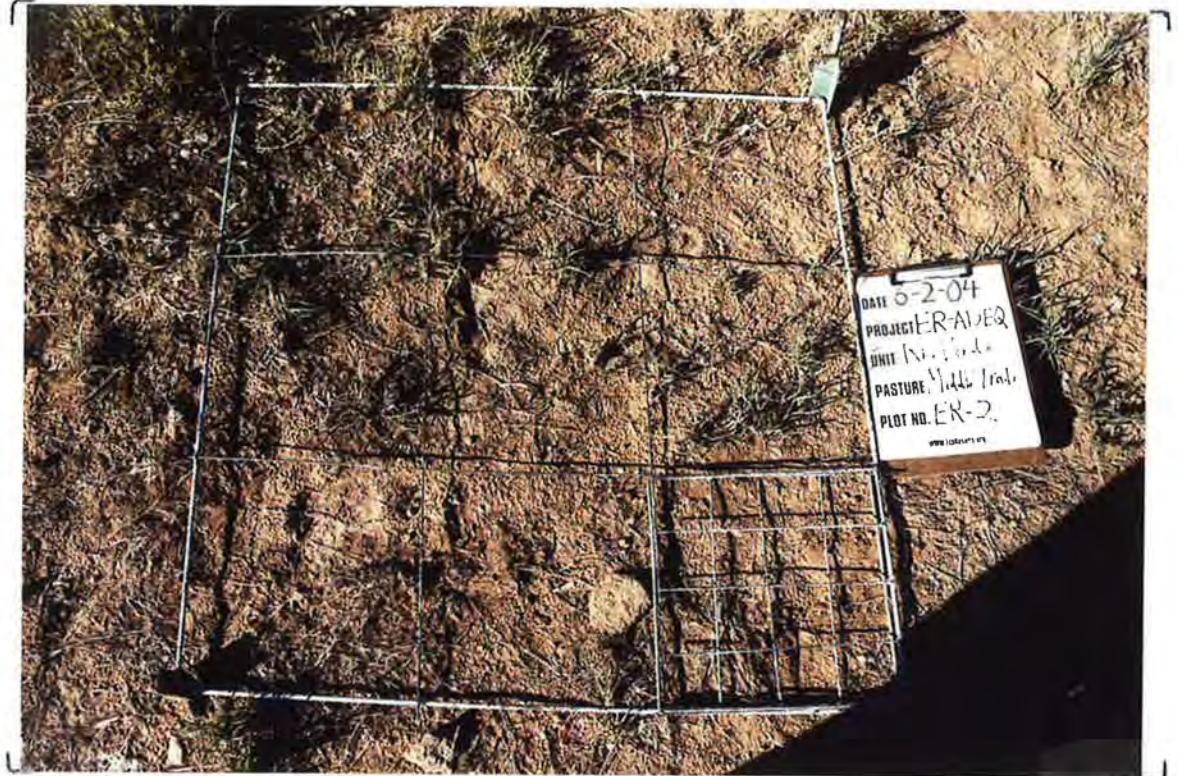
Close up of  
3x3' plot

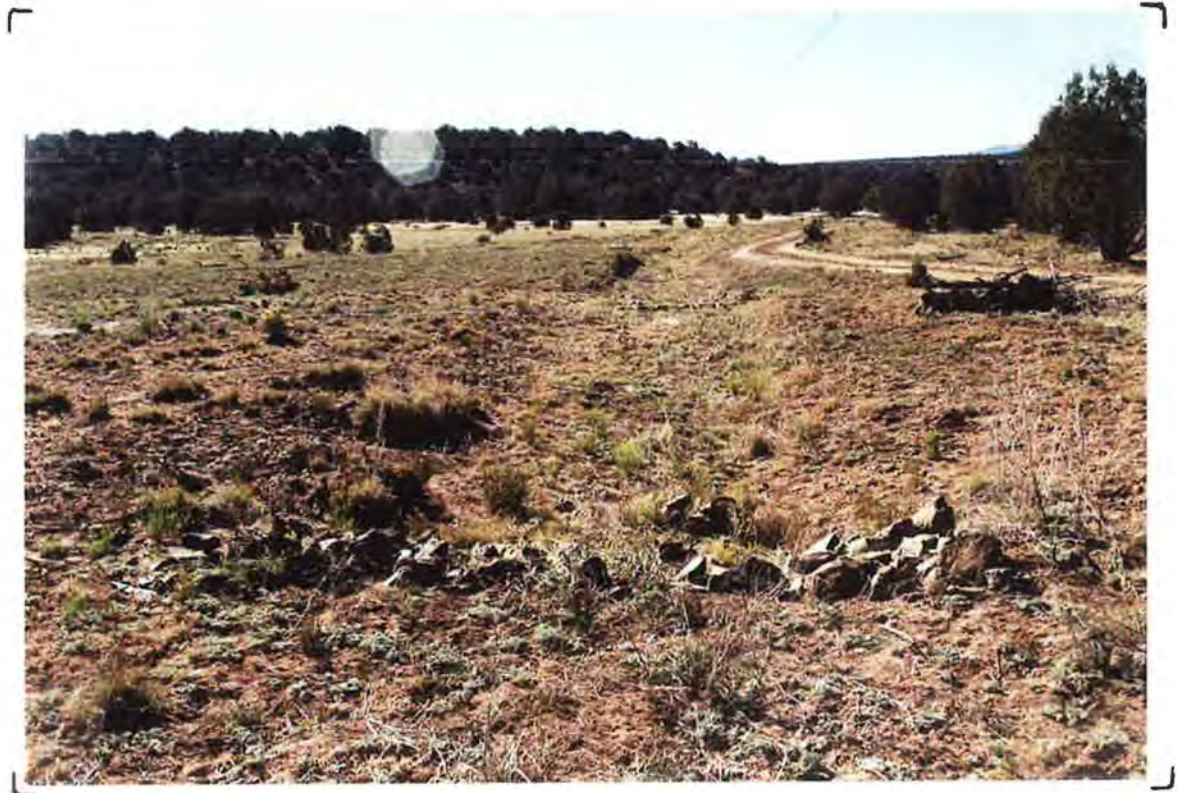
Photo of rock  
riffle down new  
fall of sediment
