**CAMPOMOCHO SACATON WATERSHED IMPROVEMENT
PROJECT
PHASE I FINAL REPORT**

ADEQ PROJECT NO. 3-005

August 18, 2005

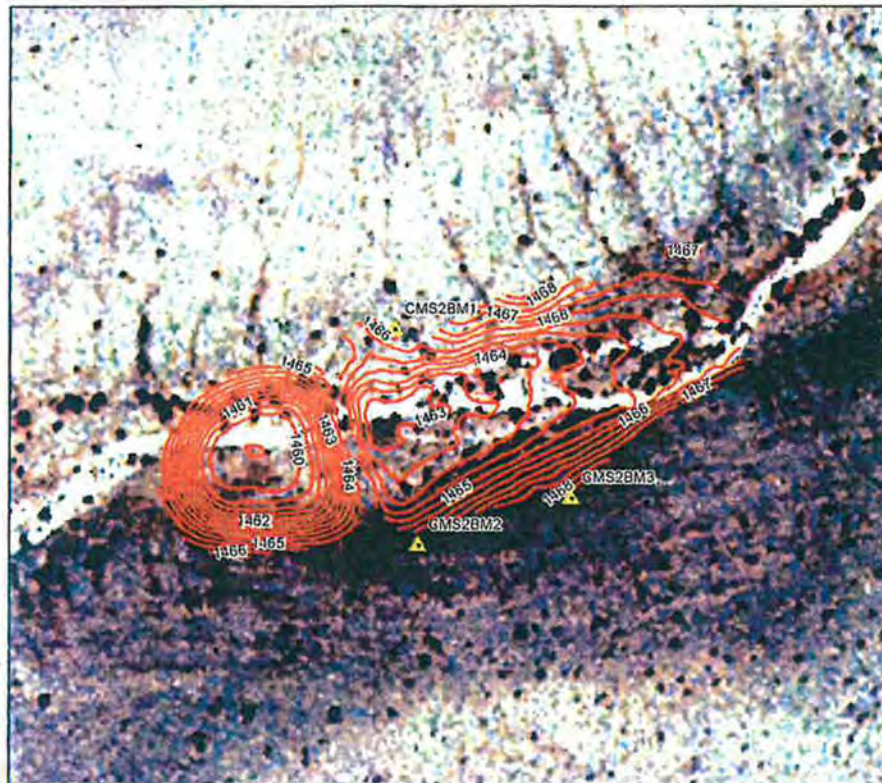
Structure 2: Campomocho - Sacaton

Table 4. Coordinates of established benchmark points.

Benchmark ID	Northing (m)	Easting (m)	Elevation (m)
BM1	3587604.67	614958.79	1467.27
BM2	3587492.94	614971.25	1468.16
BM3	3587517.29	615049.45	1470.18

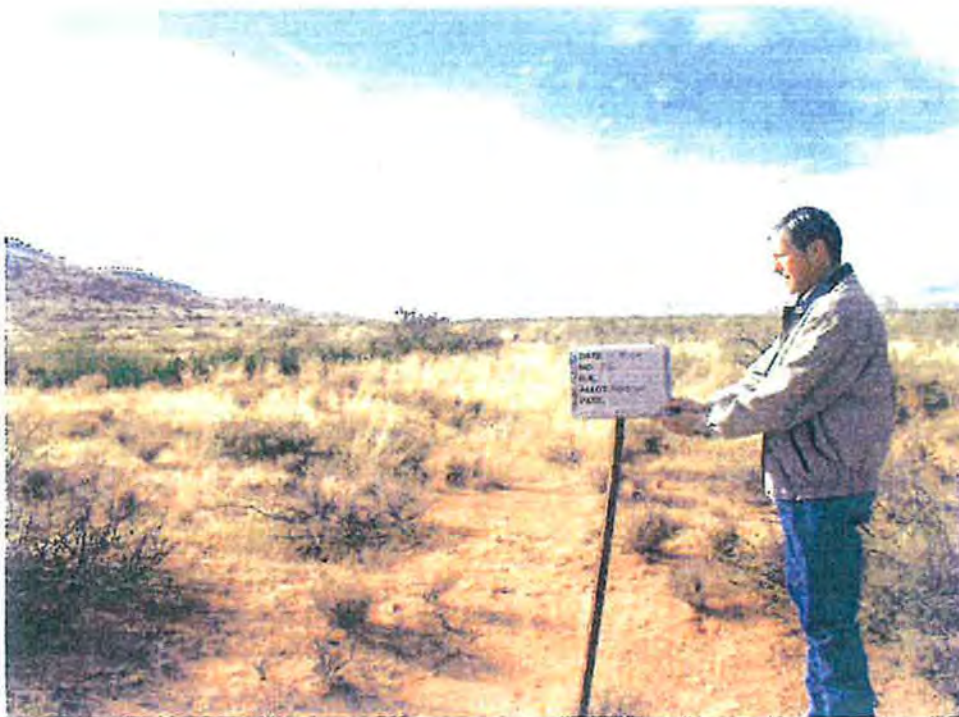
Bare ground increased from 2001 to 2003, while litter decreased the same years. This may have been due to annuals having been swept away by winds prior to monitoring. Dead annual

grasses and forbs do count as litter if they meet the criteria listed in the methods section. The trend in bare ground and litter reversed itself from 2003 to 2004. There has been no change in the percent cover of vegetation base.

Two significant changes were found in 2003. Lehmann lovegrass decreased from 17.5% to 5.5% frequency and mesquite decreased from 42.5% to 25.5%. The Lehmann lovegrass increased again in 2004 to match the 2001 level and shows an overall stable trend for that species. However, in the case of mesquite, the percent frequency remained at the lower percentage rate which indicates a significant decrease in this species. This is a positive outcome directly tied to the ripping treatment on this site. Changes in annual forbs and grasses are for information only. Significant changes in these categories are dependent on the local climate conditions and vary greatly from year to year. They are not indicators of long term trend.

Photo 1. Key Area F2, November 18, 2004, Hook Open A Ranch.

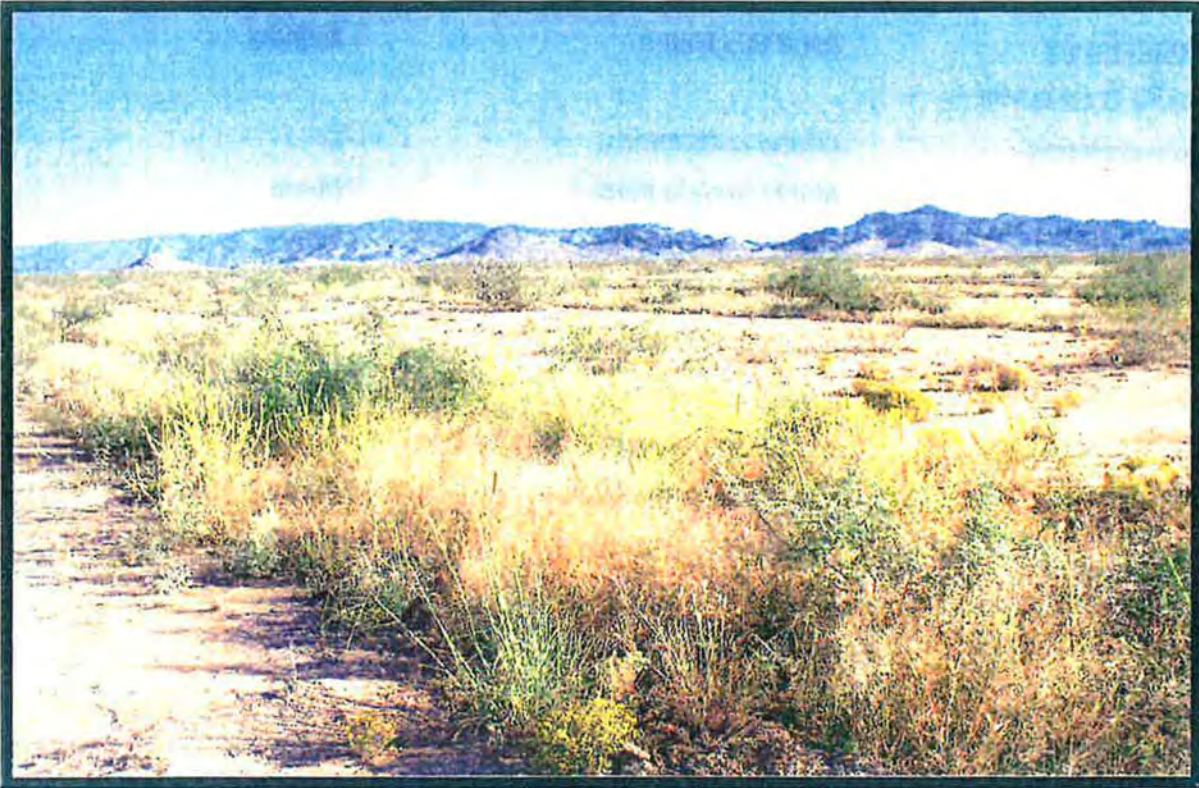
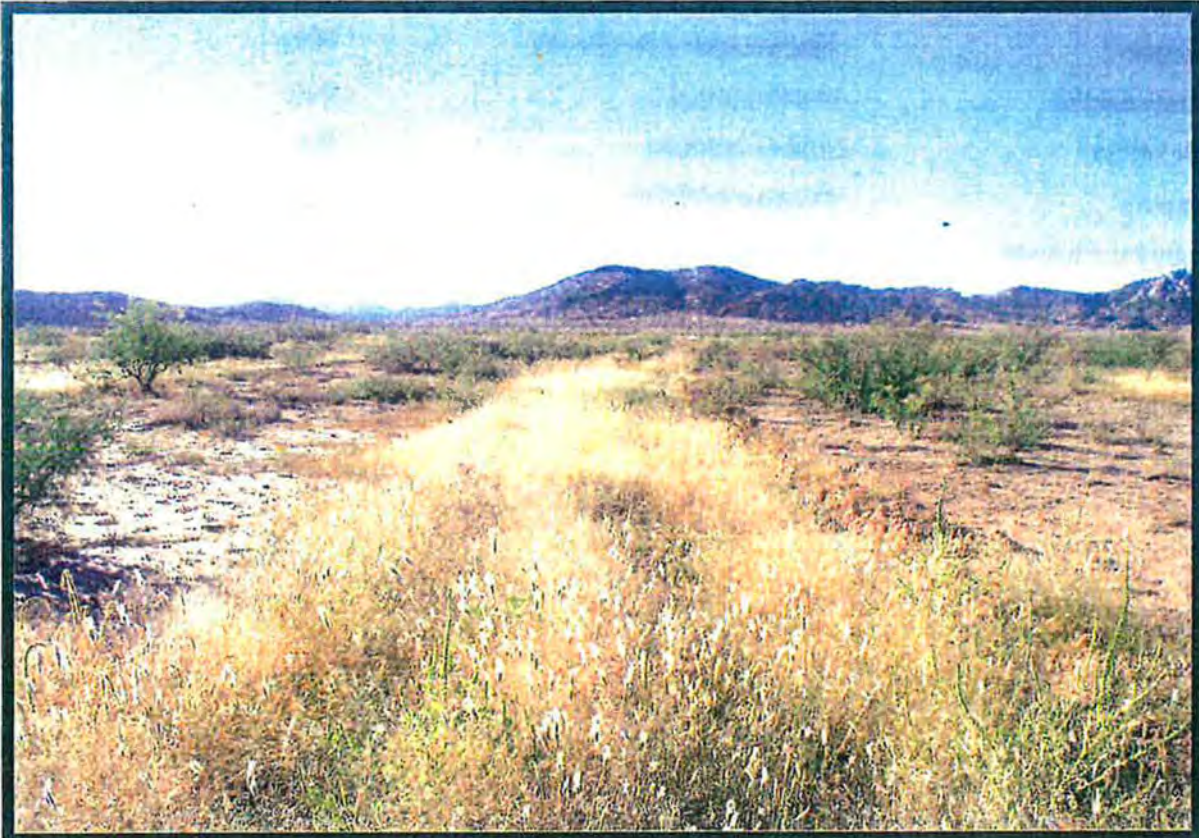
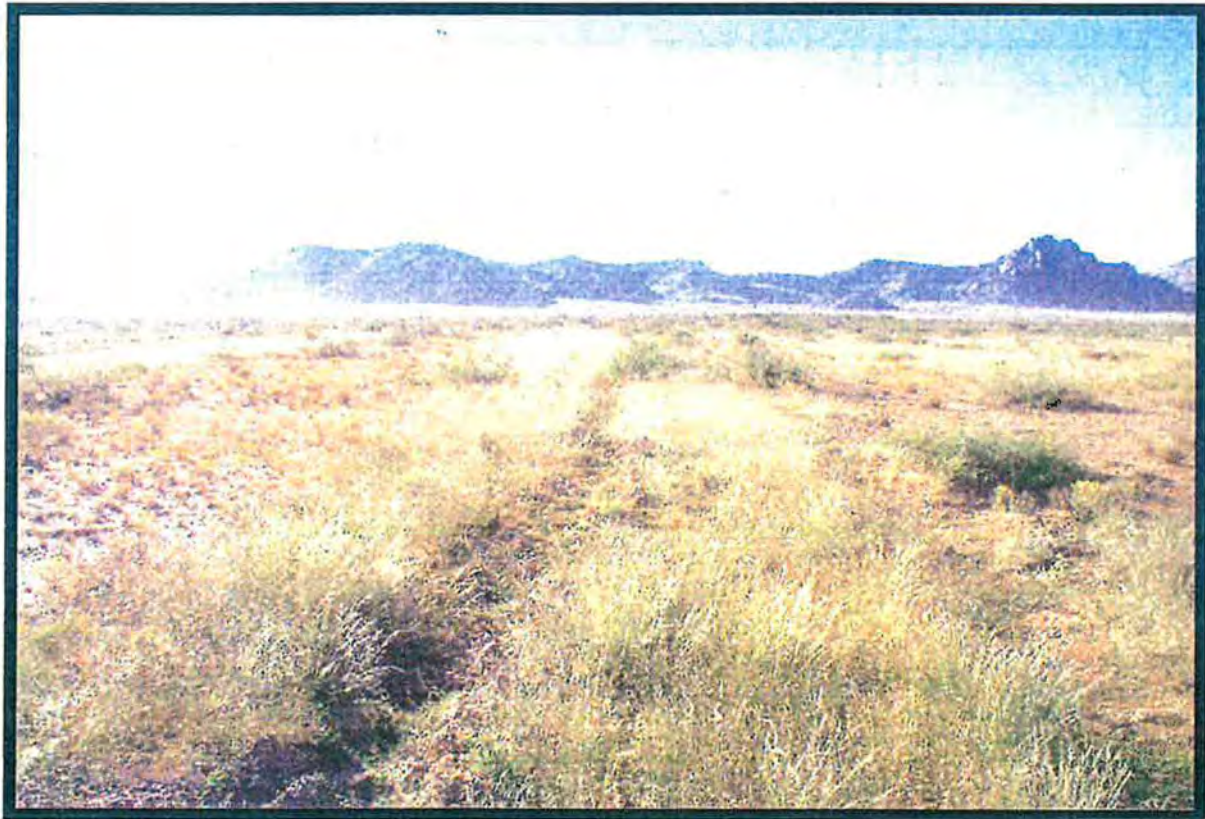
Ripped Areas

Transects for Key Areas F2 and F3 were read during the fall of the year. Initial readings were taken prior to land treatment. Photo sites at Rip 1-5 were established and photographed in July, 2003. These were established following treatment for proper locations within and outside of treatment areas. They were re-photographed in November, 2003 and April, 2005.

Five sites were selected for long term photo monitoring. They were selected based on differing soil types, treatment vs. no treatment, and differing grazing strategies. Photos were taken in the four cardinal directions at each site along with observational notes.
