**Upper Verde River Wildlife Area Turbidity Reduction  
Water Quality Improvement Grant  
FINAL REPORT**

**Arizona Game and Fish Department**  
ADEQ GRANT # 6-003

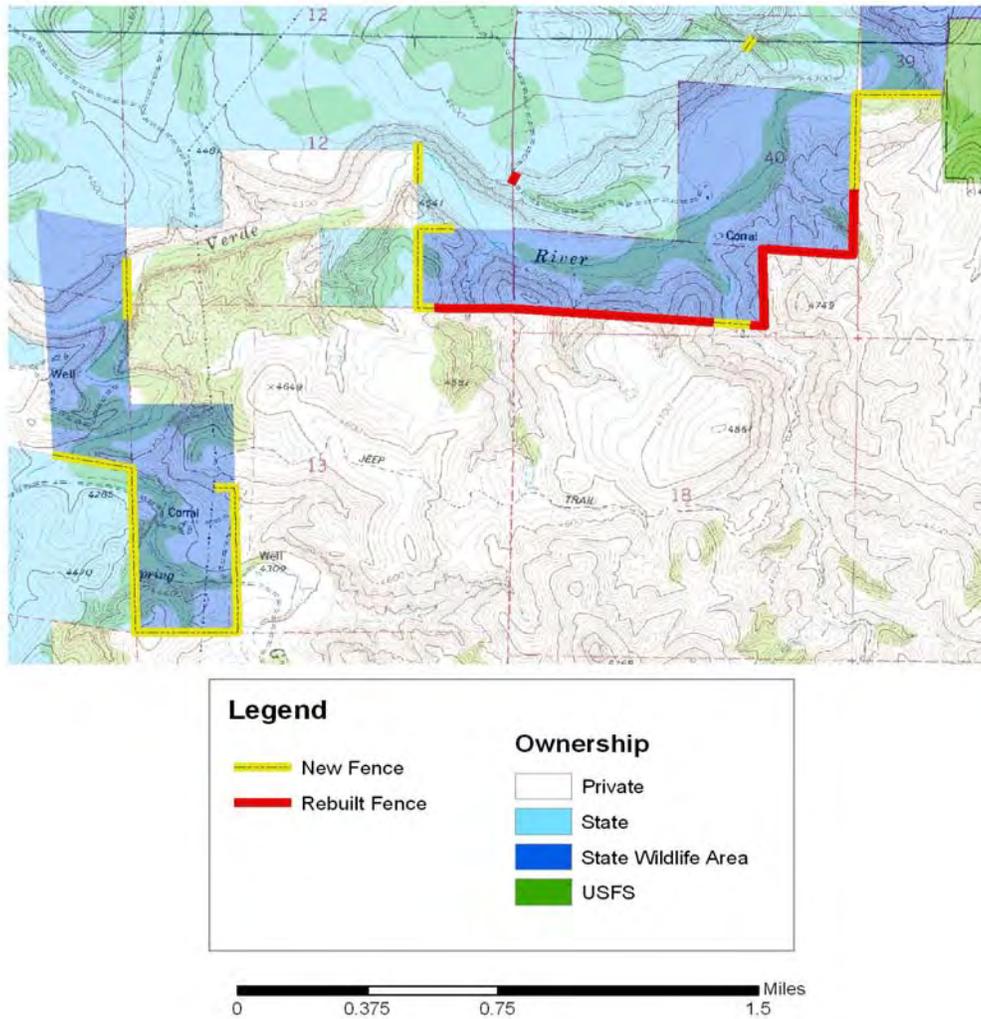
Figure 2. New and Rebuilt fence

Total fencing completed on the project includes 4,758m (2.96 miles) of new fence and 2,571m (1.60 miles) of rebuilt fence (Figure 2). Cliffs and other inaccessible areas make up the remainder of the property boundary. One small section of fence was constructed on adjacent state trust land. AGFD personnel contacted the current lessee for permission and submitted the appropriate paperwork to the Arizona State Land Department.

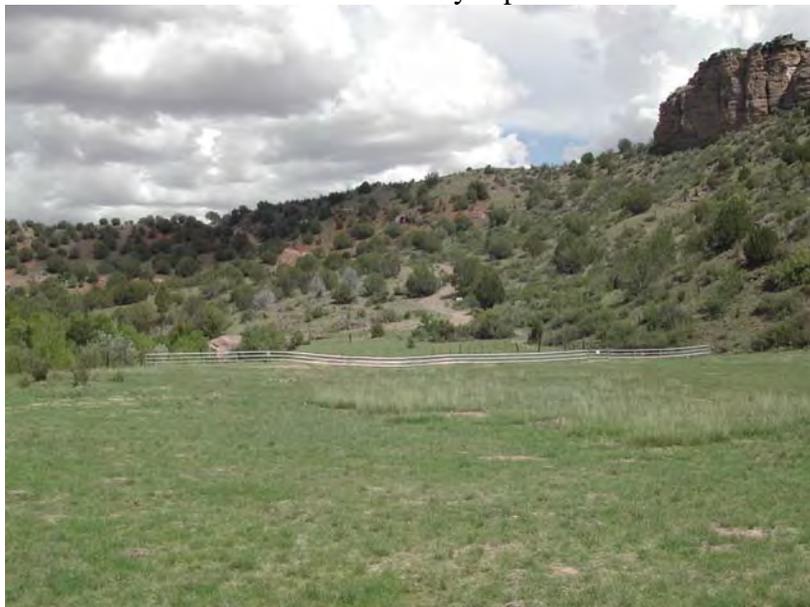
Photo 10. East Boundary Pipe Rail Fence

illegal use, vandalism and breeches from adjoining private land parcels have provided additional unauthorized access. Several steps were taken to implement this objective. Road closure signs were erected at all major access points and road diversions on the property (Photo 8-9). For the most part, signs have been ineffective due to theft and vandalism. New fence and gates were installed at remote access points. At the east boundary of the property, a pipe-rail fence was constructed to block a road entering the property from adjacent private land (Photo 10). A pipe and cable fence was erected to concentrate traffic on the main entrance road and prevent use of numerous wildcat roads around cultural sites (Photo 11-12).

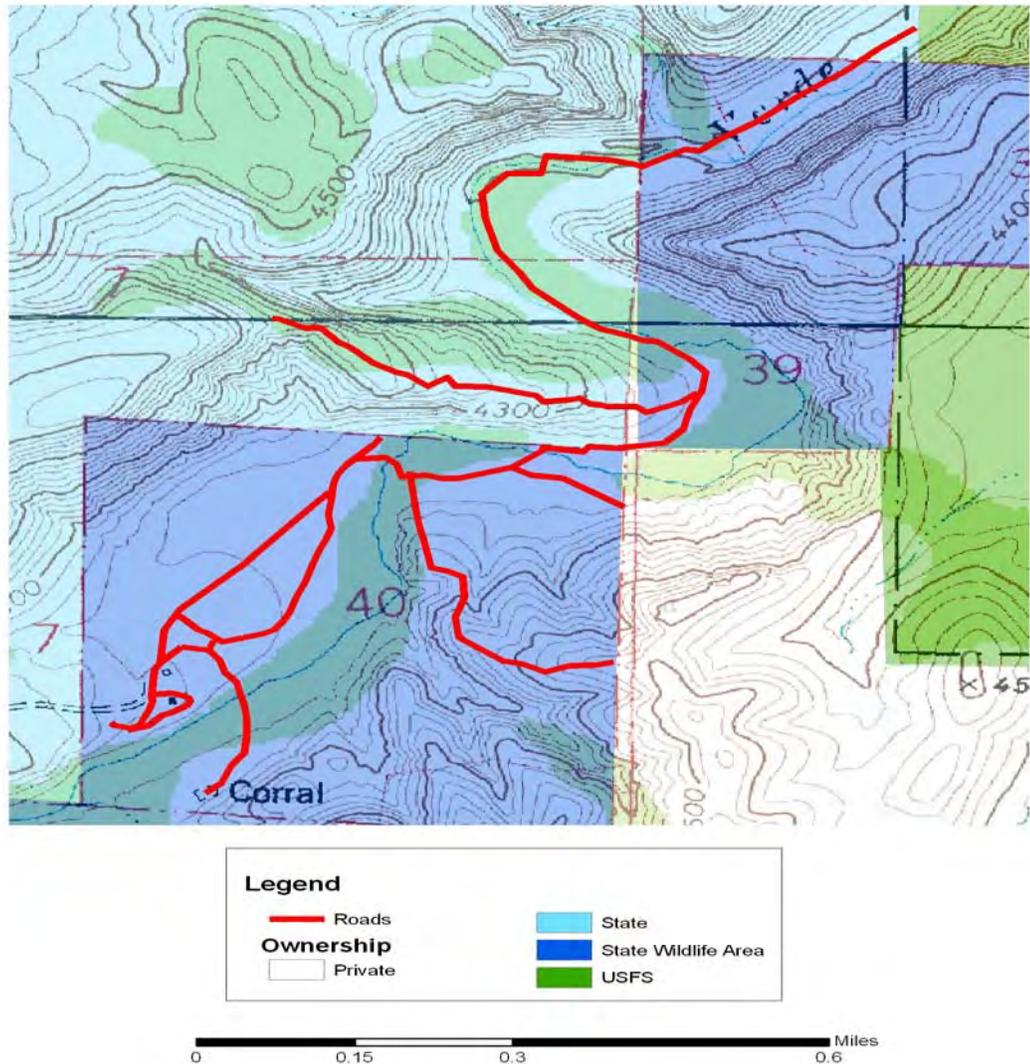
Figure 3. Closed Roads

The length of all roads was calculated (using GPS) at the beginning of the project and at the end of the project to compare the amount of roads closed. Total length of all roads surveyed is 5,506m (3.42 miles) (Figure 3). All of the roads are currently closed except for 200m of the main access road and approximately 150m of a new wildcat road that was started illegally around the end of the post-and-cable fence. This new road is scheduled to be closed using boulders by October 2006. An additional 350m of road will be kept open for administrative use to access the Salt River Project low flow monitoring gauge and AGFD maintained facilities. Many of the roads and river crossings are now starting to revegetate and show signs of healing (Photos 12-13).

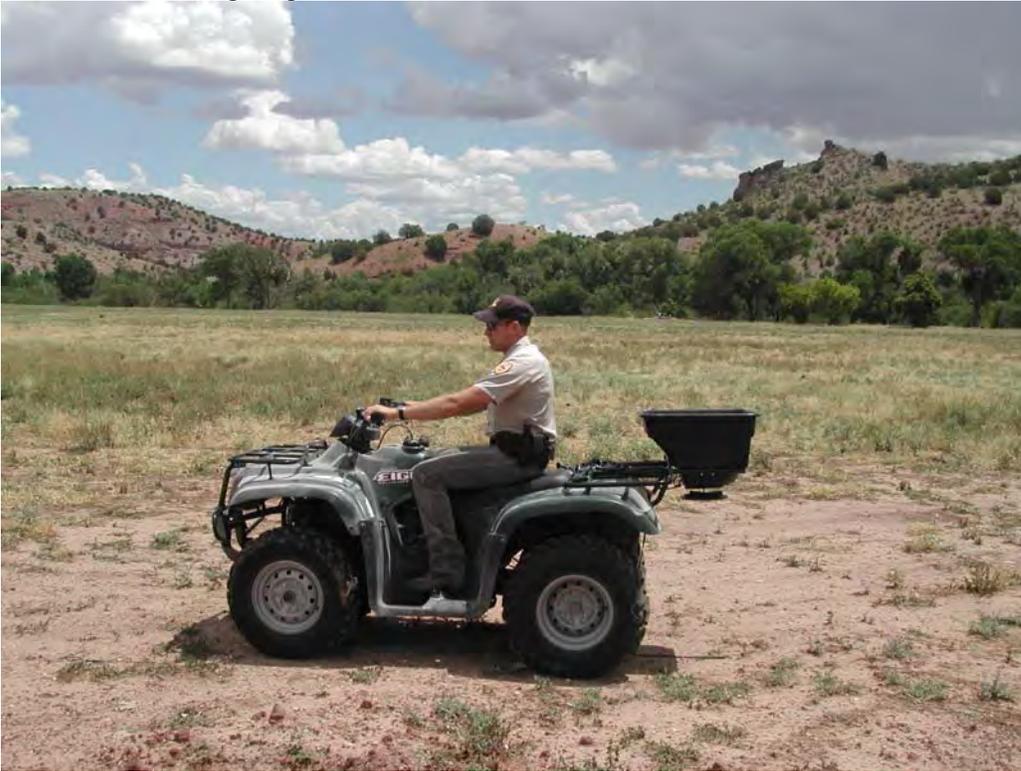
Photo 16. Seeding of grass, forb, and shrub mixture with ATV

Exposed soils due to heavy grazing, trampling, and illegal OHV use are subject to increased runoff and erosion. The objective of this conservation measure is to establish native trees, shrubs, forbs, and grasses in these areas to reduce erosion and sediment deposition into the Verde River. Floodplain terraces and associated banks that slope to the river and closed roads are the major problem areas on the project. A native seed mixture consisting of shrubs, forbs, and grasses appropriate for the area was obtained from Granite Seed Company of Lehi, Utah and used to reseed areas with exposed soils (Table 1). Because of archaeological considerations, an ATV mounted broadcast spreader was used to distribute seed (Photo 16). Adequate moisture for germination of the seed did not occur until late in the project cycle. Substantial monsoon rains in late summer 2006 have provided the moisture necessary for germination and plant growth on the site. Removal of off-road vehicles and livestock grazing from the project area will allow the area to recover and minimize erosion and exposed soils. The project is currently in the early stages of recovery and grasses and forbs are growing on banks and floodplain terraces (Photo 17).

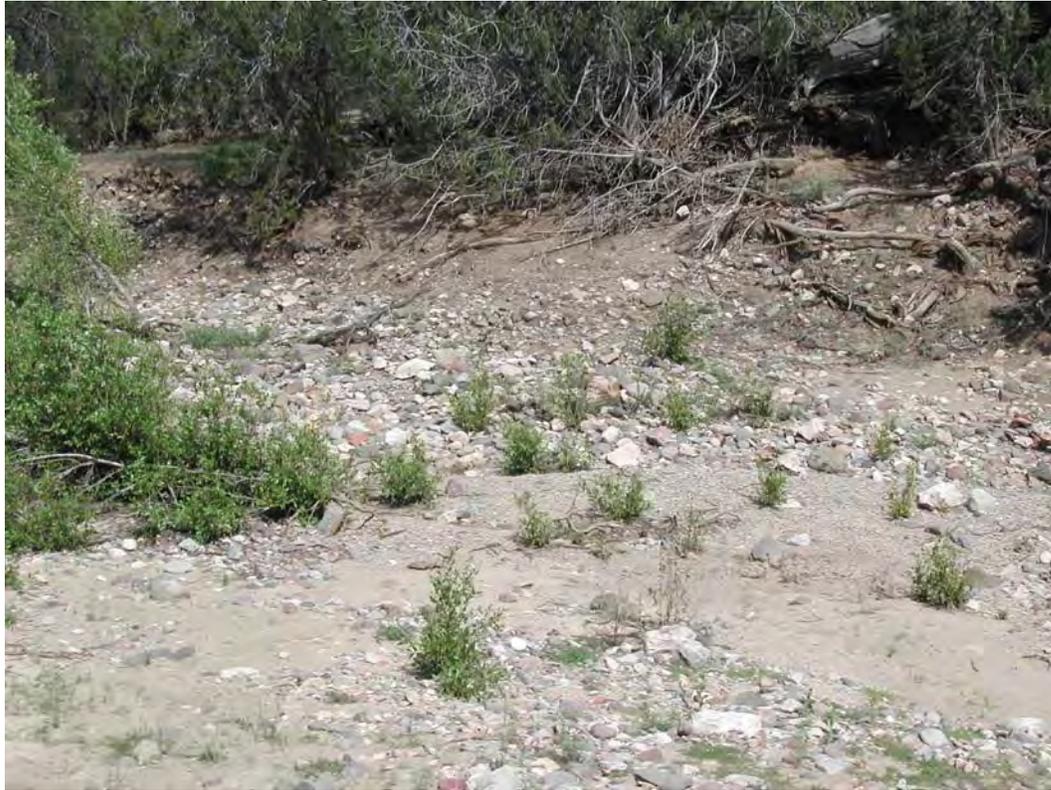
Photo 18. Cottonwood regeneration

Originally, cottonwood and willow poles were scheduled for planting on appropriate zones adjacent to the river. Flooding of the Verde River between September 2004 and March 2005 made this measure largely unnecessary. Cottonwoods and willows are disturbance adapted species and regeneration is tied to floods (Beauchamp and Stromberg, 2004). Cottonwoods and Willows regenerate profusely following appropriate flood events. Conditions were excellent for establishment of cottonwoods and willows following the 2004-05 flood events and regeneration is evident throughout the project area (Photos 18 and 19). Livestock grazing is detrimental to the establishment of cottonwood and willows. Livestock will readily consume young leaves and branches of cottonwoods and willows when nutritional quality of upland grasses falls during dry periods. Continued growth and establishment of these species is expected now that livestock have been removed from the project area.
